## BUILT IN DUAL SPECTRUM CHIRP ULTREX/FORTREX ADPT CABLE INCORRECT

**Affected Models:** Fortrex, Ultrex, and Ultrex Quest Equipped with DSC.  
1368667, 1368677, 1368668, 1368890, 1368891, 1368895, 1368896,  
1368900, 1368901, 1368902, 1368894

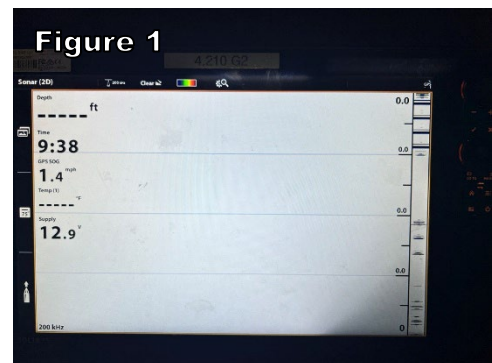
**Reason:** 490575-2 was manufactured incorrectly. Humminbird Solix and Apex Units are unable to identify the connected transducer due to this manufacturing error.

The resistor that is used to identify sonar type was installed across the wrong pins; due to this a Solix or Apex unit will not identify that a transducer is connected and will not “ping” the transducer, Figure 1 is a Solix Unit displaying the 2D Sonar Screen that should be expected when connected to a DSC motor with a faulty 490575-2.

**Actions:** Contact Minn Kota Customer Service for replacement of any 490575-2 shipped from Minn Kota prior to 17 May 2024 with Kit 2886302 (490575-2 w/Installation instructions and necessary tie wraps).

When performing any service on an affected motor replace suspect 490575-2 with 2886302 Kit and file a warranty claim for that repair.

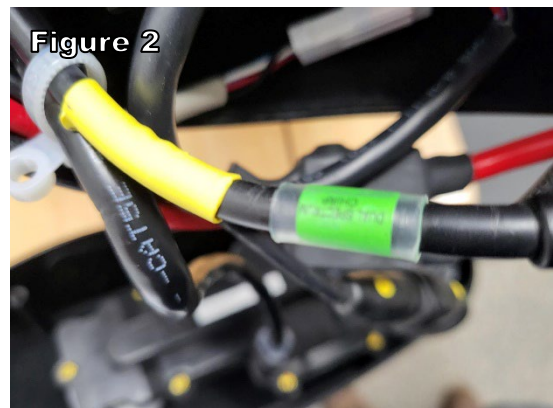
Suspect Cables will have a small green shrink with “Dual Spectrum Chirp” printed on it, and a slightly larger, yellow heat shrink, on the control box end of the cable, and no other factory markings. (Figure 2). Any other factory markings suggest the suspect cable has been replaced with a newer one.
