## Terrova BT Lift Assist Collar Changes

**Reason:** Part Update

**Affected Part Numbers:** 2771522 replaced with 2771523

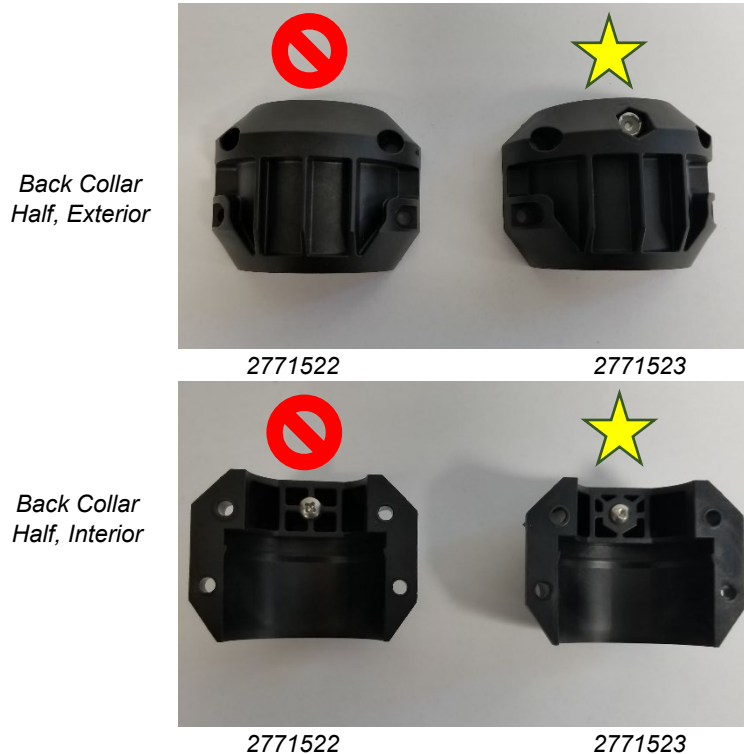
The Lower Collar Kit for the Lift Assist System on Terrova motors has changed from a thread cutting screw to a machine screw retained by a nut. This eliminates possible weakening of the collar material by the screw.

We recommend replacing any 2771522 Collar Kits in your stock with 2771523 Collar Kits. The 2771523 has a machine screw and a nut with a pass through hole in the back collar half where 2771522 has a thread cutting screw and a blind hole in the back collar half. Both kits are complete collar installation kits, only the parts that are different are described and pictured.

Contact Minn Kota Customer Service ([aschotline@johnsonoutdoors.com](mailto:aschotline@johnsonoutdoors.com)) to have any 2771522 in stock replaced with 2771523.
