Talon Updates

Since the release of the 10' and 12' Talon Shallow Water Anchors in 2014 there have been a few minor design changes to improve some of the original components. These changes did not represent safety issues, but are an indication of an effort to continuously improve the reliability and performance of the Talon product line. **If the latest/current component part is not already installed then the installation of the current part(s) should be considered an “automatic” update.** This applies to both in-warranty and out-of-warranty units. We will honor warranty claims on all 3-stage Talon Shallow Water Anchors for these updates:

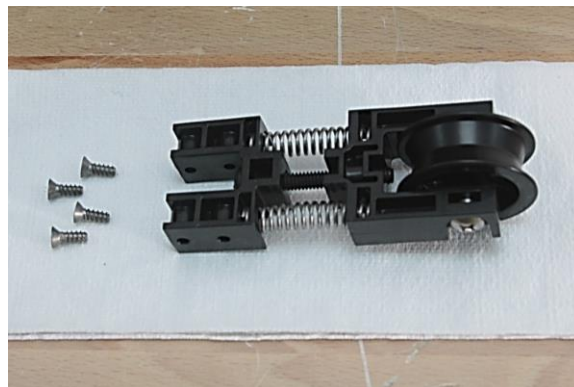
Figure 1. Lower Cable Tensioner Assembly

Cable Tensioner, p/n 2773630:

Beginning at serial number **O325MK** a lower cable tensioner replaced a fixed lower pulley to reduce the possibility of a cable coming off of any pulley internally. In addition to improving Talon function it will be necessary to install this in place of the lower pulley to reassemble the Talon as the tools to reassemble it with a fixed pulley are not going to be made available.

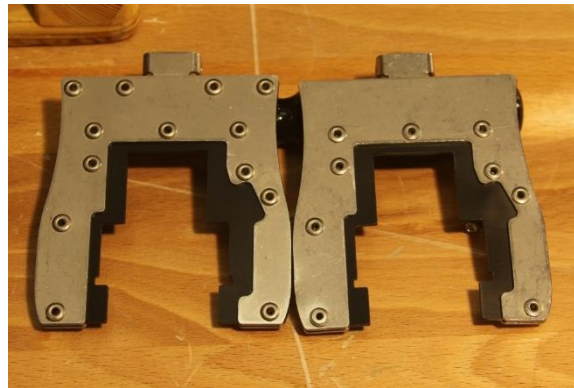
Figure 2. Second Stage Wiper Assemblies

Second Stage Wiper, p/n 2884618:

On some early units the bottom plate of the second stage wiper was pealed back. To remedy this a row of rivets was added to the leading edge of the second stage wiper assembly beginning around serial number **O183MK**. Correct wiper assemblies have a total of thirteen (13) rivets, the previous version had nine (9) rivets. Any units that still have the wiper assembly pictured on the right in fig. 2 should be updated to the current second stage wiper assembly.

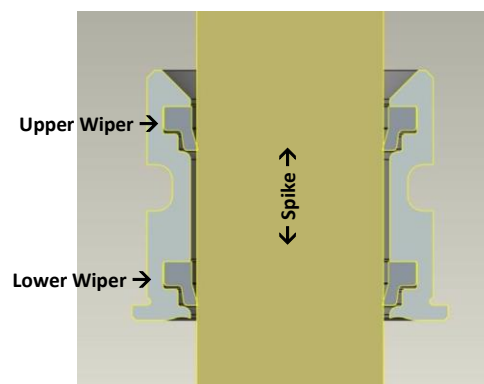
Figure 3. Spike Isolator Assembly w/Wipers in Cross Section

Spike Isolator Wiper ASM, p/n 2778825:

To further prevent mud and debris from entering the Talon the Spike Isolator was modified to include a flexible wipers that will remove more material from the Spike during retraction. This change began with serial number **P266MK**. The wipers are trapped in grooves in the spike isolator, this change is not visible externally, Figure 3 shows a cross section of the new wiper assembly with the spike in place.
