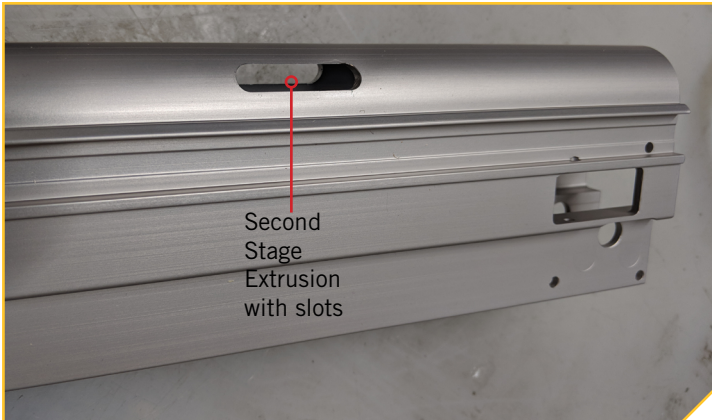
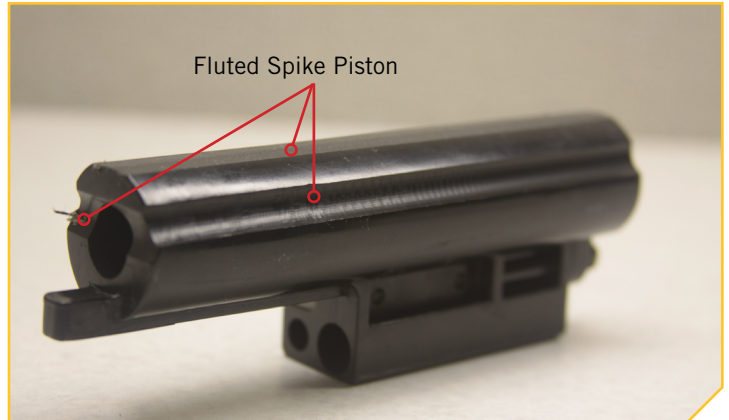
This update is intended to prevent sand or other debris from getting stuck in and around the Spike Piston, causing the Talon to bind. It will require changing the Second Stage Extrusion and spike piston. The two slots in the new Second Stage, along with the fluted spike piston will allow water to flow through and flush out sand and other small debris.
