## Ulterra Updates

Since the release of Ulterra in early 2015 there have been a few minor design changes to improve some of the original components. These changes did not represent safety issues, but are an indication of an effort to continuously improve the reliability and performance of the Ulterra product line. **If the latest/current component part is not already installed then the installation of the current part(s) should be considered an “automatic” update:**

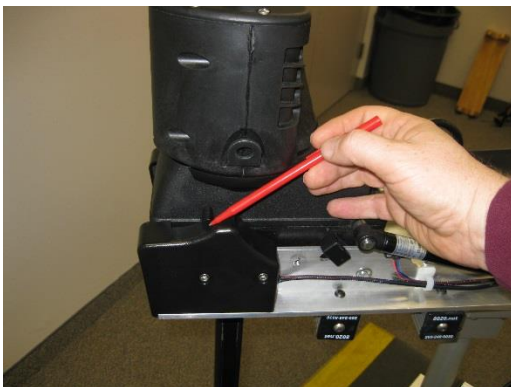
Location of ramp plunger (under motor ramp).

Beginning at serial number **P224MK** and later all magnet holders are using a mechanically staked-in process to prevent magnet loss. Verify Ulterra models with older serial numbers have the updated ramp plunger with staked-in magnet.

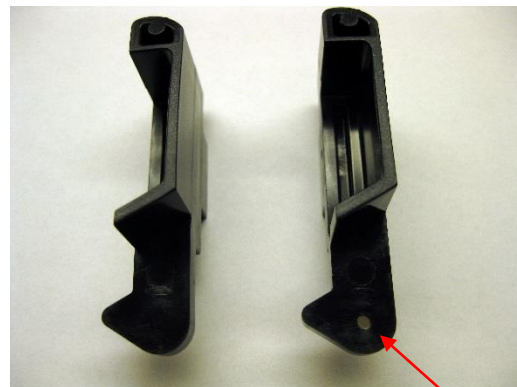
Original plunger on left. Current plunger on right.  
Notice that you can see the magnet through the pass-thru hole.

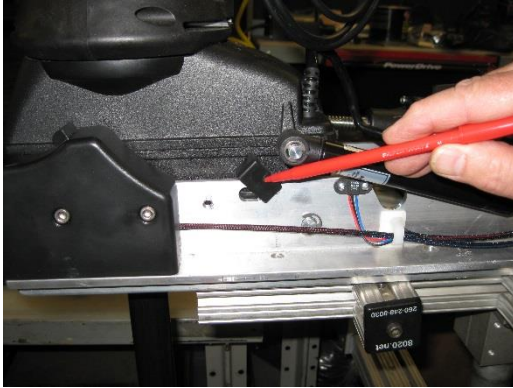
Location of tilt bracket magnet holder.

Beginning at serial number **P224MK** and later all magnet holders are using a mechanically staked-in process to prevent magnet loss. Verify Ulterra models with older serial numbers have the updated ramp plunger with staked-in magnet.

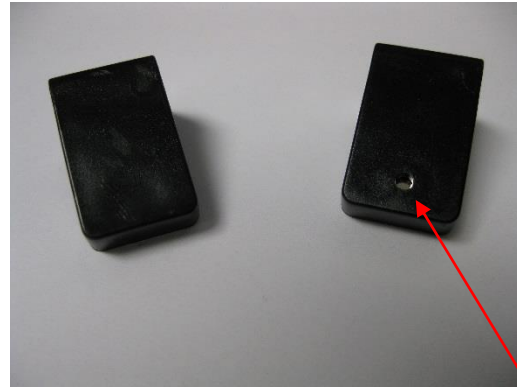
Original magnet holder on left. Current magnet holder on right. Notice that you can see the magnet through the pass-thru hole.

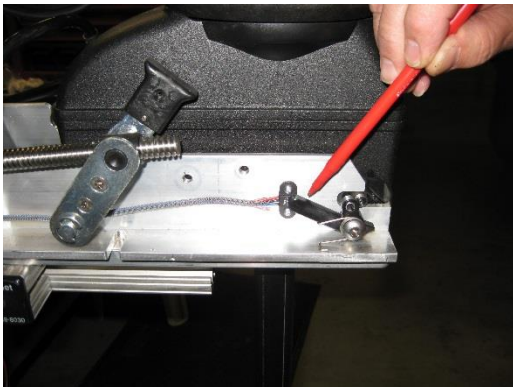
Location of cam sensor arm.

Beginning at serial number **P224MK** and later all magnet holders are using a mechanically staked-in process to prevent magnet loss. Verify Ulterra models with older serial numbers have the updated ramp plunger with staked-in magnet.

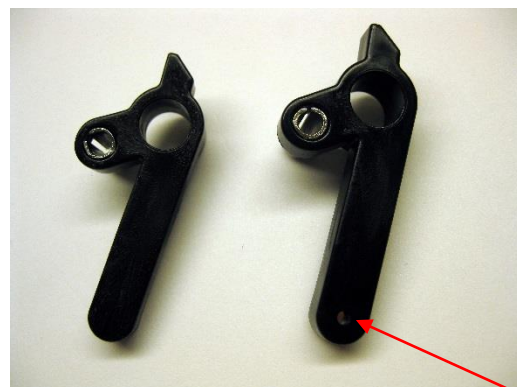
Original cam sensor arm on left. Current cam sensor arm on right. Notice that you can see the magnet through the pass-thru hole.

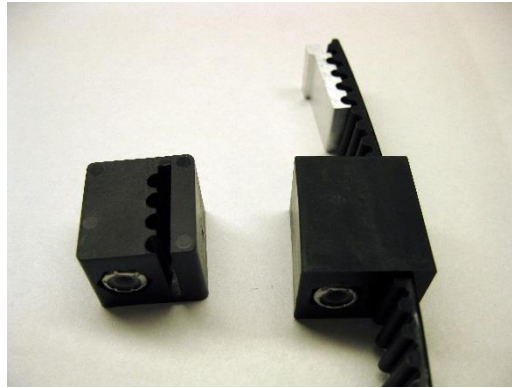
Original belt block on left. Current belt block with belt rack on right.

(Original design had the belt sliding in from the side. The current design has the belt passing through the block and is retained with a metal belt rack.)

Beginning at serial number **P349MK** the upper belt block for tensioning the belt has been changed to a multi-piece design to lessen the chance of the belt pulling out of the control box. The original belt block, p/n 2202800, supersedes to p/n 2882801 which includes the belt rack.
