## PROPER ROUTING OF CABLES AT THE MAIN CONTROL BOARD

**Service Bulletin****Effective Date:** December 13, 2024**Affected Models:** Ulterra Quest, Riptide Instinct Quest, 1358502, 1358501, 1358503, 1358540, 1358541, 1358542, 1358560, 1358561, 1358562, 1358563, 1358580, 1358581, 1358583, 1377950, 1377951, 1377952, 1377955, 1377956, 137957, 1377960, 1377961, 1377962, 1377963, 1377971, 1377972, 1377973**Serial Number****Range:** All motors older than Serial Number 24312M#####**Reason:**

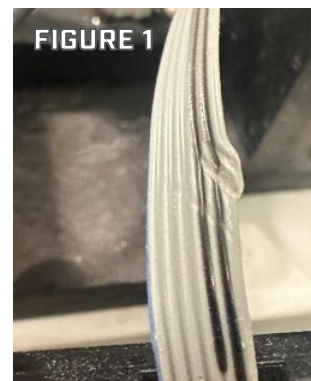
1. Incorrect Routing of the Ribbon Cable connecting the Power Button/LED Board to the Main Control Board allowed the Ribbon Cable to be pinched and damaged.
2. Routing of the Horizontal Sensor Wires to the Main Control Board allowing the wires to be pinched or damaged.

Reports of damage to the Ribbon Cable connecting the Power Button/LED Board to the Main Control Board have been received, an example of this damage is Figure 1. This damage is caused by the pinching the Ribbon Cable between the Control Board Cover and the Tilt Actuator. To be certain the Ribbon Cable cannot be pinched in this way the Ribbon Cable should be routed under the Wires to the Batteries as Shown in Figure 2.

1. During any repair of an Ulterra Quest or Riptide Instinct Quest Motor the Ribbon Cable should be inspected for damage. To ensure that is not damaged in the future the Ribbon Cable should be routed as shown in Figure 2.
2. Verify the routing of the Horizontal Sensor Wires is as shown in Figure 3 below and inspect the Horizontal Sensor Wires for damage. If the Horizontal Sensor Wires are damaged the Main Control Board should be replaced.

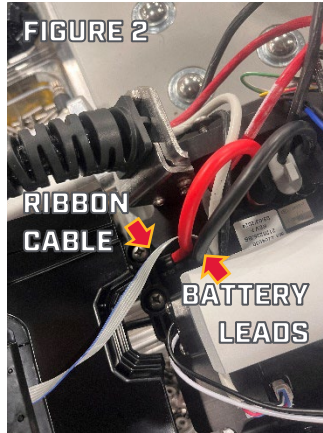
These routings prevent pinching of the wires when the Control Board Cover is in place.
