Service Bulletin

Ulterra Trim Module Repair

Model: All Ulterra and RT Ulterra

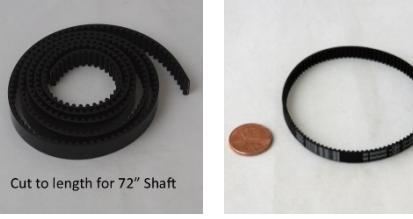
Lift Belt Example [2770819]

- The Lift Belt is the large belt that runs along the Shaft of the motor from the Control Box to the Motor Lower Unit, running through the Trim housing.
- The Trim Belt is a Small Belt inside the Trim Housing, it is driven by the Trim Motor and drives the worm gear that actuates the lift belt.

Lift Belt replacement is indicated when there is apparent damage or wear visible on the Lift Belt and no other trim housing issues that would indicate the trim housing should be replaced. Case XVII Includes the instructions on Lift Belt Replacement.
