AUTHORIZED SERVICE PROVIDER MANUAL
TALON REPAIR MANUAL

BT TALON 8', 10', 12', 15' - 2018-PRESENT

3 STAGE TALON 8', 10', 12' - 2014-2017

2 STAGE TALON 6', 8' - 2011-2015

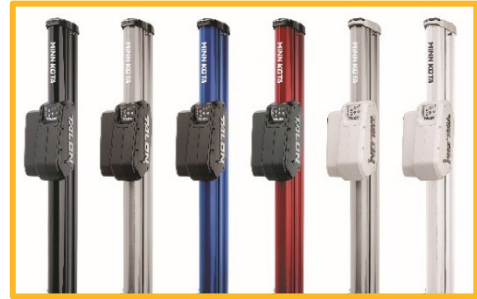
- Remote is Black with 4 Buttons
- Worklight integrated into the Top Cover
- Curved front edge of the Talon
- 5 lights Depth Indicator Lights
(Control board is programmed to length)
- 4 button Control Bezel (Up, Down, Mode, Light)

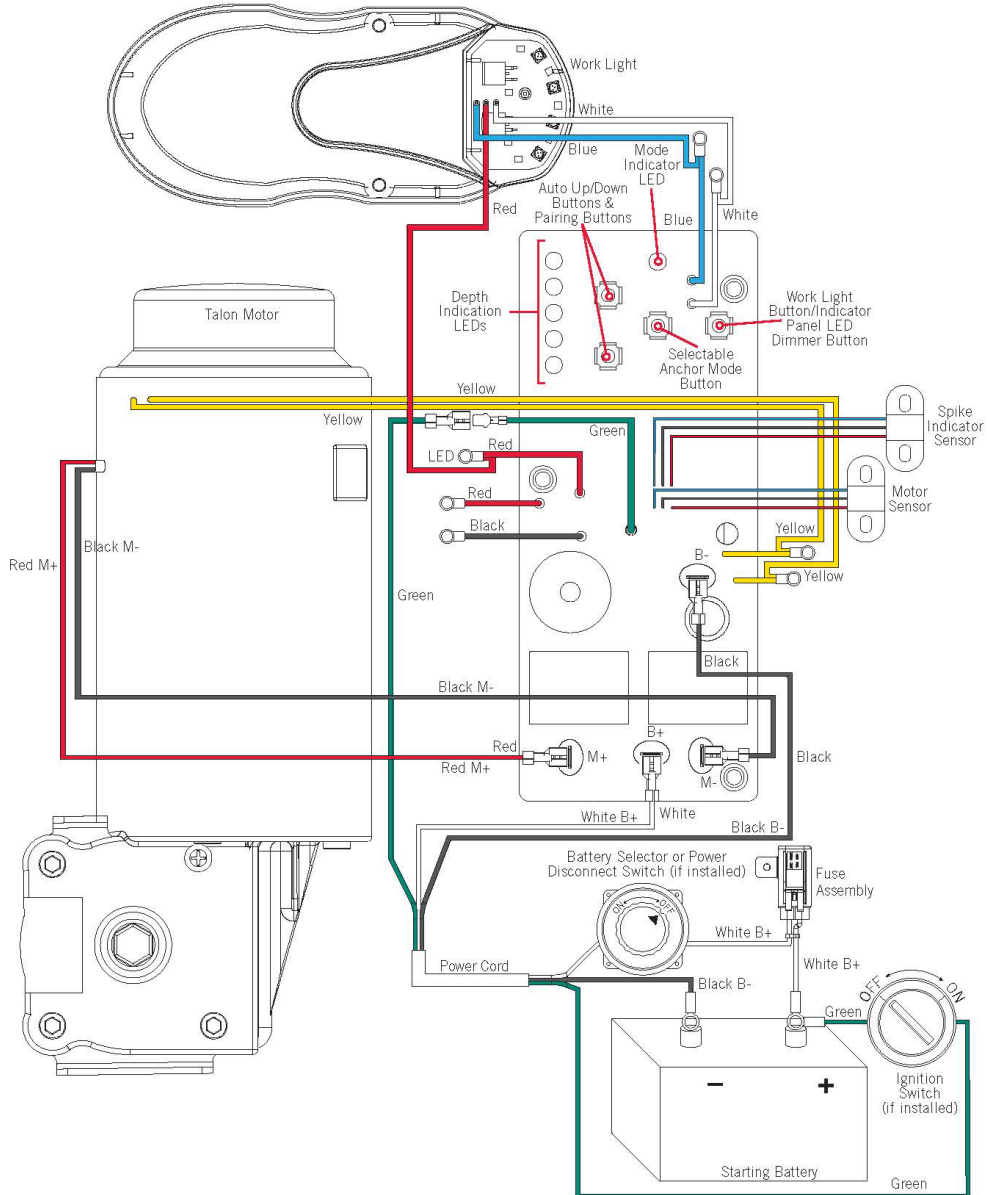
The following Motor Wiring Diagram applies to all Talon models.

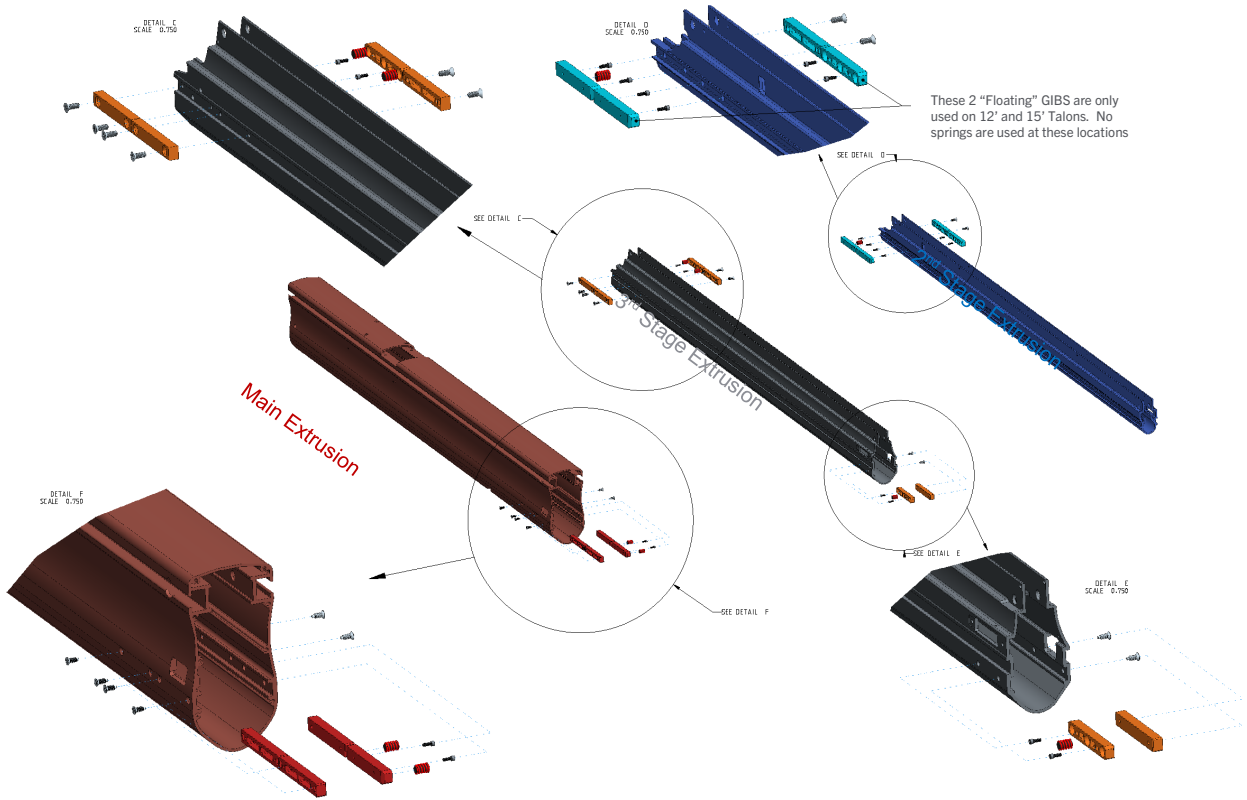
GIB (Gliding In-Line Bearing) Map. 2nd Stage in Blue, 3rd Stage in Gray/Yellow, Main Extrusion in Red

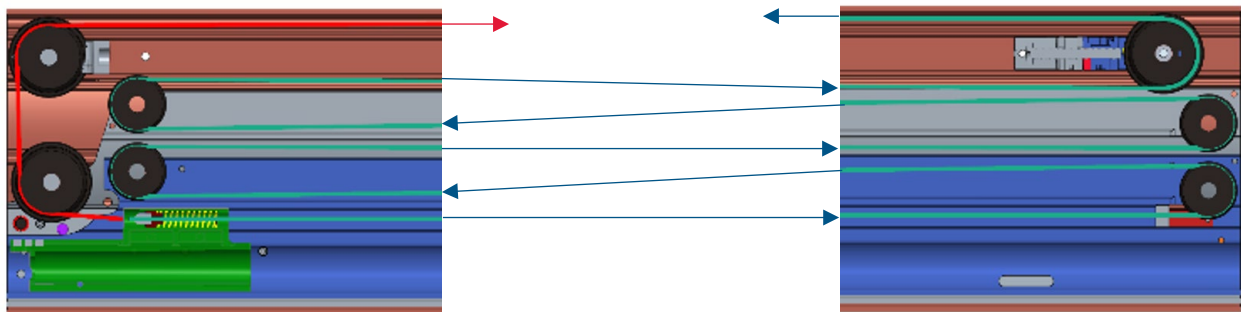
Cross Section to show Cable Routing (Talon cut in half down the midline, viewed from the side). Spike Piston Green, 2nd Stage Blue, 3rd Stage Gray, Main Extrusion Red. Retractions Cable Red, Extension Cable Teal.

Close up of top and bottom, Connecting Arrows show Cable direction away from Spike Piston/to Wrap Drum

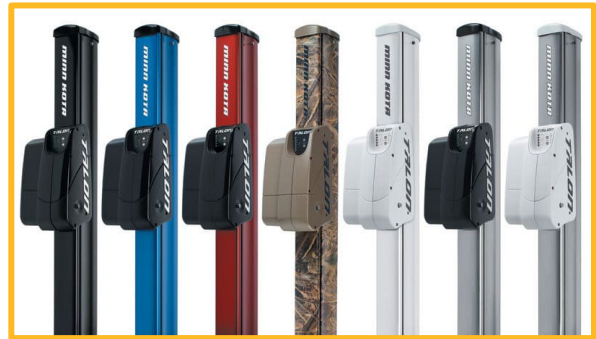
- White, 2 button remote
- 6 Depth indicator lights on board
 - 4 visible on 8' models,
 - 2 blacked out by decal
 - 5 visible on 10' models,
 - 1 blacked out by decal
 - All 6 visible on 12' models
- 3 button Control Bezel (Up, Down, Mode)

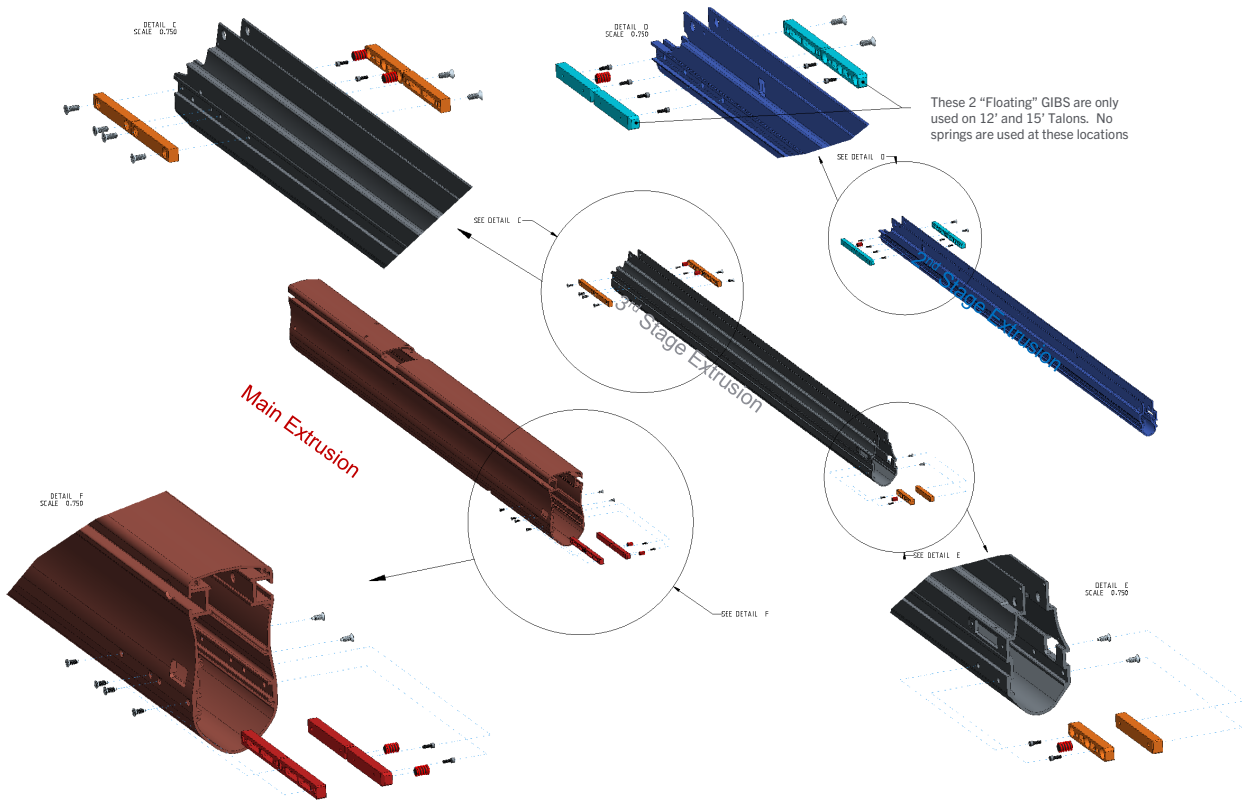
GIB (Gliding In-Line Bearing) Map. 2nd Stage in Blue, 3rd Stage in Gray/Yellow, Main Extrusion in Red

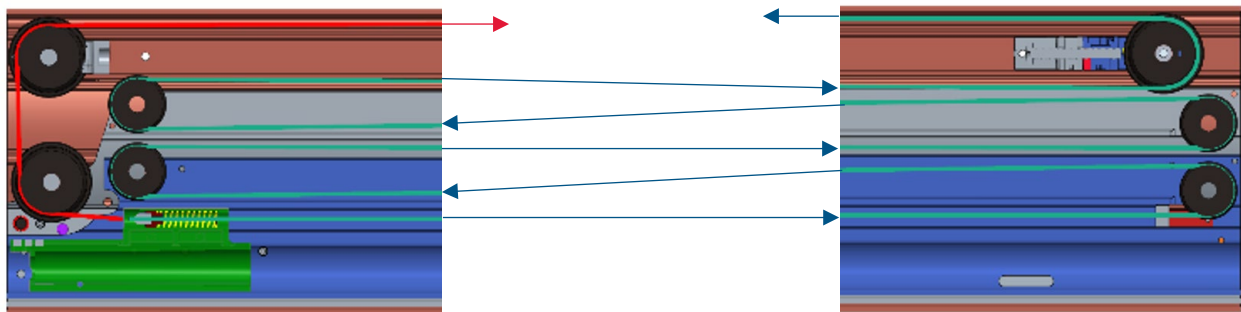
Cross Section to show Cable Routing (Talon cut in half down the midline, viewed from the side). Spike Piston Green, 2nd Stage Blue, 3rd Stage Gray, Main Extrusion Red. Retractions Cable Red, Extension Cable Teal.

Close up of top and bottom, Connecting Arrows show Cable direction away from Spike Piston/to Wrap Drum

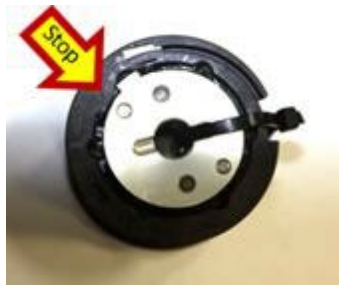
CAUSE: The wrap drum "hard stop" that engages the wrap drum drive hub is sheared off and/or the torsion spring inside the wrap drum is damaged/destroyed.

Wrap Drum Stop

CORRECTIVE ACTION: The damaged wrap drum assembly will need to be removed and replaced with p/n 2777915 (wrap drum, torsion spring, and drive hub assembly).

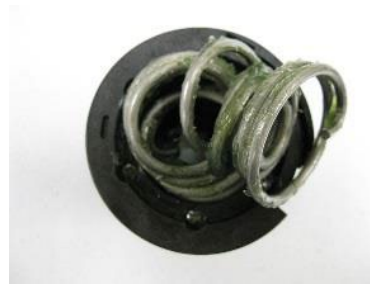
Damaged Torsion Spring

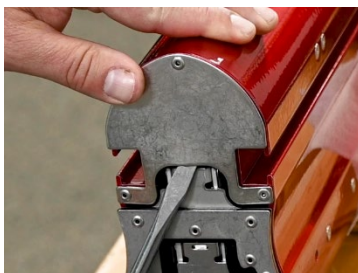
Pry Water Shield Off

STEP 4. Use a flat blade screwdriver or small prybar to remove the water shield. Using the bottom edge of the third stage as a fulcrum applying firm pressure as close to the rivets as possible will unseat the rivets without damage to any part of the Talon. Support the water shield in a vice or clamp to drill out the rivets. If slightly bent hammering on a flat surface will straighten the water shield.

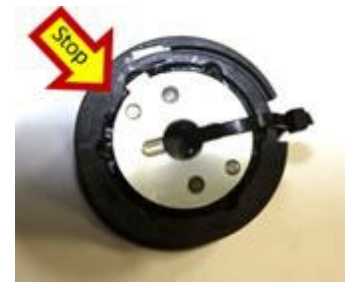
STEP 8. Remove the tie wrap from the replacement wrap drum. (The replacement wrap drum is shipped with the torsion spring and wrap drum drive hub assembled and pre-loaded. The tie wrap is used to hold everything together while in the pre-loaded condition). When "pre-loaded" the wrap drum drive hub stop will be on the clockwise side of the wrap drum hard stop. Use care not to disengage the pre-loaded hub from the spring and wrap drum).

Wrap Drum/Hub Preload

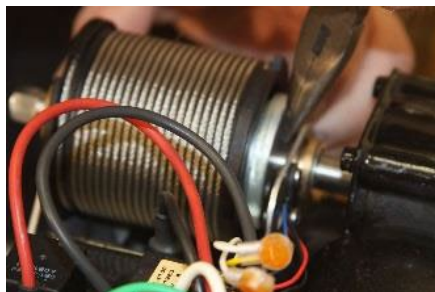
CAUSE: This may be due to the Wrap Drum Spacer either coming off or breaking. This allowed the Wrap Drum Assembly to shift to the right (away from the motor) and the Wrap Drum Hub has disengaged from the Drive Pin. As a result the motor runs but the wrap drum does not turn and the extension/retraction cables do not unwind/wind up.

Example of a Disengaged Hub

CORRECTIVE ACTION: Remove the left and right motor housing covers, noting the where used location, type, and length of the screws for reassembly. Lift the switch bezel off of the control board. With the housings and bezel removed, examine the wrap drum assembly. The wrap drum assembly should be almost centered in the wrap drum mounting bracket and a black plastic spacer should be visible between the side of the wrap drum and the mounting bracket on the right side (side away from the motor). If the wrap drum not centered or the black spacer is missing or broken check to see if the driveshaft pin is missing. If the driveshaft pin is missing attempt to locate it (it may have fallen into the main extrusion). If the driveshaft pin cannot be found, replace it.

Verify the wrap drum drive hub and torsion spring are properly preloaded as noted in [PART 11 – WRAP DRUM ASSEMBLY](#) on Page 39. Align the drive pin slot of the drive hub with the driveshaft pin inserted through the motor driveshaft. Slide the wrap drum assembly toward the motor and install the black plastic spacer (p/n 2371537 wrap drum spacer) between the wrap drum and mounting bracket.

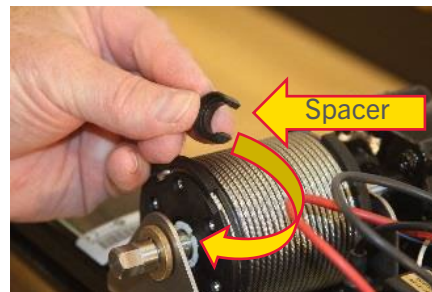
Spacer Removed for Visibility

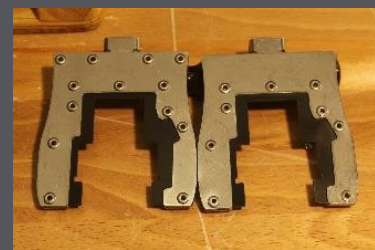
CAUSE: Damage to the leading edge of the wiper assembly is caused by water pressure against the leading edge of Talon. If this occurs on a BT Talon or a 1st Generation 3 Stage Talon with the updated wiper the Talon is mounted too low and should be raised.

The new wiper assembly, p/n 2884618, has thirteen (13) rivets compared to the nine (9) rivets for the old assembly.

Examples of 1st Generation 3 Stage Talon Wiper Assemblies (Updated version on left)

CORRECTIVE ACTION: To replace the old or damaged wiper assembly the Talon third stage extrusion must be extended a few inches out the bottom of the main extrusion. This can be done by connecting the Talon to a 12 volt power supply and pressing the DOWN button on the Talon, to stop the Talon at the desired position press the DOWN button again or disconnect the 12 volt power source. Locate the four (4) pulled rivets that hold the wiper assembly in place at the bottom end of the third stage extrusion. Spin off the heads of the pulled rivets with a 1/8" drill bit and portable drill. Drive out the rivet shanks with a 1/8" pin punch and remove the wiper assembly and the punched out shanks from the third stage. Install the new wiper assembly and secure it in place with four (4) of the p/n 2378601 rivets. Connect the Talon to the 12 volt power source and test retract/extend to verify proper function to complete the repair procedure.

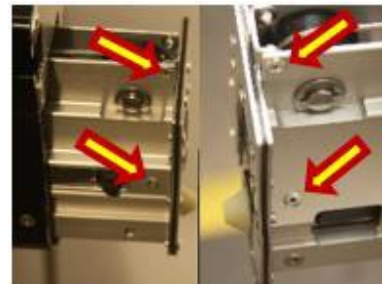
Rivet Locations

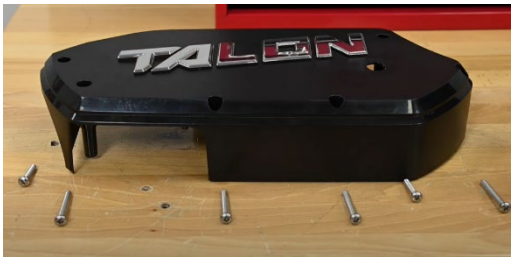
Right Motor Cover and Screws

1. Use #2 Phillips Screwdriver to remove the screws securing the Motor Covers. (4) #8-16 X 1.5” screws secure the Right Motor Cover to the Left Motor Cover, (2) #8-32 X 1.0” secure the Right Motor Cover to the Main Extrusion, and (1) #8-32 X 1.0” and (1) #8-32 X 5/8” screws secure the Left Motor Cover to the Main Extrusion.

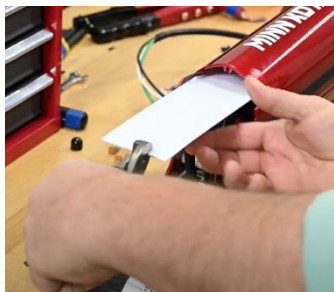
Pull The Channel Divider

1. Remove the Channel Divider
2. Remove the (2) #8-18 X 1" Screws Securing the Sensor Bracket for the Home Position Sensor to the Main Extrusion, take care to keep track of the (2) 1/8" Spacers between the Bracket and Main Extrusion.

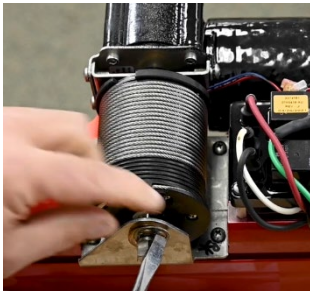
Remove the E-Clip

3. Remove the Motor Assembly.
 - a. Remove the outer E-Clip from the end of the Motor Assembly's Drive Shaft.
 - b. Use a Needle-Nose Pliers to remove the Wrap Drum Spacer, Set the jaws of the Pliers against the Spacer on either side opening of the spacer the push down on the

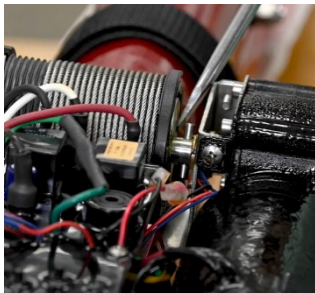
Remove the Drive Pin

- c. Pry against the Wrap Drum Hub with a Flat Blade Screwdriver to free the Drive Pin, then Remove the Drive Pin.
- d. Remove the (3) #10-32 X 1/2" Screws that secure the Motor Assembly to the Motor Bracket.

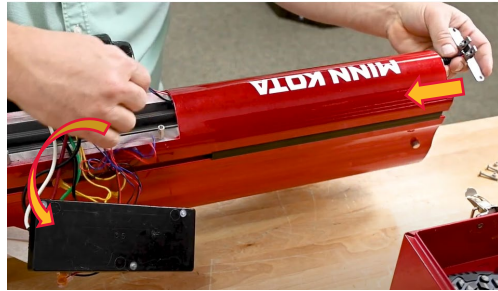
Control Board Set Aside/Feed Sensor Assy

- g. Lift the Main Control Board away from the Extrusion and set it aside.
- h. Feed the Home Position Sensor, attached to its bracket, from the top of the Talon to the opening for the Control Board and Motor Assembly.
- i. Pull the Motor Assembly Away from the Main Extrusion, Wrap Drum and Wrap Drum Bracket. Make Note of the Bushing Locations to make sure they are reassembled correctly.

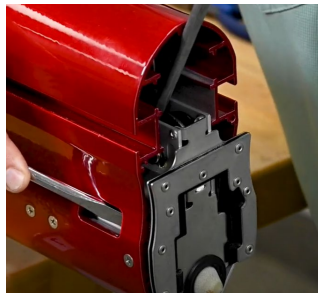
Extend 3rd Stage Out

3. Use a small flat blade screwdriver to depress the 3rd Stage Latch while Prying against the lower pulley of the 3rd Stage to extend the 3rd Stage a few inches out of the Main Extrusion.
4. Drill out the heads of the (4) Rivets that affix the 2nd Stage Wiper to the 3rd Stage Extrusion, remove the wiper and retrieve any rivet slugs that may be left behind.

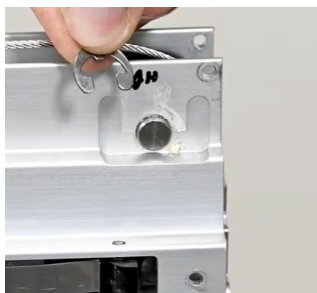
Remove Upper and Lower Pulley

1. Remove the pulleys at the top and bottom of the Third Stage by removing (1) E-Clip from each and sliding the Pulley Pin from the Extrusion
2. Remove the screws that retain the GIBs at the Bottom of the Third Stage. These are (2) #8-18 X .437" on the left side and (2) #4-40 X 5/16" on the right side. The Floating/Spring Loaded GIB is on the opposite side as compared to the GIBs at the bottom of the Main Extrusion.

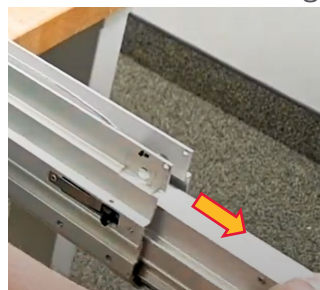
Advance the Second Stage out of the 3rd

3. Begin advancing the 2nd Stage and Spike out of the 3rd Stage Extrusion by pushing in on the 2nd Stage Latch and pushing the 2nd Stage Extrusion down/out from the top.
4. As the 2nd Stage is pulled out of the 3rd the spring loaded GIBs will be on the Talon's right side. One spring in the center pocket of the lower floating GIB.

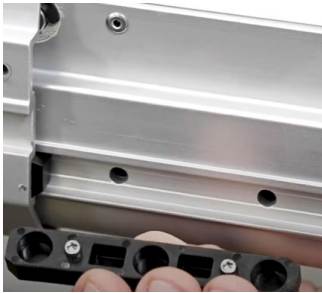
Catch the Free-Floating GIBs

5. On 12' and 15' Models there will be two "free floating" GIBs that are next to come off of the 2nd Stage, these are floating GIBs with the #4-40 cap screws installed and no springs.
6. Last there will be a spring loaded floating GIB on the Talon's Right side and a Fixed GIB on the Talon's Left side.
7. Finish removing the 2nd Stage and Spike Assembly from the 3rd Stage Extrusion. Set the 3rd Stage and its support aside, place the 2nd Stage assembly in its holder.

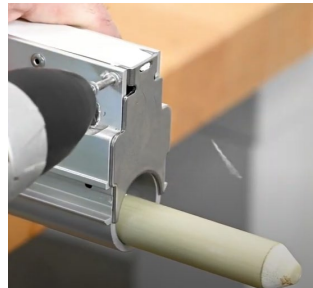
Drill out the Rivets

8. Remove the Spike Isolator; use a 1/8" Punch to drive the retaining pin out of the second stage extrusion then pull the Spike Isolator Bushing out of the 2nd Stage Extrusion.
9. Use a Drill and 1/8" Drill bit to drill out the heads of the rivets retaining the debris shield.
10. Remove the Debris Shield from the 2nd Stage Extrusion.

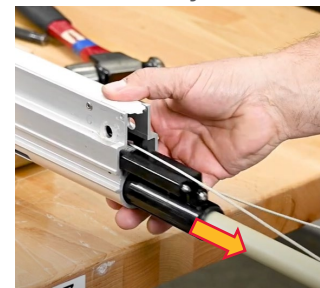
Remove the Piston/Spike Assembly

11. Remove one E-Clip from the Lower Pulley Pin, then remove the Pulley Pin and Pulley from the bottom of the 2nd Stage Extrusion.
12. Remove one E-clip from the Upper Pulley Pin (stabilizing the pin with a pliers makes this task easier). Then remove the Pin and Pulley from the top of the 2nd Stage Extrusion.
13. Remove the Spike and Spike Piston from the 2nd Stage Extrusion as an assembly.

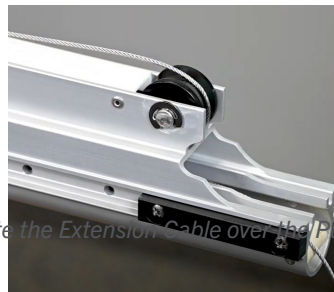
Install the Upper Pulley

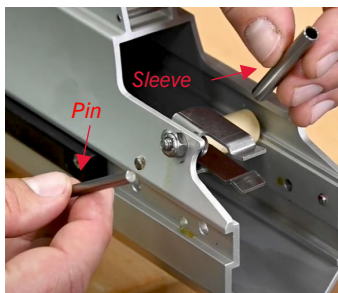
Install the Spacer Sleeve

2. Feed the retraction cable (exiting the top of the 2nd Stage assembly currently) through the 3rd Stage Extrusion from the bottom to the top. At the top of the 3rd Stage make certain the cable is routed between the bumper and the sleeve, if the cable is not routed correctly at this point the Talon will not operate correctly and will require a complete tear down to correct.

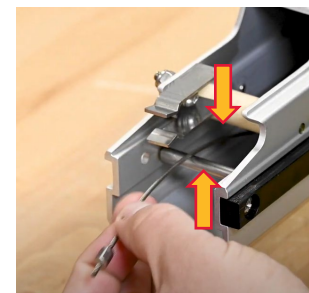
Cable Exits between the Pins

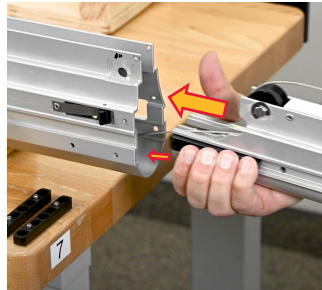
Start the 2nd Stage Assembly into the 3rd

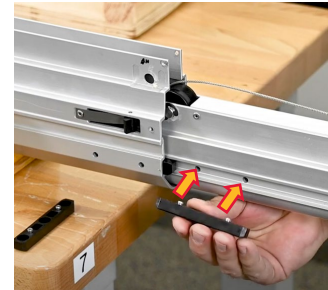
Place the Free Floating GIBS

7. Place 1 Spring in the center pocket of a Floating GIB that does not have cap screws installed in it. Place the closed/flat side of this Floating GIB facing the 2nd Stage Extrusion and the Spring facing out. The Tail of the Spring must not be at the middle of the GIB, it is centered it might catch on the holes the Cap Screws ride in; pointing the Tail so it is out will make it grind less as the GIB is inserted. Depressing the Spring Insert the GIB until the bottom edge of the GIB is flush with the Bottom of the 3rd Stage Extrusion.

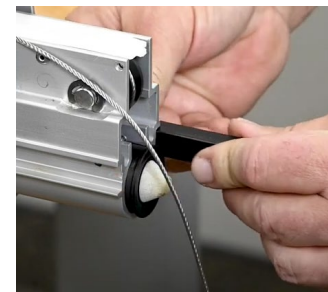
Install the Lower Fixed GIB

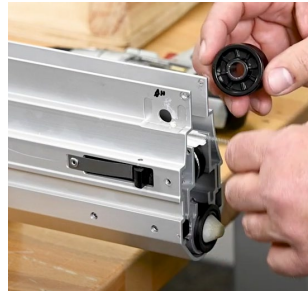
10. Push the 2nd Stage the rest of the way into the 3rd Stage.
11. Install the Lower Pulley, place it such that the extension cable comes from below the pulley, over the top of the pulley and continues to the top end of the 3rd Stage.
12. Install the upper Pulley. Lay the Cable down the Channel of the 3rd Stage, Place the upper Pulley above it and install the Pulley Pin. Route the Extension Cable back to the bottom of the Talon, leaving the whole length of the retraction cable at the top of the Talon. Take a

Install the Lower Pulley

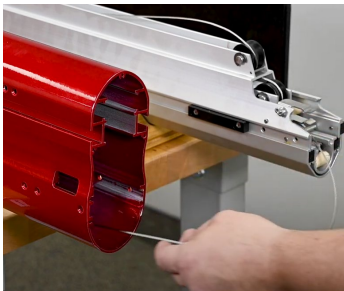
1. Feed the Retraction Cable to the top of the Main Extrusion.
2. Place two Springs in the outer pockets of a Floating GIB that has the Cap Screws pre-installed in it. Align the heads of the Cap Screws with the holes near the top of the 3rd Stage Extrusion and Squeeze the Floating GIB into place.
3. Line the GIBs attached to the 3rd Stage up with the tracks in the Main Extrusion and Slide the 3rd Stage into the main Extrusion until only a few inches of the 3rd Stage are left out of the main extrusion.

Feed the Retraction Cable into the Main Extrusion

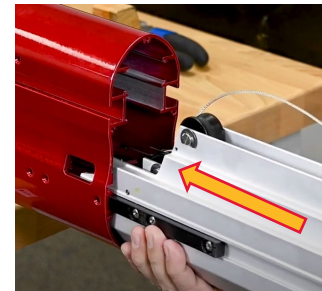
Insert the 3rd Stage Assembly into the Main Extrusion

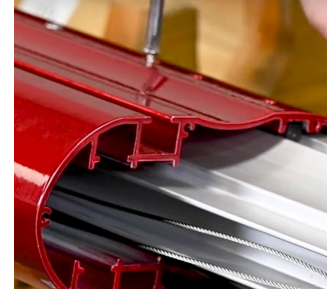
4. On the Talon's Left (your Right looking up from the bottom with the Talon in the support fixture) position one Fixed GIB in the GIB track with the closed surface facing the 3rd Stage Extrusion, then slide it into the Main Extrusion.
5. Also on the Talon's Left Place 2 Springs in a floating GIB without screws installed in it, Closed Face of GIB facing the 3rd Stage Extrusion, Springs Facing Out/ toward the Main Extrusion. Make sure the Spring tails are not at the midline of the GIB and push the Floating GIB into the Talon until the bottom of the GIB is flush with the Bottom of the Main Extrusion.
6. Use a #2 Phillips Screwdriver to install 2 Flathead/countersunk Screws in the Fixed GIB then use a 3/32" Allen Wrench to install 2 Cap Screws in the Floating GIB to function as guide pins.

Install the Screws

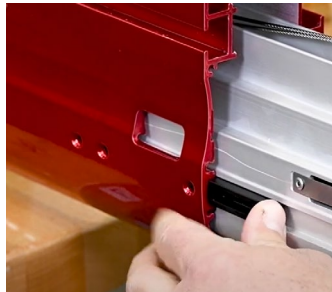
7. On the Talon's Right side (your left looking at the Talon in the fixture from the bottom) position the final two fixed GIBs with the closed face toward the 3rd Stage Extrusion and slide them up until the bottom of the bottom GIB is flush with the Edge of the Main Extrusion.
8. Use a #2 Phillips Screwdriver to install the flathead screws that retain the Fixed GIBs.

Position Fixed GIBs

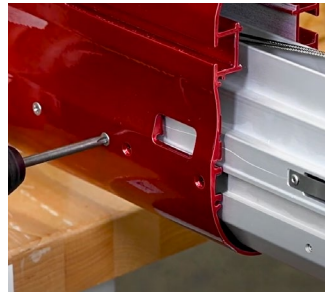
Install the Screws

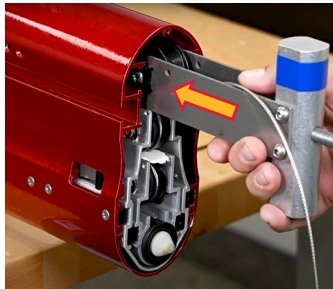
9. With the Tensioner captured in the Tensioner Tool, route the Extension Cable from the bottom of the Tensioner Tool out the Top, Slide the Tensioner in the Tensioner Tool into the main Extrusion.
10. Use a dowel or other "stick" to feed the Extension Cable from the Bottom of the Talon up to the Wrap Drum Holder

Slide the Tensioner Into Place

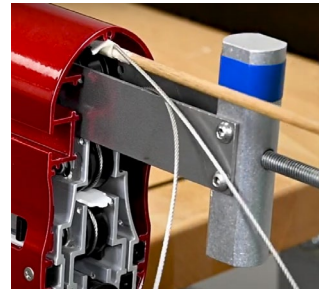
Fish the Extension Cable to the Talon's Center

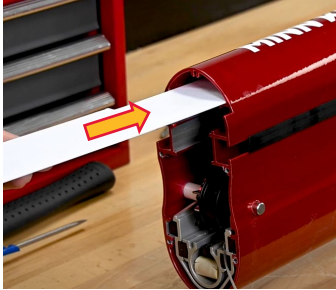
1. Slide the Divider into place temporarily. (Using it as a guide for the Cable at this time).
2. Route the retraction Cable above the Divider, to the Middle.
3. Remove the Divider to allow the Retraction Cable to fall to its proper location.

Position the Divider

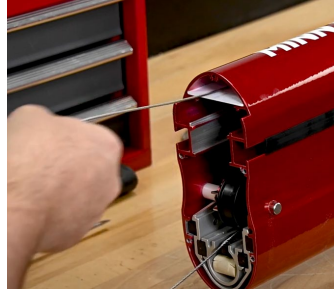
Insert the Cable

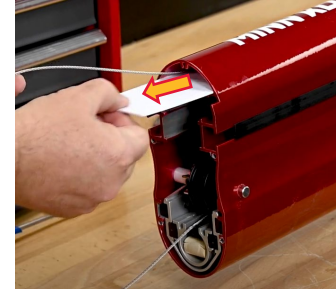
Remove the Divider

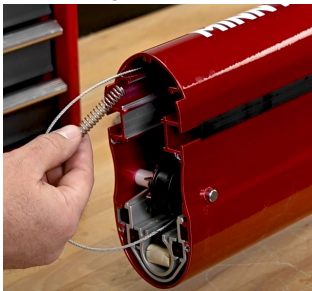
4. Place the Upper Tensioner Spring in the pocket of the support.
5. Place the Upper Tensioner/Pulley onto the Spring. The screw goes to the Talon's Left, the side away from the Motor Assembly.

Position the Spring

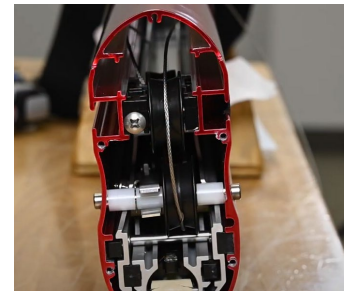
Top View

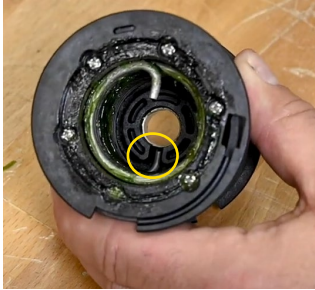
1. The lobes of the Wrap Drum Spring engage slots. Looking into the Wrap Drum engage the slot on the far end when positioning the spring in the wrap drum.
2. Engage the slot of the Hub on the close spring lobe.
3. Grip the Hub with a Needle-nose Pliers, keeping the spring engaged rotate the Hub Clockwise past the Wrap Drum Stop.

Wrap Drum and Spring

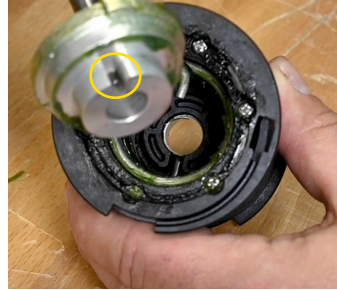
Hub Showing Hub Slot

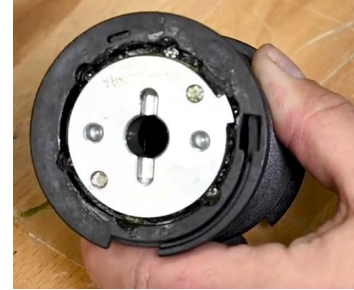
Hub Preloaded

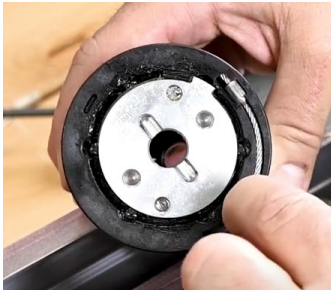
4. Place the end of the Retraction Cable into the pocket on the Hub Side of the Wrap Drum Assembly.
5. Wrap the cable onto the Wrap Drum by turning the Wrap Drum and guiding the cable into the grooves of the Wrap Drum. The amount of Wrap Drum covered by cable will vary by length of the Talon.
6. Insert the end of the Extension Cable in the cable pocket opposite of the hub and apply one wrap of Extension Cable onto the Wrap Drum.

Place the Retraction Cable

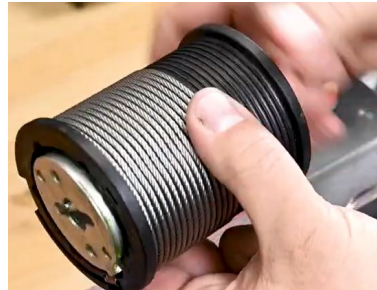
Lay the retraction cable in the grooves

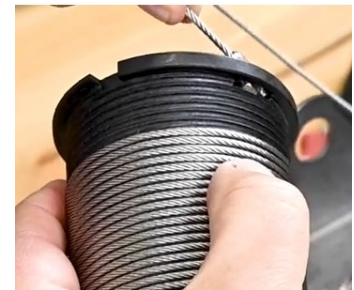
Place the Extension Cable

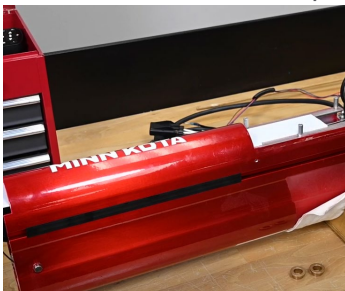
1. Place the Channel Divider. The ledges of the divider rest against the standoffs for the Control Board.
2. Set the home position sensor, attached to its bracket, on the channel divider then feed it to the upper end of the Talon.
3. Set the Control Board in place, Do Not Screw it Down yet.

Place the Channel Divider

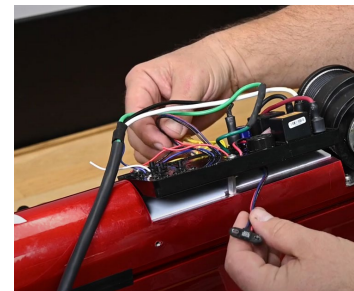
Set the Control Board in Place

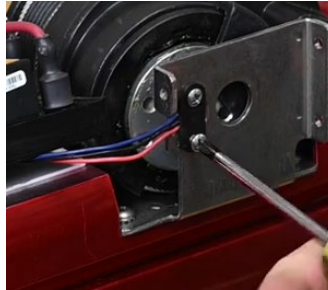
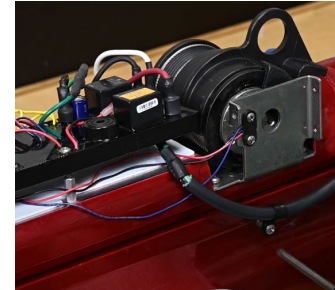
Install the Leadwire P-Clip

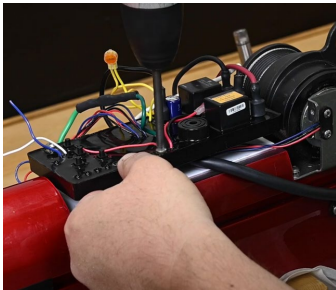
7. Secure the Control Board to the Control Board Standoffs. Be careful to not pinch any wires while installing the screws.
8. Install the Bronze Bushing in the Motor Side of the Wrap Drum Bracket.
9. Insert the Motor Assembly shaft through the Bronze Bushing then through the Hub and Wrap Drum Assembly.

Install the Control Board Screws

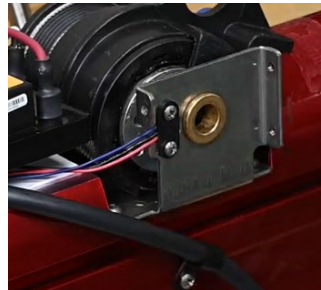
Install the Motor Side Bushing

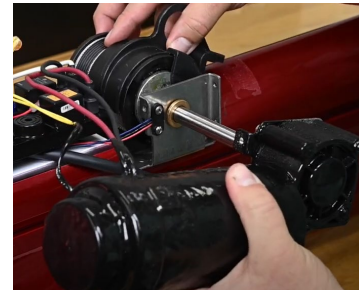
Slide the Motor Shaft into Place

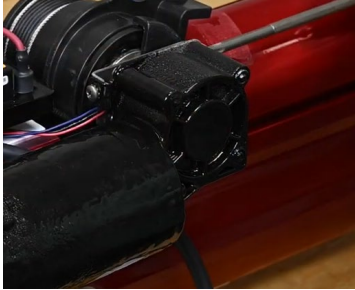
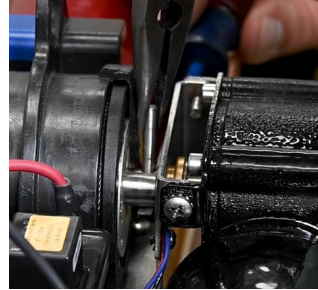
12. Remove the Spool Clip then Slide the Wrap Drum Assembly toward the Motor Assembly engaging the Hub on the Drive Pin.

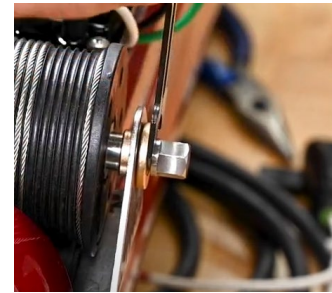
13. Make sure the Nylon Bushing is fully in the Wrap Drum Assembly.
14. Insert the Bronze Bushing opposite the Motor.
15. Install the E-Clip opposite Near the End of the Motor Shaft. (If the Motor Side E-clip was not installed prior to inserting the motor, install the E-Clip now also.)

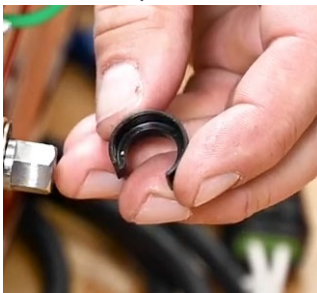
16. Note the cavity in the Wrap Drum Spacer. That Cavity will be away from the Motor Assembly toward the Bronze Bushing.
17. Push the Spacer with the cavity oriented towards the bushing and wedge it between the Wrap Drum and the Wrap Drum Bracket.
18. Push the Space down onto the Motor Assembly Shaft.

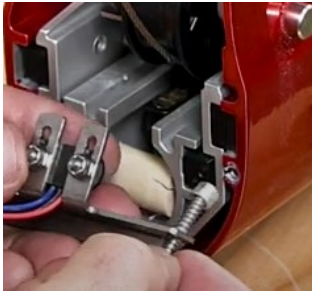
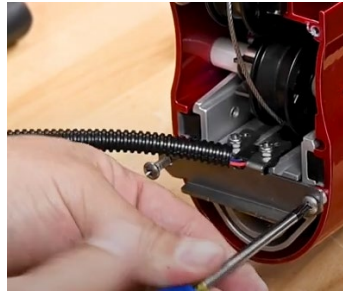
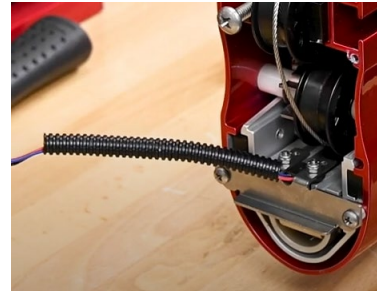
19. Start a screw through the Bracket for the Home Position Sensor. Put the 1/8" spacer onto that screw and start it into the Main Extrusion
20. Repeat that process on the other side. Then tighten both screws.

21. Keep the protective Wire Loom next to the Sensor.

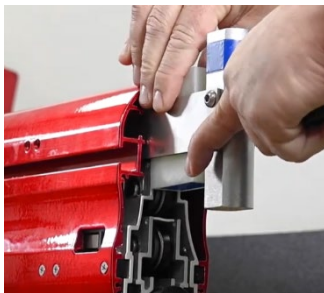
2. Turn the screw of the Tensioner Tool clockwise until the screw holes of the Extension Cable Tensioner align with the countersunk holes in the Main Extrusion of the Talon.
3. Once the holes are aligned install the four screws for the tensioner (2 on each side).

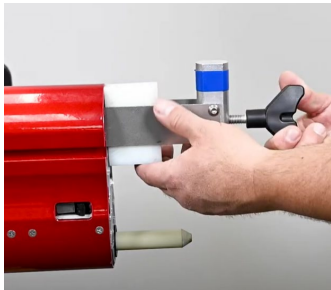
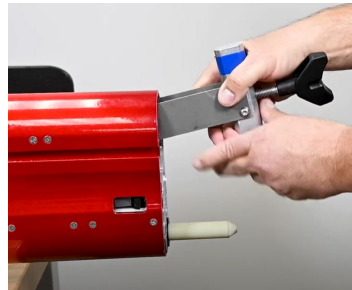
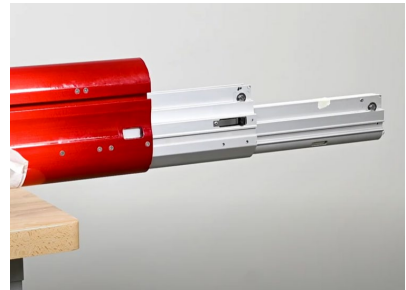
4. Remove the tensioning tool by turning the screw counterclockwise until the tensioning block can be removed, remove the tensioning block, push the tool further into the Talon slightly, tip the tool down to disengage it from the tensioner and slide the tool out.
5. Connect Power and test the Talon for operation, making sure it fully extends and retracts. After testing extend the Talon until the third stage exits the main extrusion pausing the Talon as soon as that happens. Retract the Talon, pausing shortly before the second stage is fully inside the third stage (as in the right image below). This has the Talon ideally positioned for installing the covers. Disconnect power again.

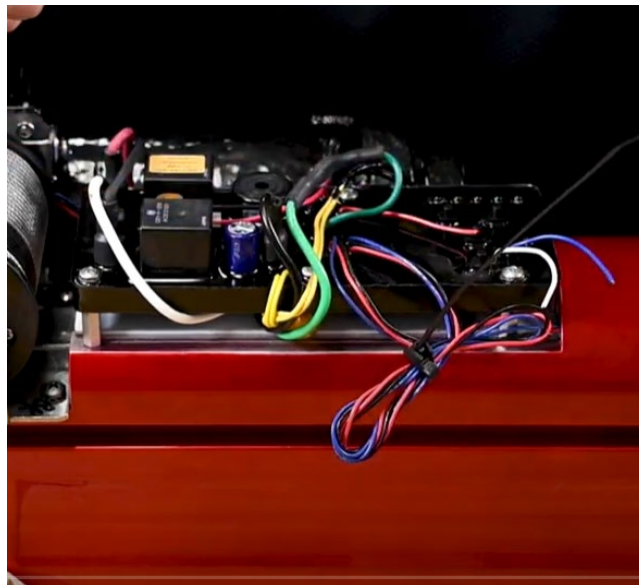
1. Position all of the control board wires so they will not be pinched when installing the covers. Tuck wires under the control board where possible, use a zip tie to secure the excess sensor wire so it is secure and will not block button operation or get pinched by the covers.

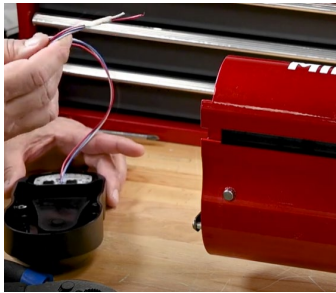
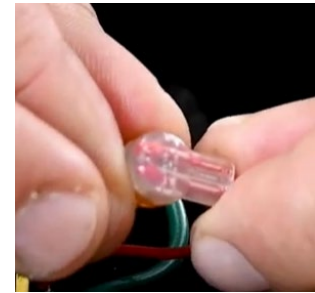
2. Install the worklight/top cover. Fish the wires for the worklight down the channel to the control board. Position the work light at the top of the Talon and install the two screws that secure the worklight assembly to the top of the Talon. Use 2040340 Scotchlock connectors to connect the Red wire from the worklight to the red wire from the Control Board, the white wire from the worklight to the white wire from the Control Board, and the blue wire from the worklight to the blue wire from the Control Board.

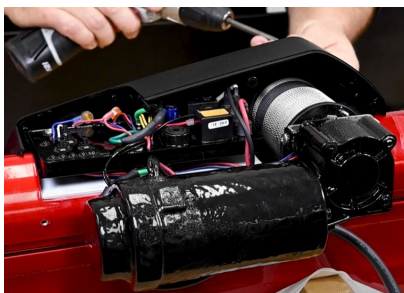
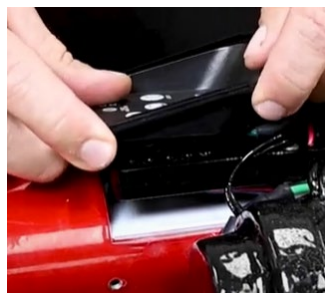
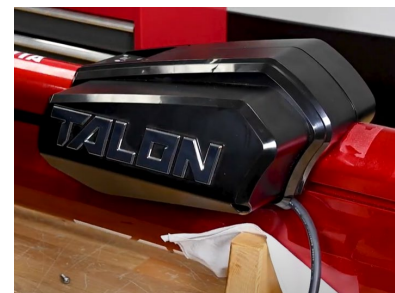
3. Install the left side cover, make sure the screw boss toward the top of the cover extends beyond the wires that are tucked under the control board. Secure the cover to the main extrusion with two of the longer machine screws.

4. Place the control bezel. Tuck the left side of the bezel under left side cover that was installed in the previous step and maneuver it to drop into place over the buttons and lights of the Control Board. At this point recheck that all wires are securely tucked and will not get pinched by the screws/screw bosses.

5. Place the Motor Cover so that it capture the right side of the control bezel and the leadwire exits through the "mouse-hole" at the bottom of the cover. Secure the cover to the main extrusion with two machine screws, the shorter screw goes toward the top of the cover, the longer screw toward the bottom. Using a long machine screw in that top location will damage the Talon, make certain it is the shorter screw in this position. Once both covers are secured to the Main Extrusion install the 4 long thread-cutting screws to secure the covers to each other, installing them through the Left Side Cover into the Right Side Cover.

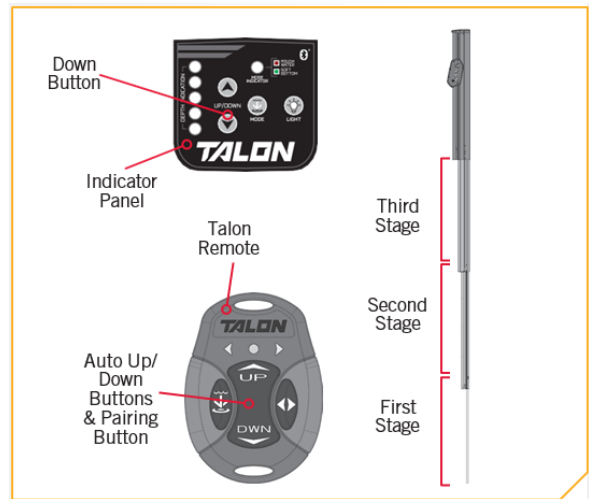
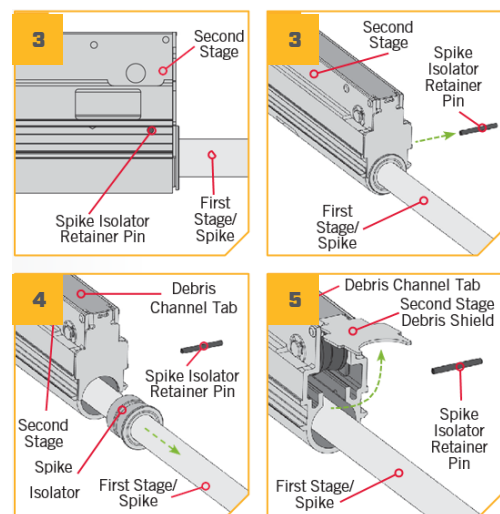
6. Locate the Spike Retainer Screw and remove it using a 3/32" Allen Wrench.

7. Once removed, the Spike should pull free from the Second Stage along with the Spike Retainer and an O-ring that is in place around the Spike. The Spike Retainer is the piece that the Spike Retainer Screw was just removed from.

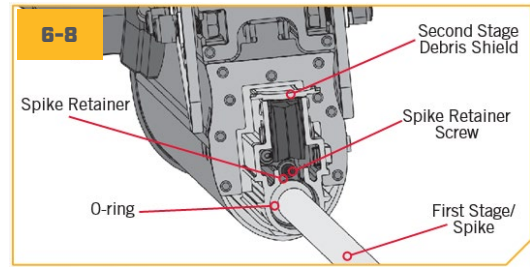
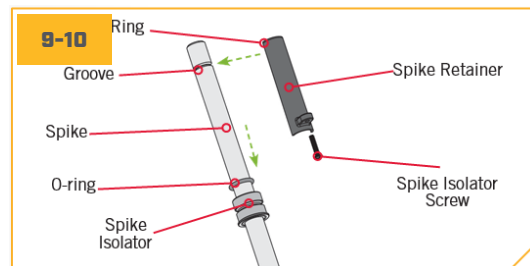
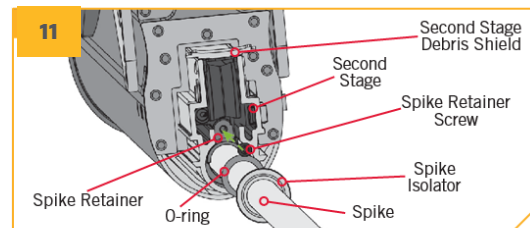
11. Slide the assembly back into the Second Stage and replace the Spike Retainer Screw in the Spike Retainer using a 3/32" Allen Wrench.
12. Once the Screw is secure, close the Second Stage Debris Shield.

13. Push the O-ring and Spike Isolator towards the Second Stage and until they are in position against the Spike Retainer and Second Stage Debris Shield.
