Terrova / RipTide Terrova

All Terrova & Riptide Terrova motors rely on a microprocessor based network serving as the communication link between the main control board and network accessories such as the foot pedal, AutoPilot compass control board, CoPilot receiver board, i-Pilot controller, and i-Pilot Link controller (if the motor is so equipped). Any failure in this communication link can cause problems for the Terrova motor. At power-up (power ON via power button on 2017 and later motors, when the motor is deployed for pre-2017 models) the microprocessor on the main control board checks for any network accessories (foot pedal, AutoPilot, CoPilot, i-Pilot, or i-Pilot Link) that could be connected to the main control board. If the microprocessor on the main board is getting an incorrect reading at this time, or if the AutoPilot, CoPilot, or i-Pilot network accessory is not properly connected, the microprocessor will not “recognize” the accessory and that accessory function will not be enabled. Also, if the microprocessor recognizes both an i-Pilot and a CoPilot network accessory it will ignore CoPilot. A faulty network accessory can also cause Terrova motor malfunctions due to ne

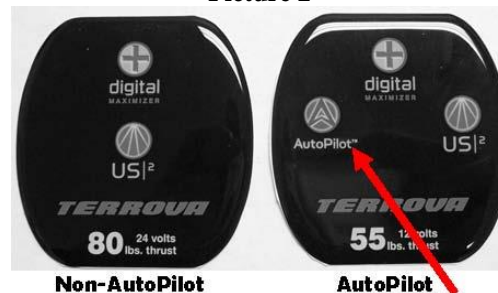
Picture 2

- A. All 2016 and earlier Terrova motors that leave the factory with the AutoPilot feature installed will indicate this on the control box cover decal. (see **Picture 2**) All Terrova motors made after 2009 will indicate their model information on the serial number decal, this will be the best indicator on 2017 and Later motors.

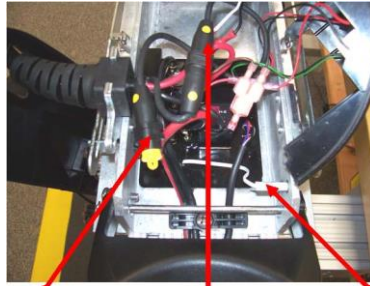
Picture 3

not being used connected to AutoPilot network plug system ready reed switch

(In 2014 some control boards may only have 1 network cable plug.) **This picture is showing 2 network cables coming off control board. In this case, one is connected to the compass board network plug and the other is not being used. (No CoPilot attached, so yellow cap still on plug.)** NOTE: if there are 2 network plug leads from the main control board they are common / either lead can be connected to either accessory.

- Step 3.** If it was determined in **Step 1A** or **1B** that the motor is AutoPilot equipped check to ensure that the network accessory plugs for the AutoPilot compass control board (in the control box at the top of the motor shaft) and at the main control board (on the motor base plate) are clean, show no signs of corrosion, have no bent pins, and are fully engaged and properly seated together. (see **Pictures 3 & 4**)

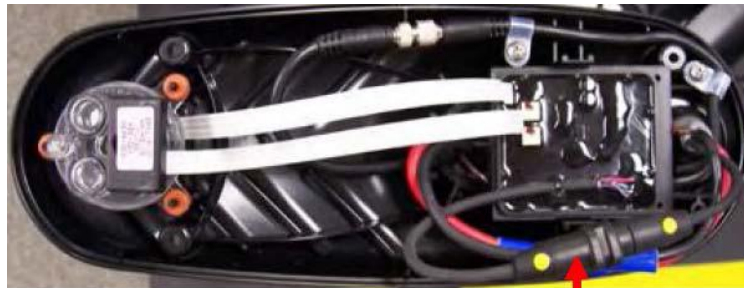
Picture 4

AutoPilot network plug

This picture is showing the control box with AutoPilot Compass Control board and network cable plugs.

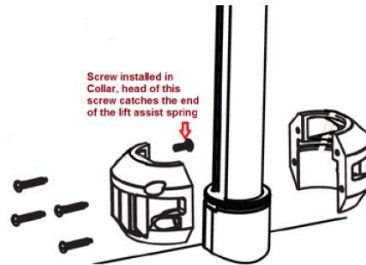
Step 2. With one hand, maintain pressure on the two collar halves so they do not release when the four screws holding the collar together are removed. Remove the four screws that hold the collar halves together.

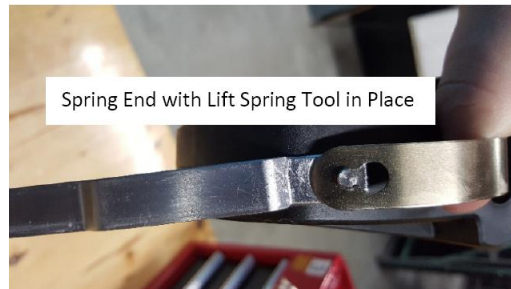
Step 4. Deploy the motor. Pull the spring out 6-8 inches, firmly grasp the spring, remove the lower collar from the spring by pushing it up until the screw head moves from the narrow portion of the keyhole slot to the open area. Then disconnect the spring from the screw/collar, and attach your lift spring assembly tool (p/n 2888800) to the spring by positioning the post of the tool into the keyhole slot. **NOTE:** The tool will install from the side of the spring assembly opposite from the side the collar was attached. The raised/offset portion of the tool will be oriented away from the shaft when properly attached.

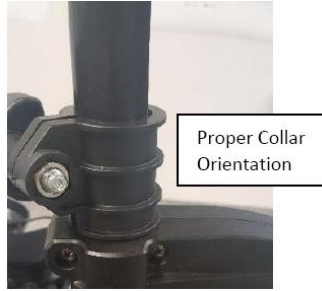
Step 7. Support the motor's lower unit (if it is not contacting the floor) then remove the depth collar. Note the orientation of the collar for proper reassembly later (the steering "drive" portion of the depth collar goes down against the mating "drive" of the Lift Assist Spring Assembly).

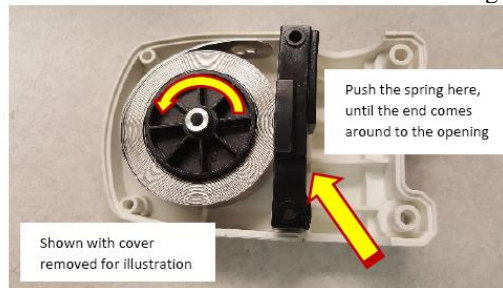
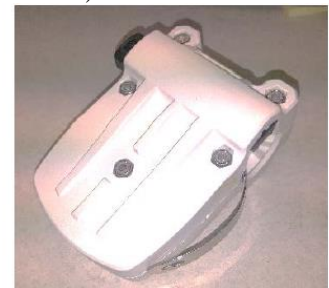
Step 9. Prepare the replacement Lift Assist Spring Assembly: The spring usually has 3-4 inches of spring extending from the housing, but due to vibration when shipping it may be fully retracted inside the housing. If it is fully retracted you will need to gain access to the spring by reaching into the shaft opening from the bottom end and pushing upward on the spring assembly until the end comes around to the opening. Once the end is at the opening it will be possible to use the lift spring assembly tool (or a hook-shaped pick tool) to hook the end of the spring and pull it out of the housing.

(As of October 2020 all Lift Assist Housings will be black in color. A material change was implemented to improve impact resistance and reduce damage from misuse, the new material is not available in white. After careful review it was decided the benefit of the new material was worth the cosmetic change to the motor.)

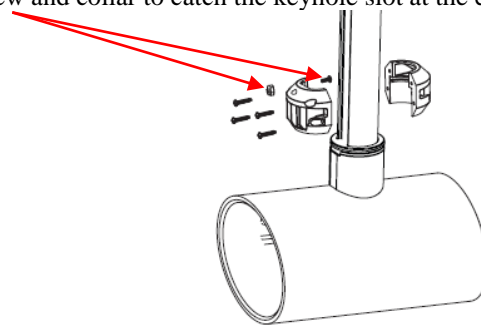
Step 12. Prepare the lower collar: Install the machine screw through the rear collar and into the nyloc nut. Verify that the screw in the inside diameter of the back half of the lower collar is installed with nyloc nut and that there is enough of a gap between the screw and collar to catch the keyhole slot at the end of the spring assembly in the next step.

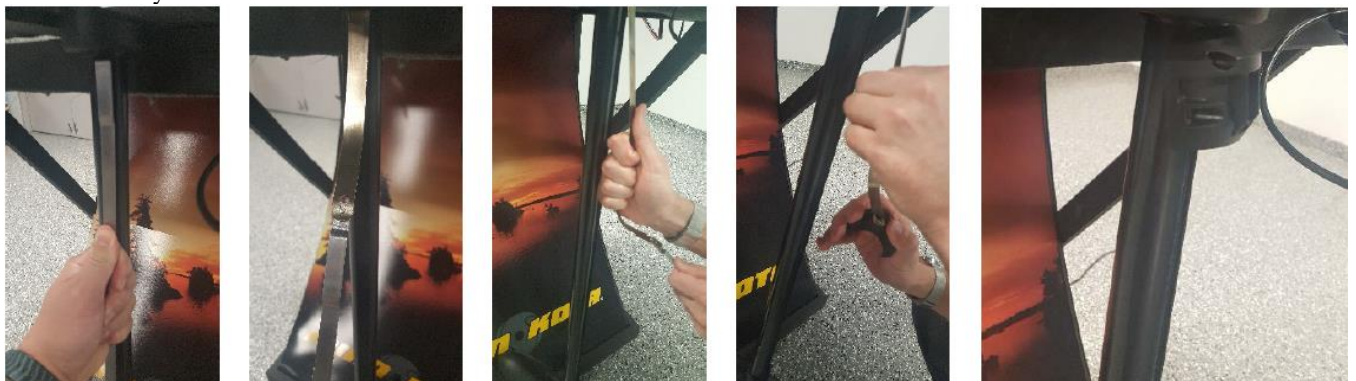
Step 13. Pull the handle of the lift spring tool down toward the lower unit until 4-5 inches of the lift spring is extended beyond the bottom of the steering housing. Firmly grasp the lift spring, remove the lift spring tool from the end of the lift spring, and attach the back half of the lower collar to the end of the lift spring. Use a #2 Phillips Screwdriver to tighten the machine screw that passes through the keyhole slot in the lift spring, through the rear collar, then into the nyloc nut.

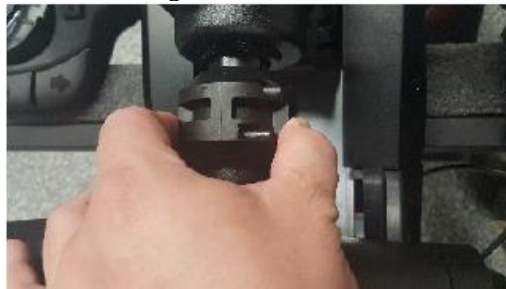
Step 16. Pull the back collar half and spring down from the steering housing and place the collar half on the motor bung so it aligns with the front collar half. Install and tighten the four screws that secure the lower collar in place.

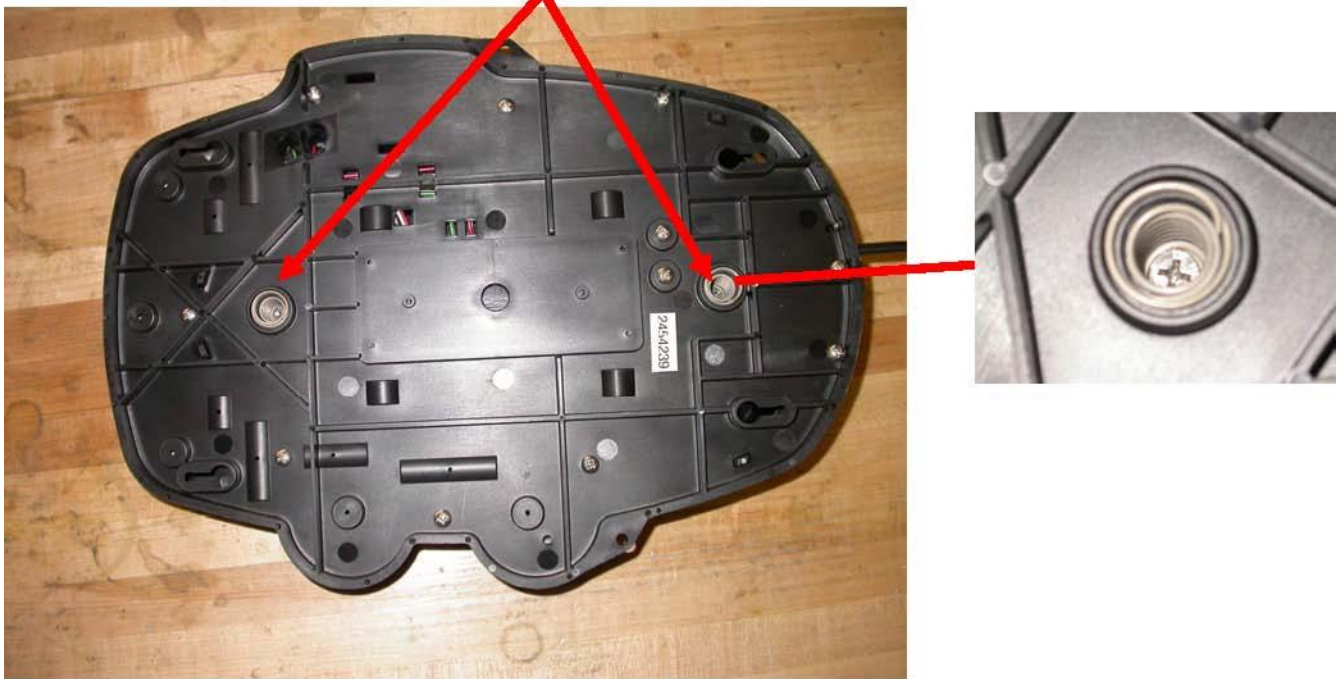
Step 1. Turn the foot pedal upside down and remove the two screws shown with a #2 Phillips screwdriver.

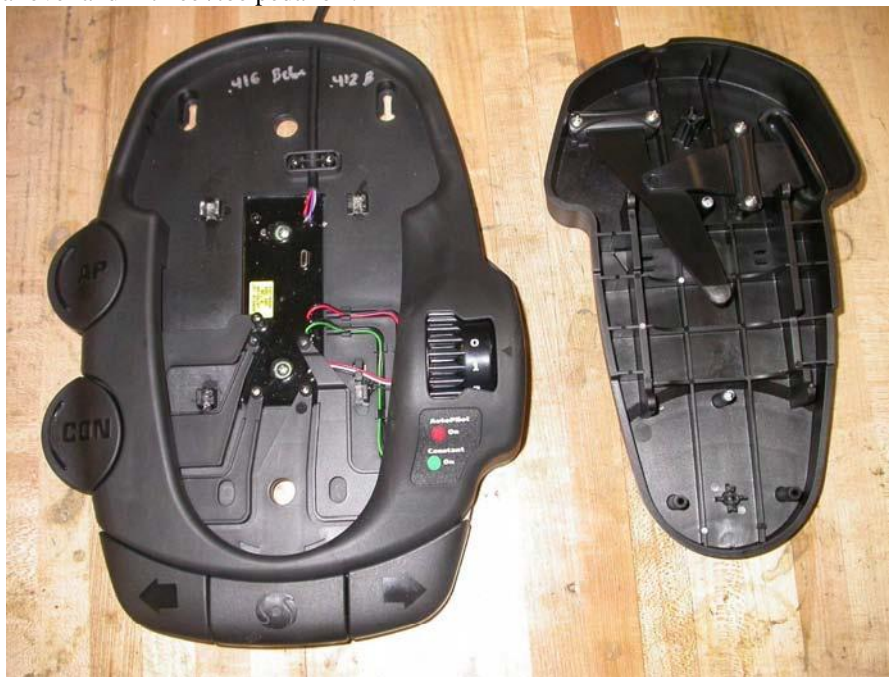
Step 2. Flip foot pedal over and lift heel/toe pedal off.

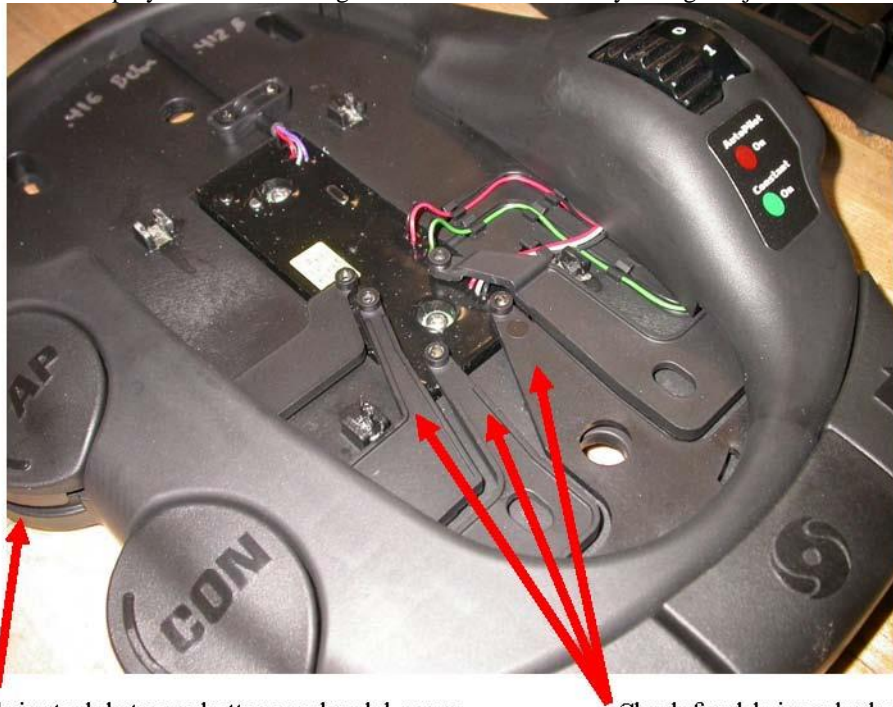
Step 3. Check for rocks, twigs, sand, or other debris that may be lodged under buttons or button arms. The foot pedal is water proof and can be sprayed off or submerged in water to remove any foreign objects such as sand and rocks.

Check for debris stuck between buttons and pedal cover

Check for debris under button arms

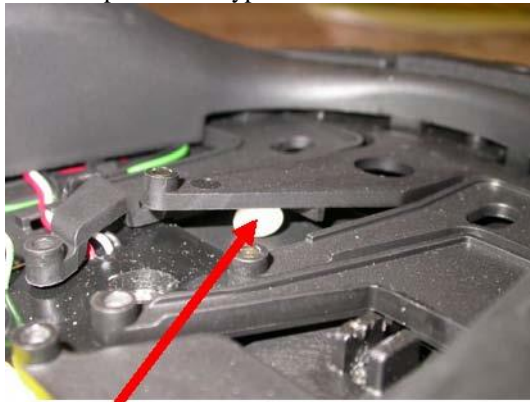
Below are pictures of typical locations debris can reside which may cause undesirable foot pedal operation

Rock stuck under button arm.

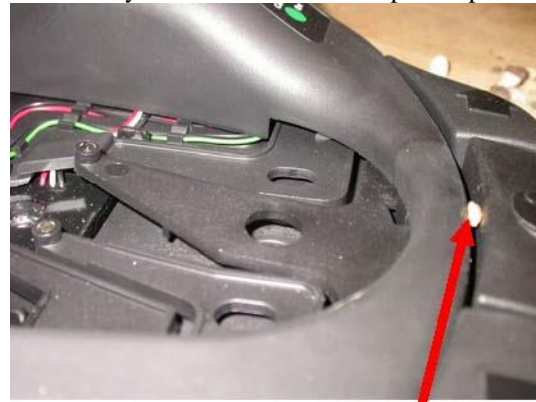
Rock stuck between button and cover.
