Service Bulletin

Optimum Desiccant Bag

Model Number: 1902335 Optimum; 1902340 Optimum TS

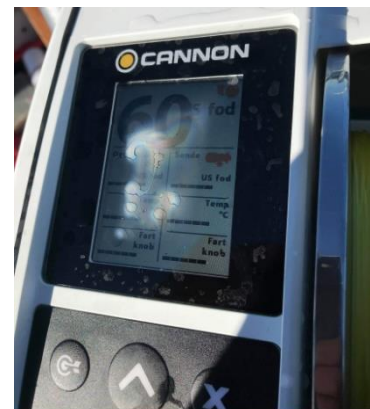
Some early production Optimum downriggers exhibited lens fogging in the field. Examining these found that the right circumstances between production and delivery to the consumer could allow just enough excess moisture into the housing to cause the lens to fog. The addition of a desiccant bag in the motor housing prevents any potential for fogging.

Example of Fogged Lens

The motor housing has a vent/patch in the design that should remove any moisture over time, in these select cases the moisture introduced was enough that the vent could not expel the moisture before fogging occurred. Because the vent patch exists and the nature of the desiccant bag chosen this should be a one time install, the bag will not need to be replaced because it is saturated. This should be a one-time installation.

Please install Kit 3778800 in any Optimum with serial number prior to U205CN##### you have in for service for any reason unless it already has the kit installed.
