# MINN KOTA®

**SERVICE PROVIDER REPAIR MANUAL**

## **QUEST SERIES MOTOR REPAIR**

**ULTREX QUEST 2023-PRESENT**  
**ULTERRA QUEST 2023-PRESENT**  
**RIPTIDE INSTINCT QUEST 2023-PRESENT**  
**TERROVA QUEST 2023-PRESENT**  
**RIPTIDE TERROVA QUEST 2023-PRESENT**

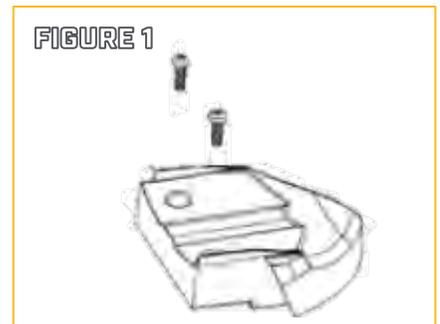
The motor is not registering that it is fully deployed. A magnet embedded in the underside of the Motor Ramp (2993900 Motor Ramp with Magnet, Figure 1) is “read” by a sensor in the steering housing. Aftermarket motor ramps (especially those that function as light mounts) do not have this magnet.

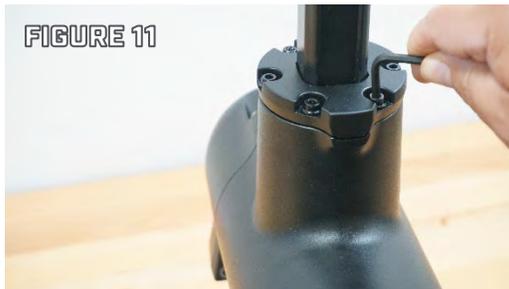
FIGURE 11

- Step 1. Remove the Lower Unit and shaft from the motor. This varies depending on the motor model.
  - a. Disconnect Motor and Sonar Wires in the Control Box
  - b. Disconnect Depth Collar or Belt
  - c. Slide Lower Unit and Shaft out from the Steering Housing
- Step 2. Use a 4mm Hex Bit/Allen Wrench to remove the six screws that secure the Clamp Plate to the Motor Bung. (Figure 11).

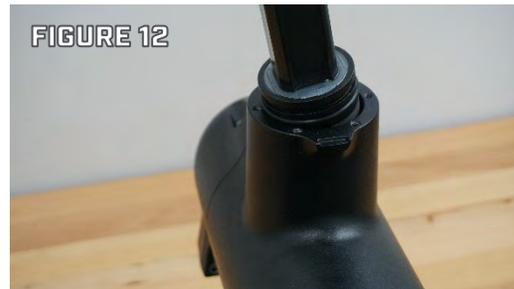
FIGURE 12

- Step 3. Slide the clamp plate up the shaft to give easy access to the shaft plug and motor bung.
- Step 4. Remove the Motor Shaft and Shaft Plug from the Motor Bung. This will be firmly engaged and will need some persuasion to separate; suggest tapping the edge of bung on alternating sides with soft face hammer or mallet. (Figure 12)
- Step 5. Slide the shaft the rest of the way off of the wires. (Figure 13)

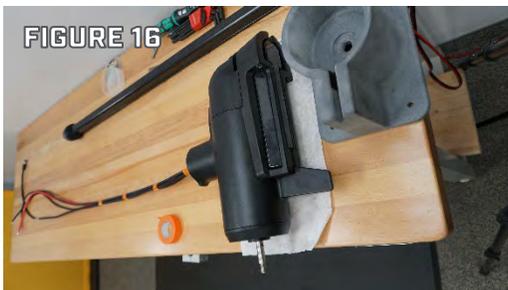
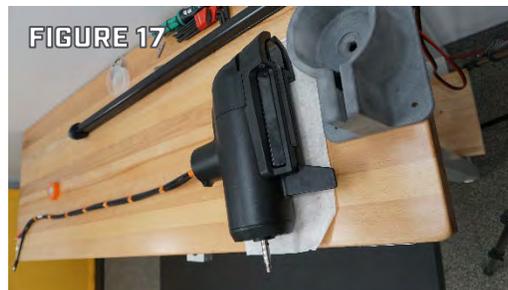
- Step 3. Starting at the Motor Bung, comb/straighten the four wires coming from the Lower Unit so they do not cross. If the wires cross they will not fit through the Shaft of the Motor. (Figures 16 &17)

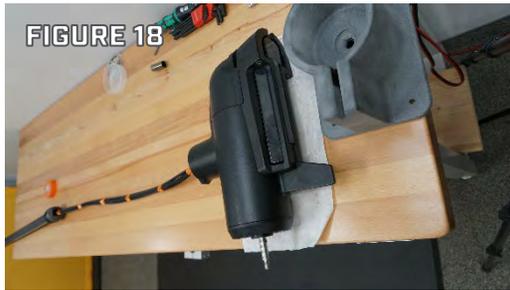
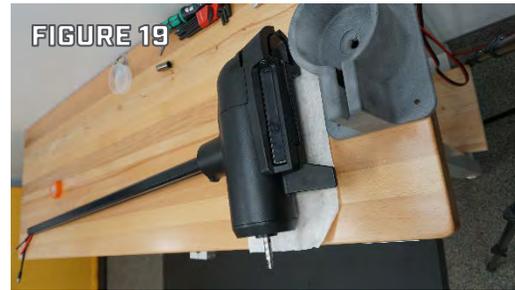
Step 4. Feed the wires into the shaft and slide the shaft assembly down the wires until the shaft plug is in contact with the motor bung. (Figures 18 &19)

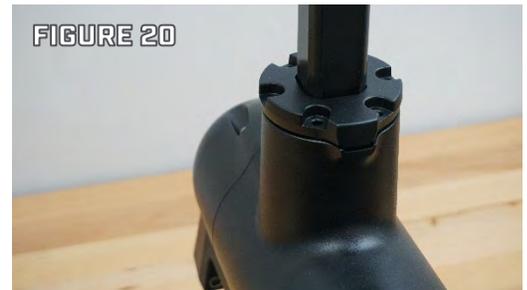
Step 5. Slide the clamp plate on to the shaft. Reposition the motor to the a vertical orientation. In this position the weight of the shaft is helping the connection into place, this will help prevent cross threading any of the bolts that secure the clamp plate. (Figure 20)

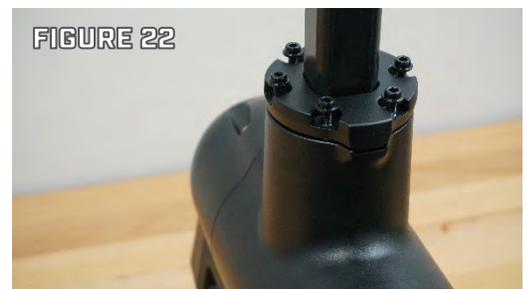
Step 9. Repeat steps 7-9 for the other 5 clamp screws. (Figure 22)

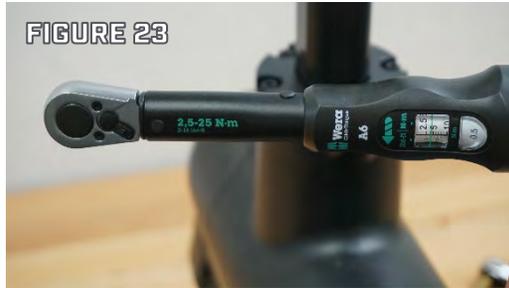
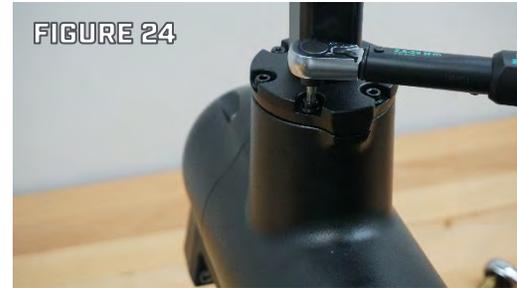
Step 10. Use a torque wrench set to 40 in-lbs or 4.5 Nm to finish tightening the clamp screws. Tighten a screw to the correct torque, then do the same for the screw directly across from it, torque a different pair, then do the last pair. (Figures 23 & 24)

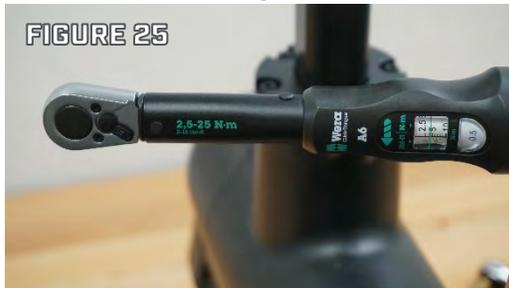
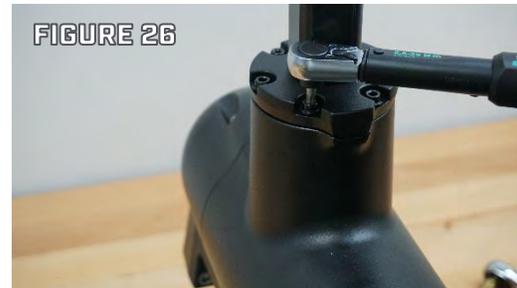
Step 11. Let the Lower Unit and Shaft Assembly rest for 10 seconds without contact, then re-torque all 6 bolts a second time. (Figures 25 & 26)

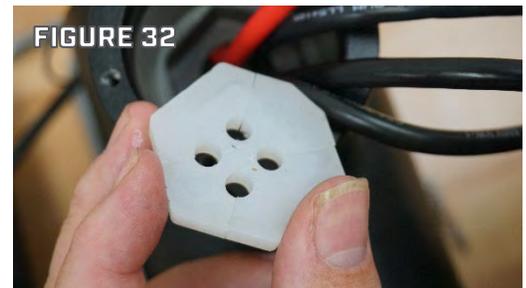
Step 2. Remove the gummy seal from the bung of the Lower Unit. (Figure 32).

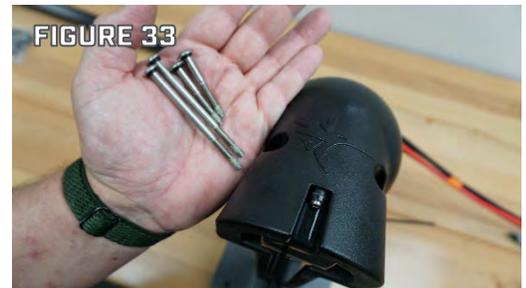
Step 3. Use a T25 tool to remove the 4 bolts that secure the sonar end to the motor assembly. (Figure 33)

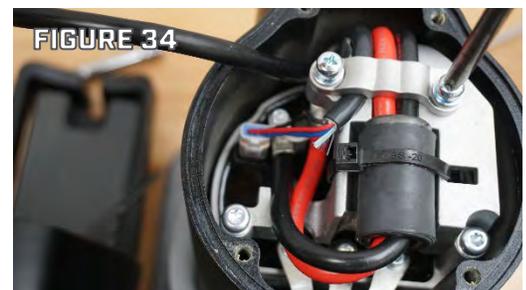
Step 7. Disconnect the com wire from the Inverter, use a small flat blade screwdriver or a pick to depress the lock on the connector, do not force the connector. (Figure 35)

Step 8. Use a T25 tool to remove the screws securing the Strain Relief Body and remove the strain relief from the Motor Assembly.

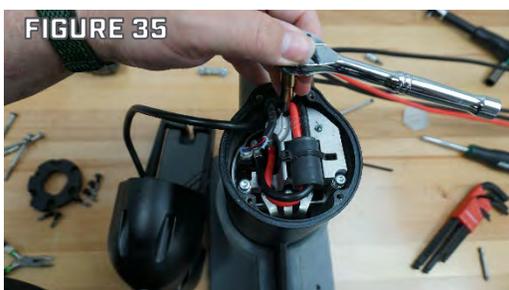
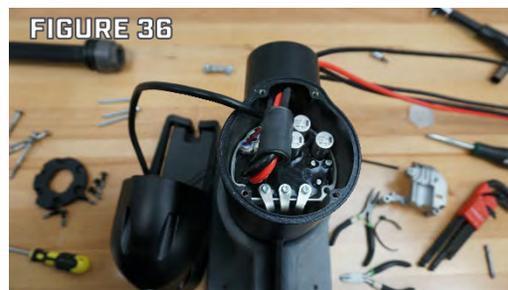
**NOTICE:** One of the screws securing the Strain Relief body is under the Com Wire.

Step 9. Feed the Com Wire out of the Lower Unit Assembly to make space for the Sonar Connector to pass through the Bung. (Figure 37)

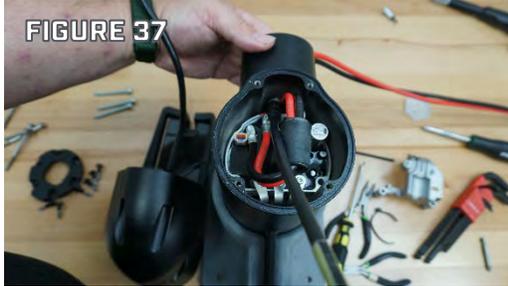
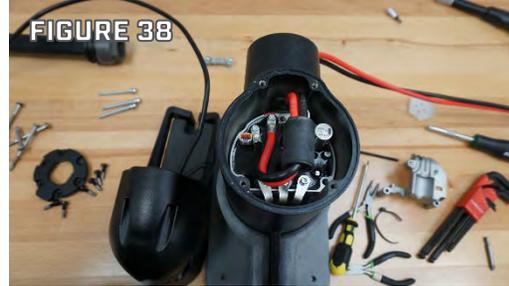
Step 10. Feed the Transducer wire through the Bung and out of Lower Unit. (Figure 38)

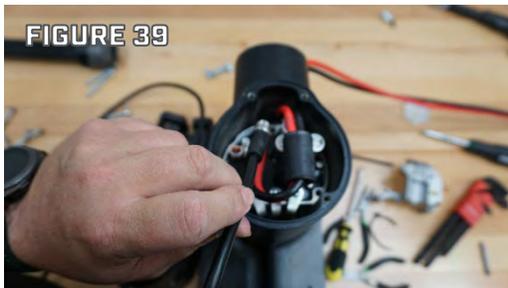
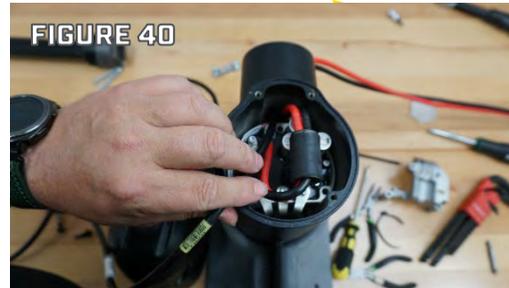
Step 1. Feed the Transducer wire past the Inverter Board through the bung and out. (Figure 39 & 40)

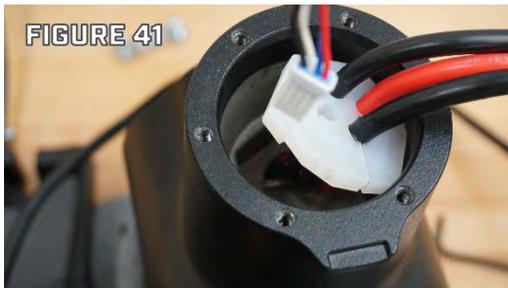
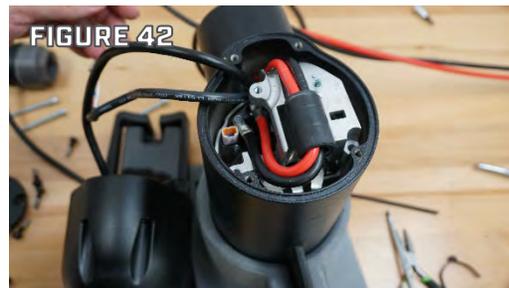
Step 2. Feed the Motor Communication Wire through the bung into the front end of the Motor Assembly. (Figures 41 & 42)

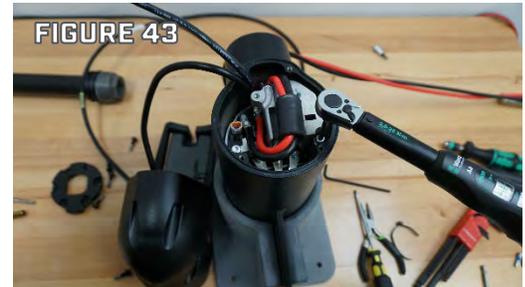
Step 3. Place the Strain Relief over the Inverter Board so the wire tracks are toward the bung, the flat surface is in contact with the Inverter Board and the screw holes are aligned and no wires are caught or pinched. (Figure 43)

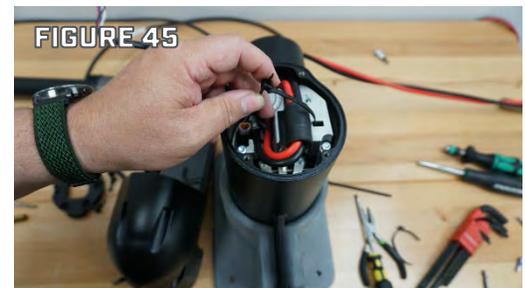
Step 6. Apply a zip tie securing the ferrite bead to the strain relief. (Figure 45)

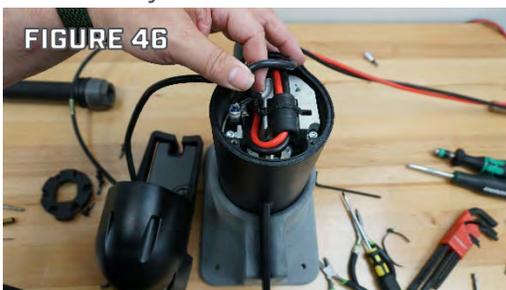
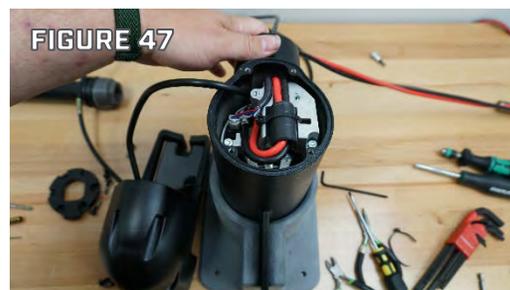
Step 7. Position the Com Wire in its groove in the strain relief. And push the connector into its spot on the inverter board. Be sure to push the connector in until the locking tab clicks in, check to verify the connector is secure. (Figure 46 & 47)

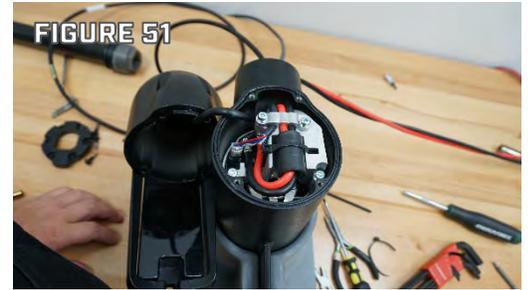
Step 2. Position the Sonar/Plain End to the side so you have access to the interior Front End of the Motor. (Figure 51)

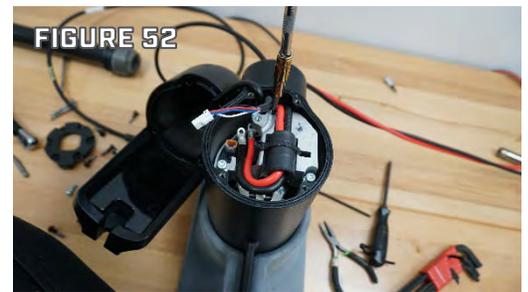
Step 4. Disconnect communications cable from the inverter. Use a pick or small flat blade screwdriver to disengage the locking tab on the connector. Do not force it apart. (Figure 52)

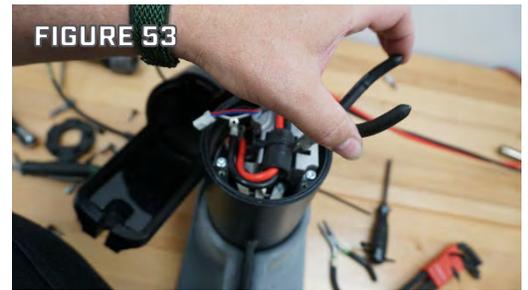
Step 6. Clip the Zip Tie that secures the wires and Ferrite Bead to the Strain Relief. (Figure 53).

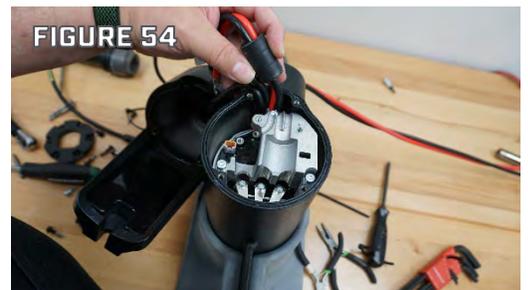
Step 7. Move these out of the way. The ferrite cable core can remain on the cables. (Figure 54)

Step 8. Use an appropriate driver to remove the 3 phase screws from the inverter.

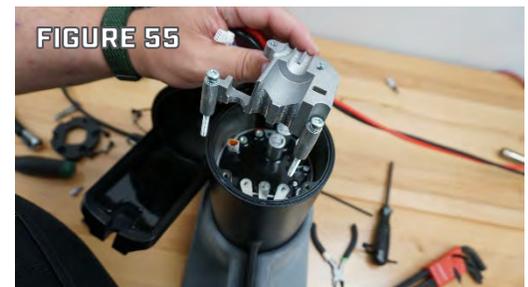
Step 9. Remove the 3 screws that hold the strain relief to the motor with T25 driver.

Step 10. Remove strain relief. (Figure 55)

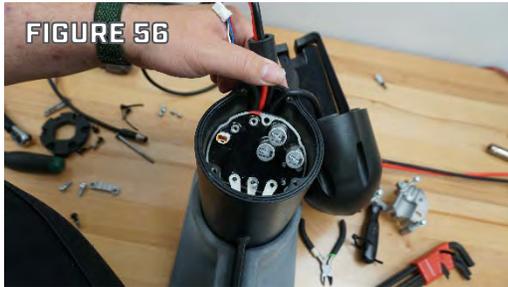
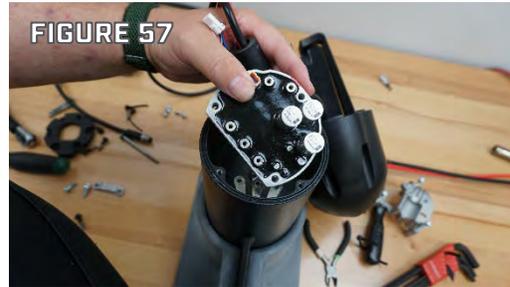
Step 11. Remove inverter. Tip the inverter up away from the phase leads for removal. (Figures 56 & 57)

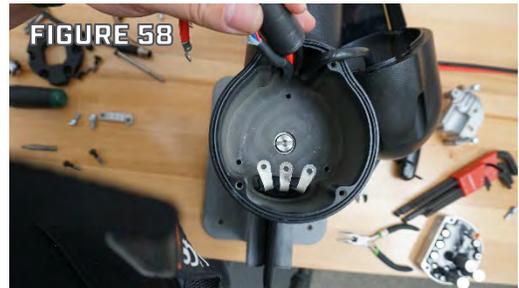
Step 12. Remove any foreign material from the mounting surface of the Inverter Board. Figure 58 shows a cleaned mounting surface.

A CLEAN MOUNTING SURFACE FOR THE INVERTER BOARD IS CRITICAL TO COOLING. THE MOTOR WILL NOT OPERATE PROPERLY IF CONTAMINANTS ARE BETWEEN THE INVERTER BOARD AND THE SURFACE THE INVERTER BOARD MOUNTS TO.

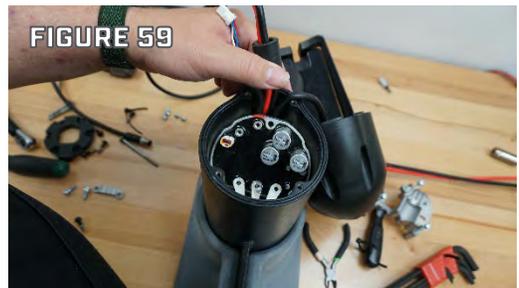
Step 13. Slide the new Inverter Board under tabs for the Phase Leads. (Figure 59)

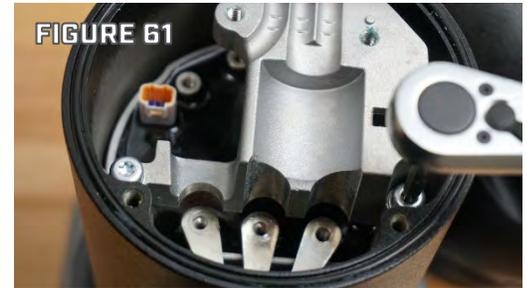
Step 16. Use a T25 Tool set to 30 in-lbs (3.4 Nm) to tighten the three screws that secure the Strain Relief and Inverter Board. (Figure 61)

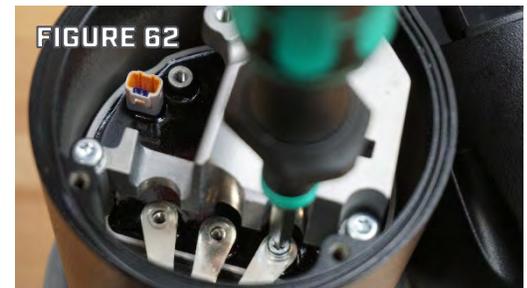
Step 17. Install the Terminals to the Phase Leads, Use an appropriate Driver Bit and a torque driver set to 15 in-lbs (1.7 Nm) to install the terminal Screws. (Figure 62)

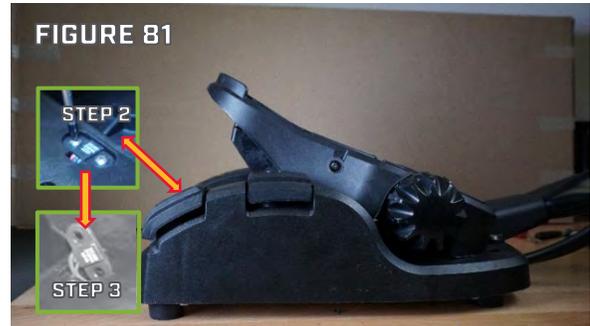
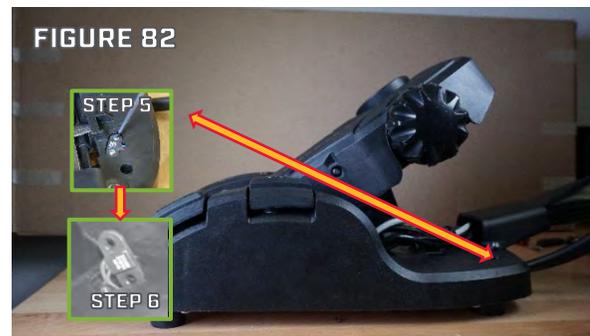
Step 4. Rotate the Motor Lower Unit/Control Box so the Foot Pedal is positioned “Toe Up” as Shown in Figure 82.

Step 5. Use a #1 Phillips driver to remove the two #4-24 x 1/4” screws from the sensor adjacent to the steering cables, in the base of the foot pedal. Set the two screws aside, they will be reused during reassembly. (Figure 82, Step 5)

Step 6. Tip the sensor to slide it into the opening in the foot pedal base. (Figure 82, Step 6)

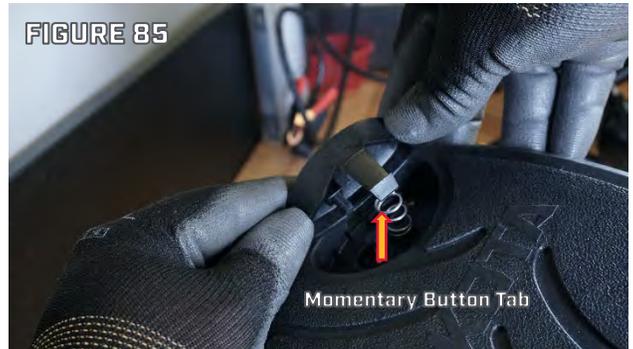
Step 10. Remove the momentary button by pushing the exposed tab on the underside of the foot pedal upper (the tab is visible in Figure 84) so it unlatches, then lift the button until it clears the Button cavity (Figure 85).

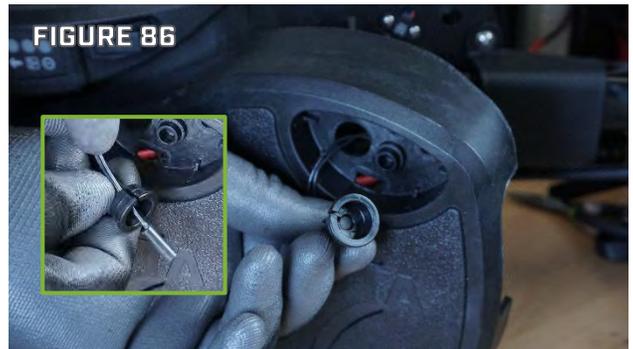
Step 12. Slide the Reed Switch out of the Reed Switch Clip by pushing the bottom edge of the Reed Switch with a small flat blade screwdriver upward through the slot in the side of the Reed Switch Clip. See inset in Figure 86.

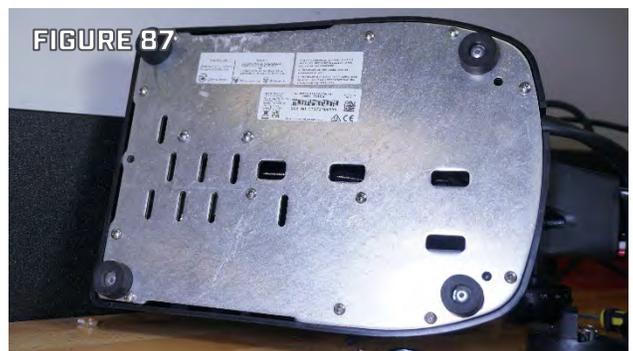
Step 14. Turn the Foot Pedal Assembly over to expose the Bottom Plate. Use the #2 Phillips driver to remove all the screws in the Bottom Plate. Note that there are two types of Screws used here, the (2) #10-32 x 1/2" Machine Screws that secure the control board to the Bottom Plate and the (12) #8-18 x 5/8" Thread Cutting Screws that hold the Bottom Plate to the Foot Pedal Base. See Figure 87.

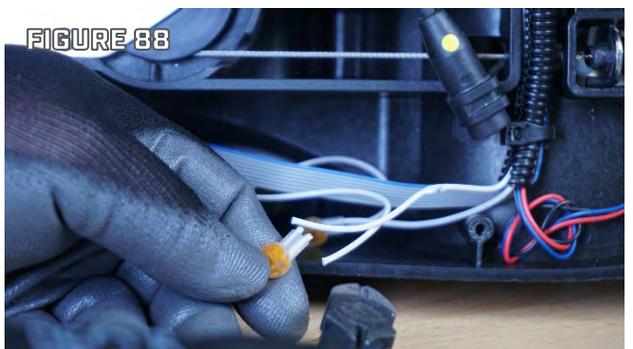
Step 15. Cut the two white leads from the power switch as close to the connectors as possible. (Figure 88)

Step 16. Cut the cable tie that secures the White Power Switch wires, End of Limit Sensor Wires, and Indicator Light Board ribbon cable. (Figure 88)

Step 17. Remove and set aside the conduit from the power switch and the sensor wires. (Figure 88)

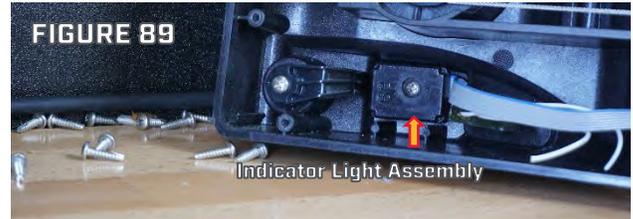
Step 18. Use the #2 Phillips driver to remove the screw securing the Indicator Light Assembly to the Foot Pedal Base. Set this screw aside, it will be reused during reassembly. (Figure 89)

**NOTICE:** The #8-18 x 3/4" screw securing the Indicator Light Assembly is the same thread size as the #8-18 x 5/8" screws securing the bottom plate but is slightly longer. The #8-18 x 3/4" screw must be used in this location at assembly.

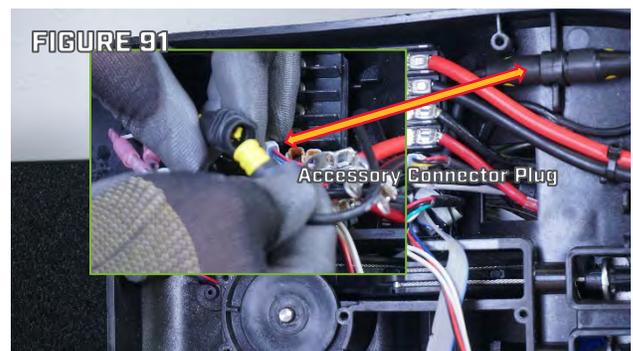
Step 22. Remove the accessory connector plug. (Figure 91)

- a. Lift the accessory plug out of its slot in the foot pedal.
- b. Remove the heat shrink from the connector
- c. Pull the connector apart, pull straight apart, and do not twist.

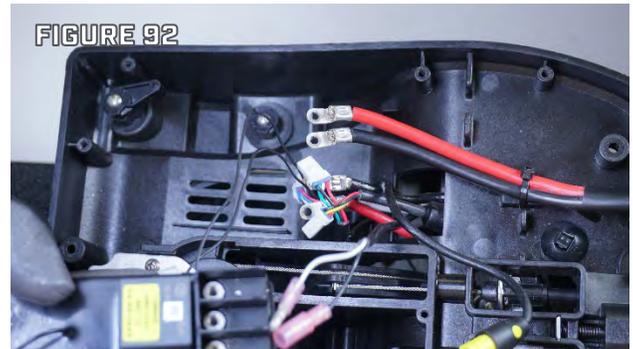
Step 23. Remove the old control board from the foot pedal assembly. Guide the wires for the disconnected components out of the foot pedal, this should include the potentiometer ribbon cable, the reed switch, and the end of limit sensors.

Figure 92 shows the pedal with the control board removed.

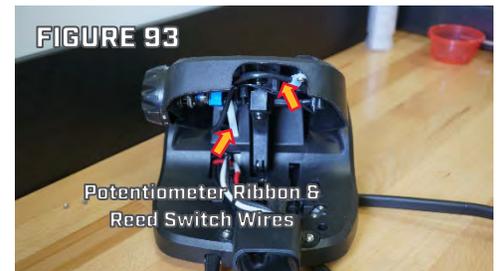
Step 1. Guide the Potentiometer through the upper opening in the Foot Pedal Base, then guide the Reed Switch through that same opening. There are two openings in the foot pedal base, it is necessary for all the connectors routed to the foot pedal rocker to go through the upper opening Figure 93 is a fully assembled pedal shown to illustrate where the opening is located.

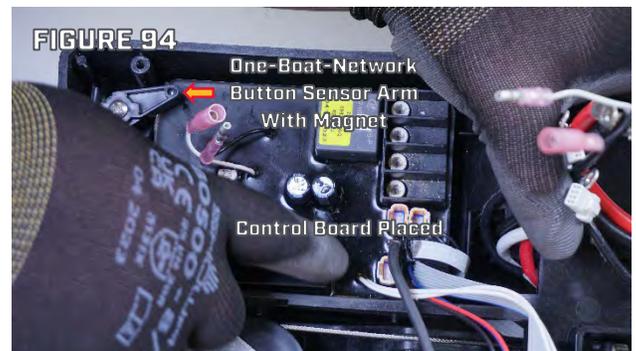
Step 2. Slide the Control Board under the One-Boat-Network Button Sensor Arm with Magnet and place the Control Board in the Foot Pedal Base Assembly. (Figure 94)

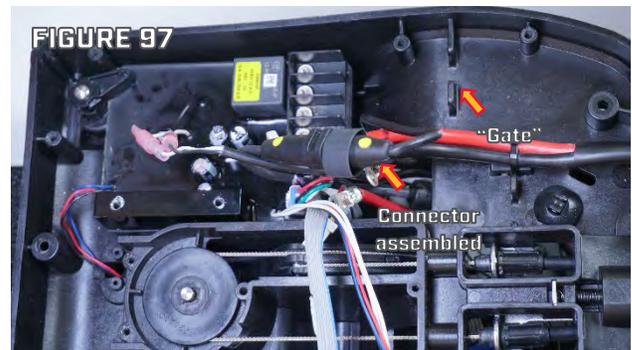
Step 4. Follow Steps a-d to properly connect the accessory plug and place the connected assembly in the foot pedal.

- a. Slide the included heat shrink, 2205414, over one side of the Accessory connector.
- b. Align the two sides of the connector and then push them straight together until they are fully seated (no yellow showing between the two connector halves, the connector should “click” twice as you push it together.)
- c. Position the heat shrink so it covers the seam between the two plug halves and use a heat gun to shrink the heat shrink sealing the connection. Figure 97 shows the heat shrink in place ready to apply heat.
- d. Place the Accessory Plug in the “Gate” just toward the toe end of the Pedal from the Control Board.

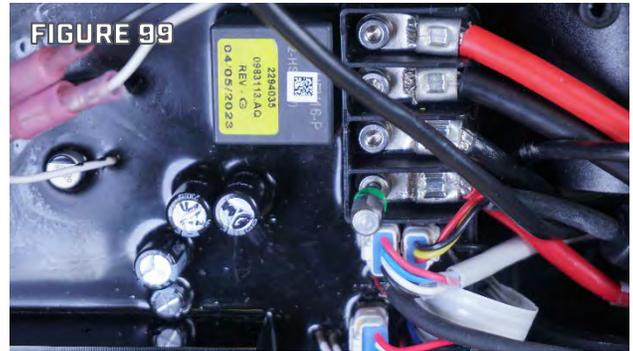
Step 9. Use a torque driver set to 15 in-lbs/1.7 Nm to install the lugs and secure the motor leads in the position indicated in the included wiring diagram. (Figure 99)

Step 10. Use a torque driver set to 15 in-lbs/1.7 Nm to install the lugs and secure the power leads in the position indicated in the included wiring diagram. (Figure 99)

**FAILURE TO TIGHTEN THE LUGS TO THE CORRECT TORQUE MAY DAMAGE THE CONTROL BOARD OR LEAVE THE LUGS LOOSE RESULTING IN MOTOR MALFUNCTIONS**

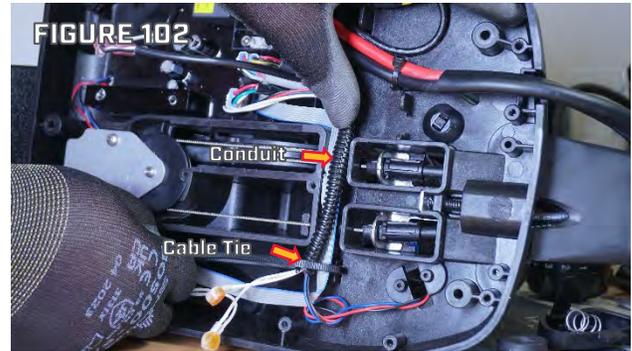
Step 15. Place the two white wires to the power switch and the red, black and blue wires from the Right End of Limit Sensor in the section of conduit and position the conduit on the bridge between the Control Board and Power Switch. (Figure 102)

Step 16. Install the included Cable Ties so that it secures the wires for the Power Switch and Right End of Limit Sensor and the Ribbon Lead for the Indicator Light Assembly. (Figure 102)

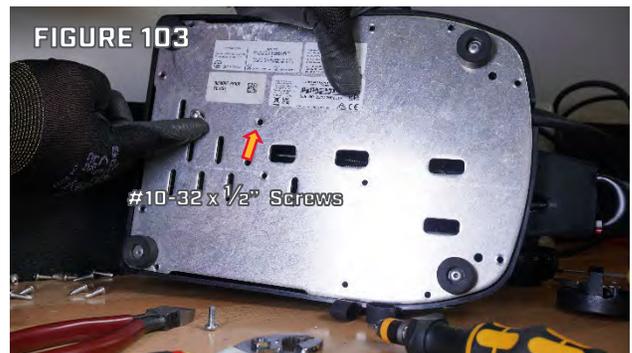
Step 17. Position the Bottom Plate over the Foot Pedal Base. (Figure 103)

Step 18. Using the two new #10-32 x 1/2" Screws included in this kit Secure the Control Board to the Bottom Plate. In Figure 103, 10-32 x 1/2" Screw locations are indicated by arrows. One location has a screw getting inserted.

Step 19. Install the 12 #8-18 x 5/8" Screws securing the Bottom Plate to the Foot Pedal Base. These are the 12 unmarked holes in figure 103. Use hand tools and take care to follow the threads that were created on first installation of the screws to avoid damaging the foot pedal lower.

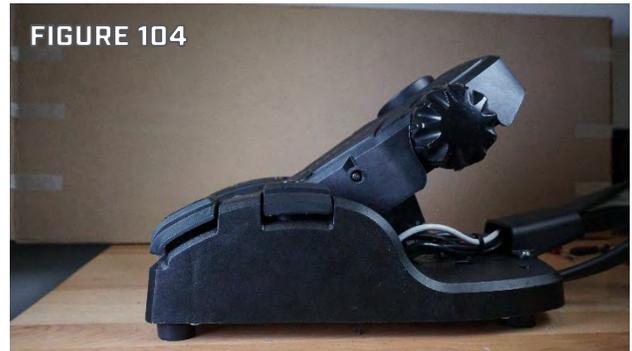
Step 20. Turn the Foot Pedal over so the Base is down. Rotate the Control Head/Lower Unit to place the Foot Pedal in the "Toe Up" position. (Figure 104)

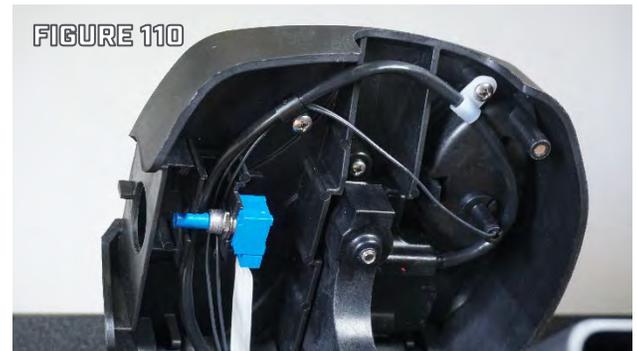
Step 28. Use the 1/2" wrench to tighten the Potentiometer Nut. (Figure 110)

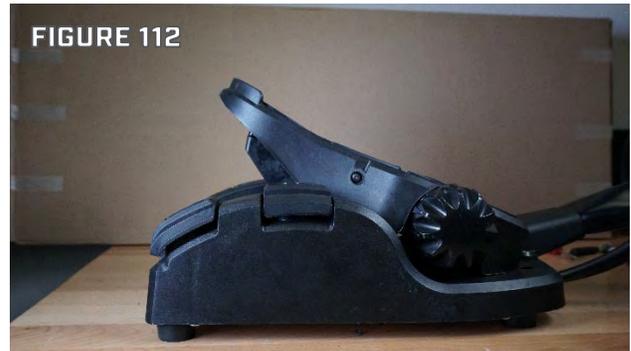
Step 31. Reposition the Motor Lower Unit so the Foot Pedal Assembly is positioned “Toe Down”. (Figure 112)

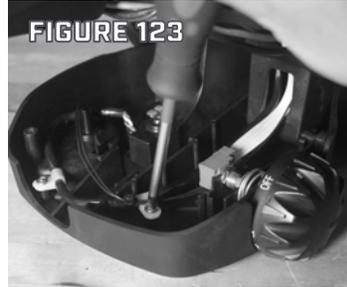
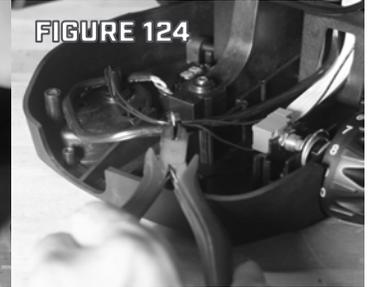
Step 3. Using the #2 Phillips screwdriver, remove the two, #8-18x1/2" screws from the cable clamps that hold the steering sensor board cable (see Figure 123). If a zip tie secures the two black momentary reed switch leads to the steering sensor board cable use the side cutter to remove the zip tie. (See Figure 124) If the motor has a black cable clamp that cable clamp secures the reed switch wires and there is no zip tie.

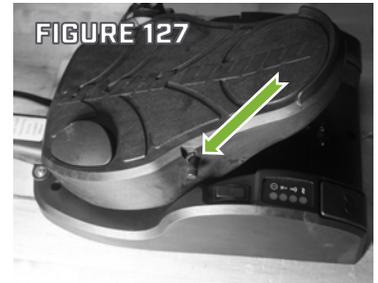
Step 5. Turn the foot pedal back over and locate the knurled side of the pivot pin. Use a hammer and a 3/16" punch to drive the pin out towards the knurled end. (See Figure 127)

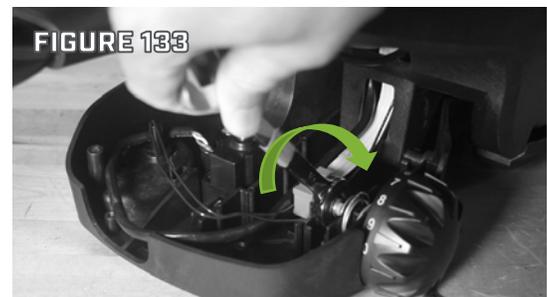
Step 6. Turn the foot pedal back over and connect the steering sensor board connector to the main control board, ensuring it clicks into place. (See Figure 134). Refer to the wiring diagrams to ensure proper installation location of the sensor plug.

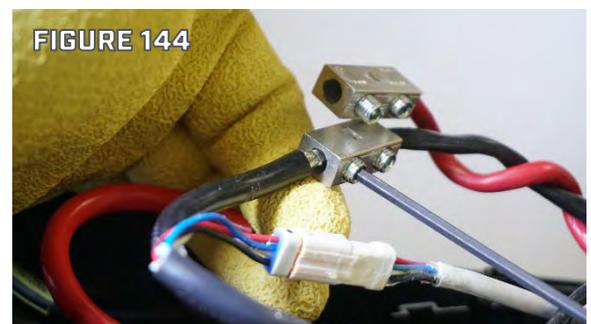
- Step 3.** Use a 1/8" Hex Key or Allen Wrench to loosen one of the Set Screws in the Splicer on the Black Motor Power Wire and repeat for the Red Motor Power Wire, allowing the Motor Power Wires to be removed from the Splicers. (Figure 144)

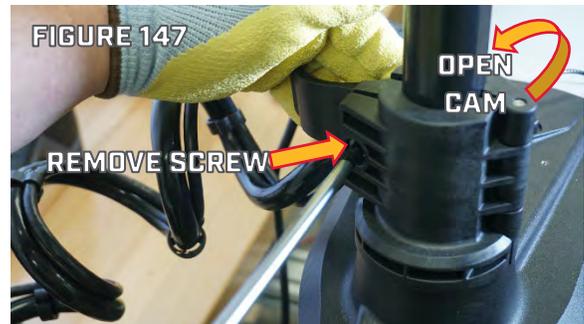
Step 8. To prevent the Shaft/Lower unit from falling, make sure it is supported before opening the Cam Arm on the Depth Collar. Pull the Cam Arm on the Depth Collar into the Open Position. Be aware of the spring in the collar assembly, do not lose the Spring while removing the screw from the collar. Use a #3 Phillips Screwdriver to remove the screw from the Depth Collar opening the Depth Collar completely. Removing the depth collar from the Steering Housing. (Figure 147)

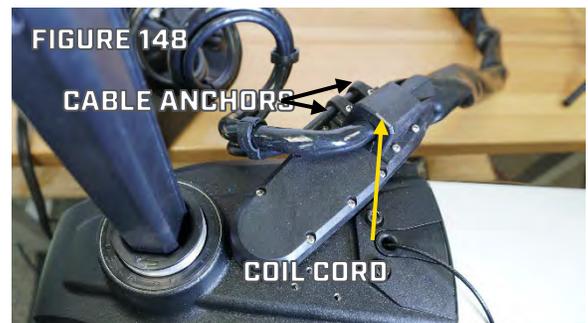
Step 10. Use a #2 Phillips Screwdriver to remove the four screws that fasten the Coil Cord Retainer and retain the two Cable Anchors. Set the Screws, Cable Anchors, and Coil Cord Retainer aside to reuse during assembly. Make note of which side of the Coil Cord Retainer the Cable Anchors are installed on, this is a user preference so the Cable Anchors should get installed on the same side during installation. (Figure 148)

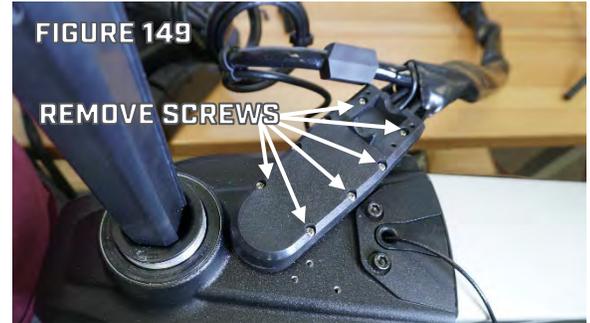
Step 11. Use a #2 Phillips Screwdriver to remove the eight Screws fastening the Top Cable Housing. Lift the Top Cable Housing off of the Cable Housing Bottom and set the Screws and Housing aside for reuse during reassembly. (Figure 149)

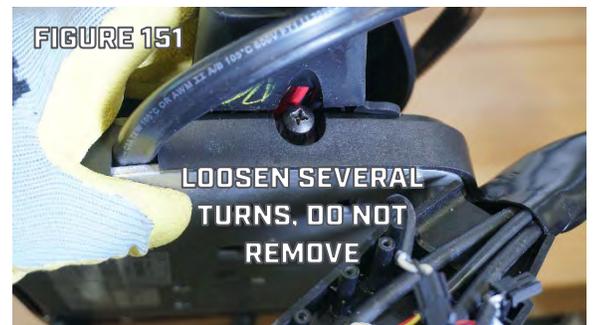
Step 14. On the toe end of the Foot Pedal Assembly, use a #3 Phillips Screwdriver to loosen the Cable Tension Screw several turns. The tension must be loosened to allow removal of the wrap drum from the steering output. Be careful to not fully remove the Cable Tension Screw. (Figure 151)

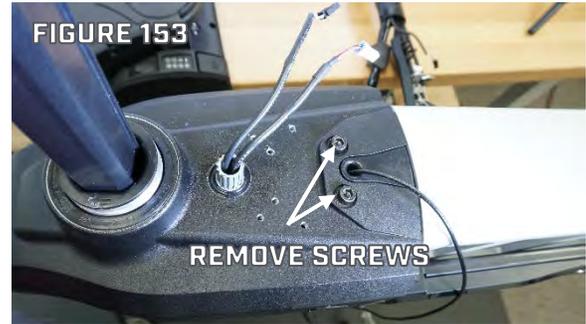
Step 17. Use a ¼” Hex Bit/Allen Key to remove the two 5/16-18 x 2.25 Screws that secure the Steering Housing to the Motor Mount. Lift the Steering Housing off the Motor Mount and slide the Steering Housing up the Motor Shaft and off of the Motor Assembly. Set the Screws aside with their Lock Washers to use in reassembly. (Figure 153)

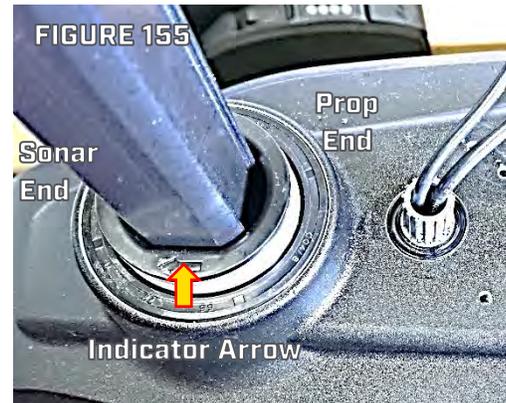
Step 1. Slide the new Steering Housing Assembly down the Motor Shaft, oriented so the Motor is pointed toward the front of the steering assembly. (Figure 155)

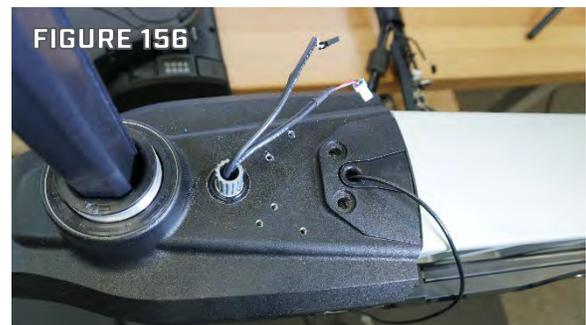
Step 2. Slide the Steering Housing onto the Motor Mount. After the Steering housing has been positioned onto the Motor Mount use ¼” Hex Key/Allen Wrench to install the two 5/16-18 x 2.25 Screws with a Lock Washer Assembly on each screw. (Figure 156)

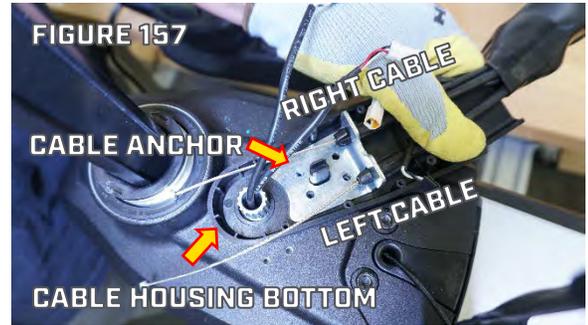
Step 3. Place the metal Cable Anchor Bracket in the plastic Cable Housing Bottom and place these two components on the Steering Housing such that the pass-through holes are aligned with the #10-24 tapped holes in the Steering Housing as Shown in Figure 157.

Step 4. Use #2 Phillips Screwdriver to install the three #10-24 Screws Securing the Cable Anchor Bracket and Cable Housing Bottom to the Steering Housing. (Figure 157)

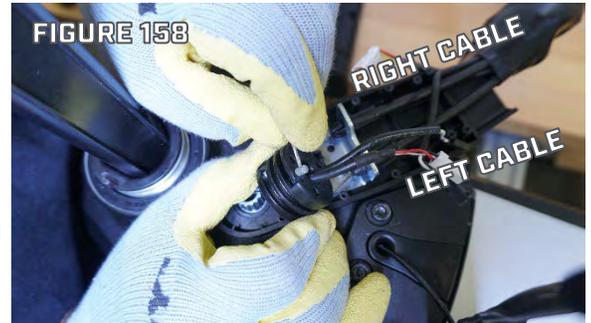
Step 5. Verify the cables are installed on the Wrap Drum. If the cables came off, reinstall them. The left cable clips into the bottom of the wrap drum, right cable into the top of the Wrap Drum, install one cable, turn the wrap drum nearly 1 full turn guiding the cable in the slot then install the other cable. (Figure 158)

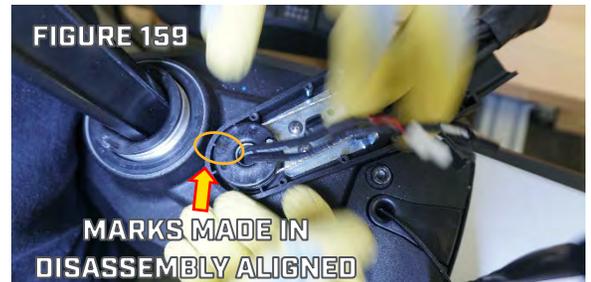
Step 6. Verify the Motor Assembly is pointed Straight ahead. Slide the Wrap Drum onto the Cable Gear in the same orientation as when removed from the replaced Steering Housing. Utilize the mark made on the Wrap Drum during disassembly to align the Wrap Drum to the user's setting. (Figure 159)

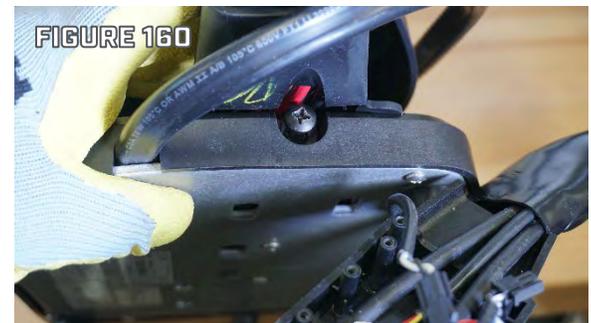
Step 7. Use a #3 Phillips Screwdriver to tighten the Tension Screw in the foot pedal. Tighten the screw until slack is removed from the cables, do not add tension beyond removing slack. (Figure 160)

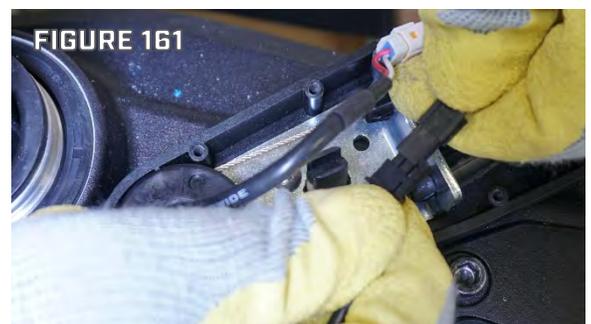
Step 9. Connect the Steering Motor Wires (Black Connector) (It is possible to force this connector on backwards so do verify it is aligned White to White, Black to Black.) (Figure 161)

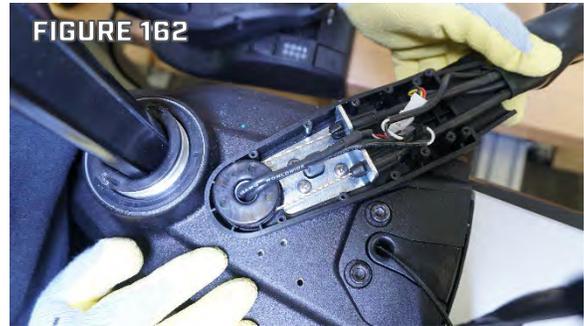
Step 10. Place the Steering Positing Sensor Cable and Steering Motor Wire Cable in the support yoke that part of the Cable Housing Bottom, then route both cables in the depression in the upper rim of the Cable Anchor Bracket between the Foot Pedal Cables. Verify the screw bosses are clear so no cables will be pinched when the Cable Housing Cover is installed. (Figure 162)

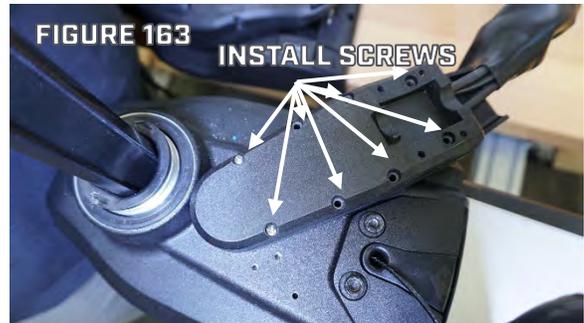
Step 11. Place the Cable Housing Top over the Cables, Wrap Drum, Steering Motor Wires Connection, and Steering Sensor Connection. Use #2 Phillips Screwdriver to install the eight #6-19 x 1" Screws that secure the Cable Housing Top. (Figure 163)

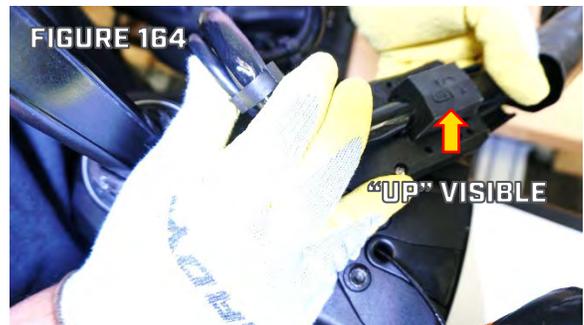
Step 12. Position the Coil Cord Strain Relief in the detail of the Cable Housing Top with "UP" visible. (Figure 164)

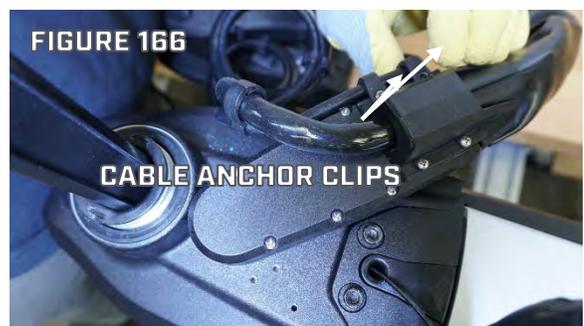
Step 14. On the other side of the Coil Cord Retainer position a Cable Anchor Clip and use a #2 Phillips Screwdriver to install a #6-19 Screw securing the Cable Anchor Clip and Coil Cord Retainer. Repeat this for the other Cable Anchor Clip and last #6-19 Screw that was set aside during disassembly. (Figure 166)

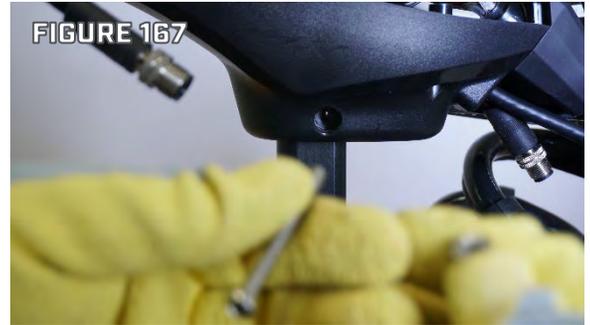
Step 15. Make sure the Nut for the Control Box Locating Screw is in the detail that captures the Nut on the right side of the Control Box. From the Left Side of the Control Box, slide the Control Box Locating Screw through the Control Box and Motor Shaft into the Nut. Use #2 Phillips Screwdriver to tighten the Control Box Locating Screw. (Figure 167)

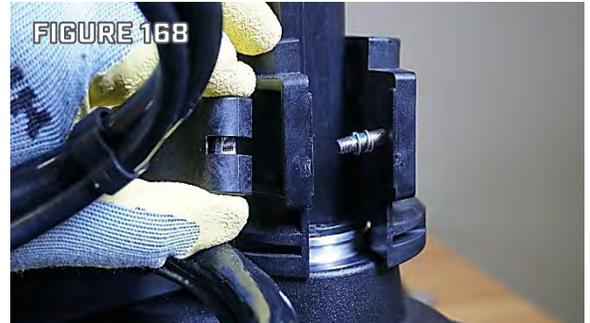
Step 16. Position the Depth Collar onto the Steering Housing. Slide the Screw through the Depth Collar Bolt Half and Spring. Close the Depth Collar Cam Half over the Spring and Screw. Verify the Cam Lock Pin is within the Cam Lock Lever, align the threads of the Cam Lock Pin with the Screw, use #3 Phillips Screwdriver to start the Screw into the Cam Lock Pin. Do not Fully tighten the collar. (Figure 168)

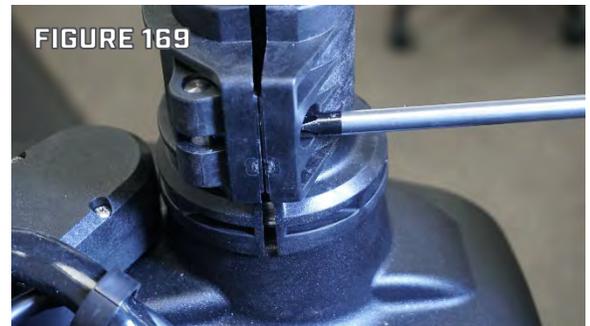
Step 17. After the Screw is three to four turns into the Cam Lock Pin close the Cam Lock Lever and use the #3 Phillips Screwdriver to fully tighten the Screw and Cam Lock Collar. Figure 169)

DO NOT TIGHTEN THE COLLAR WITH THE CAM LEVER OPEN. TIGHTENING THE COLLAR WITH THE LEVER OPEN ALLOWS OVERTIGHTENING; THE MOST LIKELY CAUSE OF A BROKEN COLLAR IS OVERTIGHTENING BY ADDING PRESSURE WITH THE LEVER OPEN.

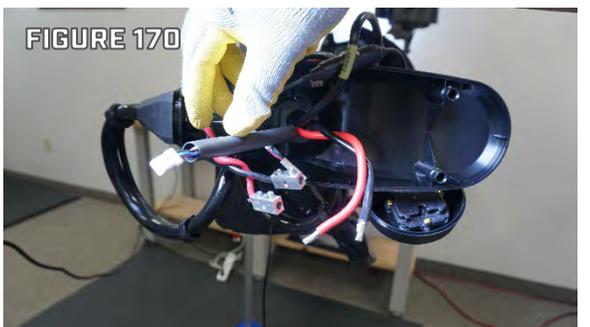
Step 18. Slide the 5" long Heat Shrink over one side of the Motor Communication Cable. (Figure 170)

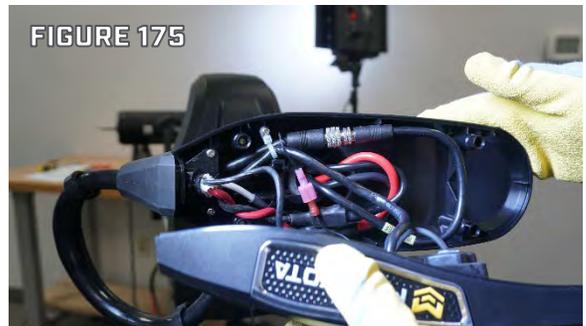
- Step 25. Reconnect the Sonar Cable, align the connectors and fully tighten the locking collar.
- Step 26. Position all the wires such that none of the wires intersect a screw boss or the outer rim of the Control Box. (Figure 175)
- Step 27. Place the Advanced GPS Controller onto the Control Box and use a #2 Phillips Screwdriver to reinstall the 4 screws that were removed during disassembly.

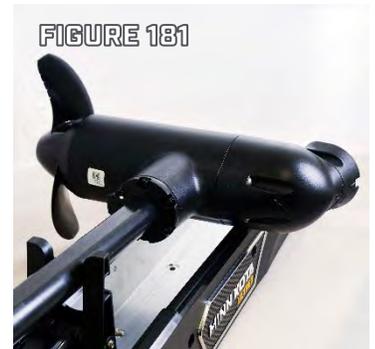
FIGURE 181

1. Turn motor power off
2. Stow motor on Motor Ramps so prop/prop shaft is pointing left (Figure 181)
3. Press and hold both Spot-Lock and OBN buttons on Foot Pedal (Figure 182)
4. While holding buttons, turn motor power switch on
5. As normal, all four lights on the pedal will turn on for about one second.
6. After that, only the Red and Green lights should remain lit
  - a. If this doesn't happen, then the calibration process did not begin and the user should start over
7. Release the Spot-Lock and OBN buttons on the Foot Pedal.
8. The Red light should turn off and the Green light should flash
  - a. If the Green light turns off and the Red light flashes, something caused the calibration to fail – see below for possible reasons
9. Turn motor power switch off to complete the process
10. Motor can now be used as normal

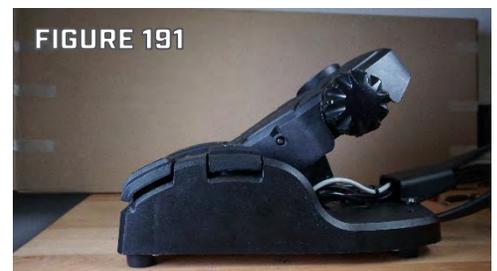
FIGURE 191

- Step 1. Turn the motor on, Deploy the Motor, Position the Foot Pedal “toe up”. (Figure 191)
- Step 2. Push the Momentary Button all the way down. (Figure 192)
- Step 3. Use a small Flat Blade Screwdriver to slowly push the Momentary Reed switch up in the Reed Switch Clip, as soon as the prop starts running stop. (Figure 193)
- Step 4. Release the button, and test the Momentary Function by pressing and releasing the button. If the momentary is too slow to engage push farther up as in step 3. If momentary will not disengage remove the button, push the switch back down in the reed switch clip, return the button and repeat step 3.

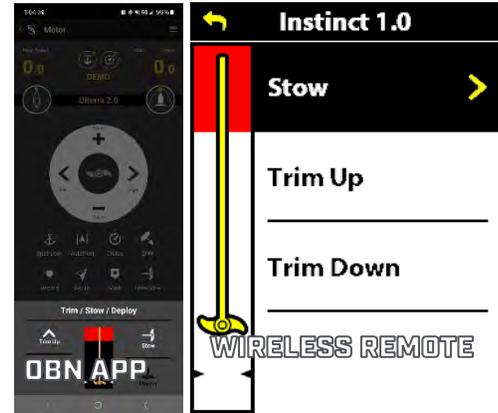
FIGURE 201

**NOTICE:** If the Tilt Disconnect Pin has been pulled you may need to push down on the Tilt Bracket to engage the Latch Pin to the point the Latch Sensor is engaged. When the sensor is properly located the Ulterra or Instinct menu in the OBN App or Wireless Remote, will have options “Trim Up, Trim Down, and Stow”, “Deploy” will not be present on the remote and will not be selectable in the OBN App (FIGURE 201)

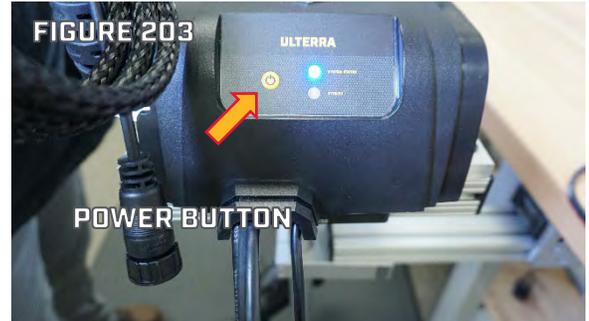
Step 4. Depress the Plunger in the Left Motor Ramp (Figure 204). Turn the Motor on as you continue to hold the Plunger.

**NOTICE:** The most likely reason the motor will not progress into Steering Limit Calibration Mode is the Plunger being depressed too far, a portion of the Plunger will be visible above the Motor Ramp when the Plunger is in the correct Position.

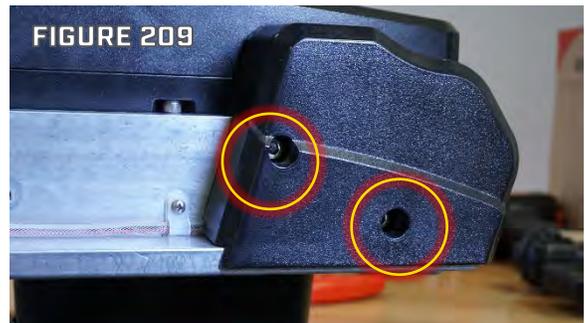
Step 5. Use a 3/16" Allen Key to remove the two Screws that fasten the Right Motor Ramp to the Base Extrusion. Set the Motor Ramp and Screws aside for use during reassembly. (Figure 209)

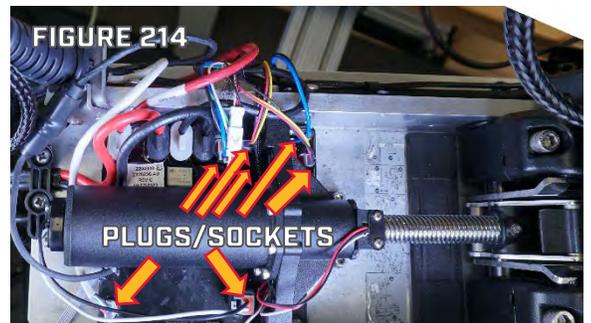
Step 10. At the Main Control Board unplug the Motor Communication Cable Plug, Tilt Motor Plug, Steering Motor Plug, Trim Motor Plug, Steering Position Sensor Plug, Trim Position Sensor Plug, and Trim Motor Brake Plug. Use a small flat blade screwdriver or pick to actuate the locking tabs on the smaller connectors. See the [WIRING DIAGRAM](#) on Page 10. (Figure 214)

**NOTICE:** If the Trim Position Sensor Plug does not have a visible red mark use a Red Permanent Marker to add a visible Red Mark to the Plug. The Trim Position Sensor Plug and Steering Position Sensor Plug are identical other than that mark, mixing them up during reassembly may result in damage to the motor during calibration.

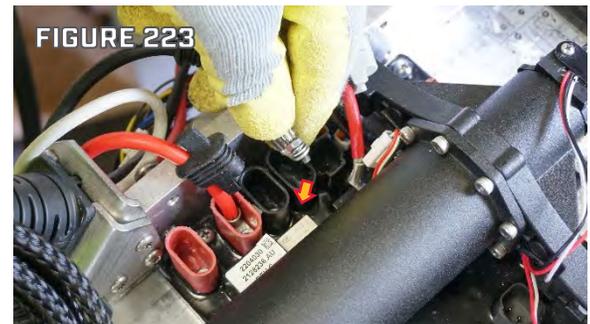
Step 3. Place a Lug Screw through the Terminal of one of the Battery Power Leads. Use a #2 Phillips Bit and Torque Driver set to 15 in-lbs (1.6 Nm) to install the Lug Screw into the pocket in the Control Board. (Figure 223)

The torque of the Lugs to the Control Board is critical. Slightly too loose the Lugs will loosen over time and not maintain a good connection; slightly too tight and the Control Board can be stripped out damaging the Control Board.

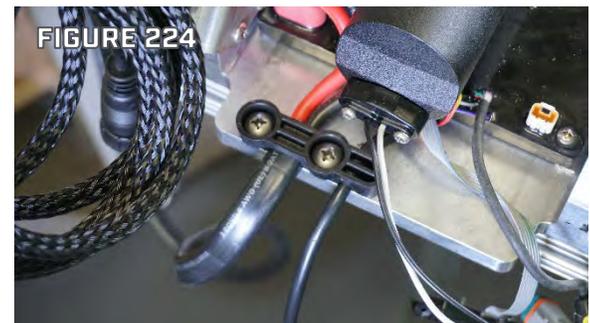
Step 4. Place the Strain Relief over Battery Power Lead Wire and the Foot Pedal Connector Cord. Use a #3 Phillips Screwdriver to reinstall the Two Screws that Fasten the Strain Relief to the Base Extrusion. (Figure 224)

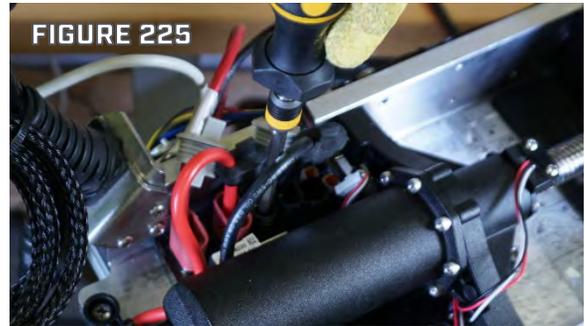
Step 5. Place a Lug Screw through the Terminal of one of the Motor Power Leads. Use a #2 Phillips Bit and Torque Driver set to 15 in-lbs (1.6 Nm) to install the Lug Screw into the pocket in the Control Board. (Figure 225)

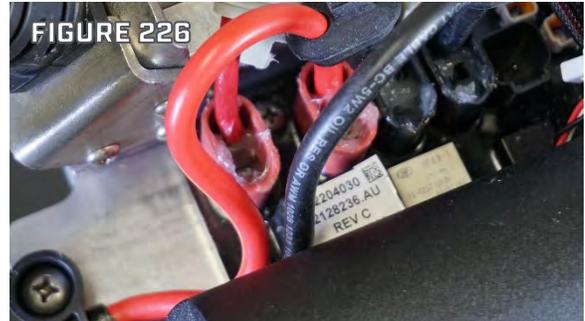
Step 6. Apply dielectric grease over each of the Battery Power Leadwire and Motor Power connections to completely cover the metal components of the connection. (Figure 226)
