# MINN KOTA®

**SERVICE PROVIDER REPAIR MANUAL**

## **QUEST SERIES MOTOR REPAIR**

**ULTREX QUEST 2023-PRESENT**  
**ULTERRA QUEST 2023-PRESENT**  
**RIPTIDE INSTINCT QUEST 2023-PRESENT**  
**TERROVA QUEST 2023-PRESENT**  
**RIPTIDE TERROVA QUEST 2023-PRESENT**

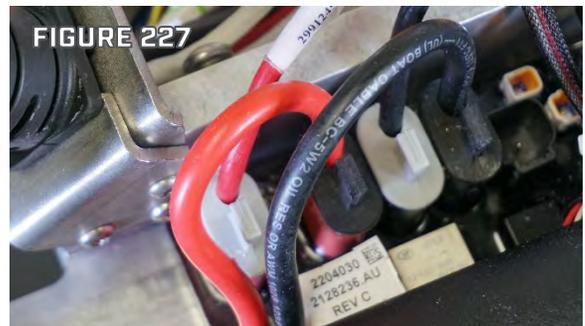
Step 7. For each of the Motor Power Leads and Battery Power Leads slide the Terminal Seals down the wire and seat them in the Terminal Pocket. (Figure 227)

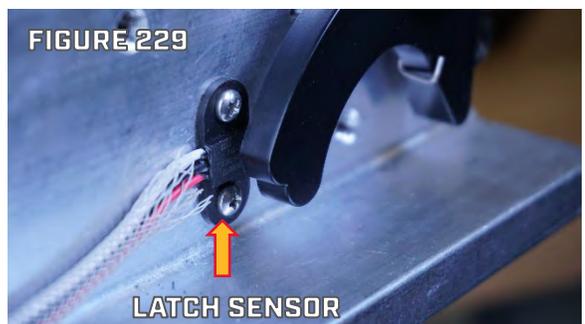
Step 9. The Hall Effect Sensor with the gray jacket is the Latch Sensor. Route the Latch Sensor down the right side of the Base Extrusion and use the two Screws set aside during disassembly to attach the Sensor to the Base Extrusion, with the raised detail/writing facing out/legible. (Figure 229)

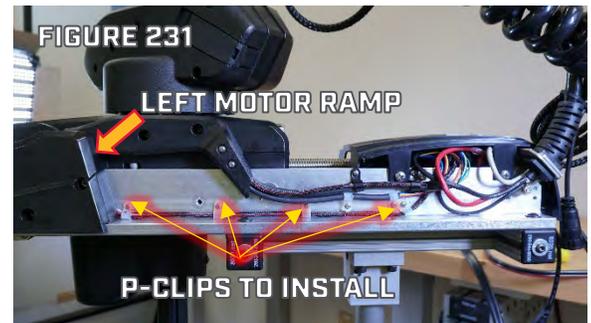
Step 11. Reinstall the P-Clips on both sides of the Base Extrusion to keep the Hall Effect Sensor Wires properly routed along the base of the Base Extrusion. (Figures 231 and 232)

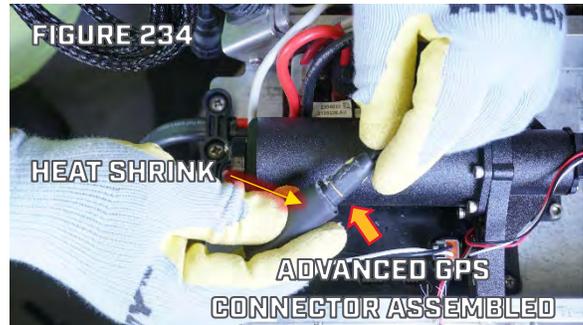
Step 16. Slide the included Heat Shrink onto one side of the Advanced GPS Navigation Connector. Push the two halves of the Advanced GPS Navigation Connector together, fully seating them together, there should be no yellow visible at the point the connectors join. Center the Heat Shrink on the Advanced GPS Navigation Connector and use a Heat gun to seal the Connector with the Heat Shrink. (Figure 234)

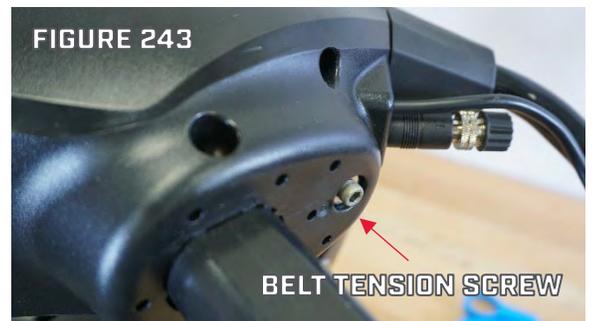
Step 5. From the underside of the Control Box use a 5/32" Hex Key/Allen Wrench to remove the Belt Tension Screw. Set the Belt Tension Screw and Washer aside for use in reassembly (Figure 243)

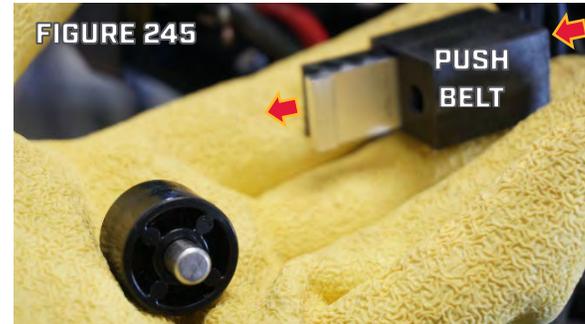
Step 8. Push the Belt out of Belt Block to access the Belt Rack, remove the Belt Rack, then remove the Belt from the Belt Block. (Figure 245).

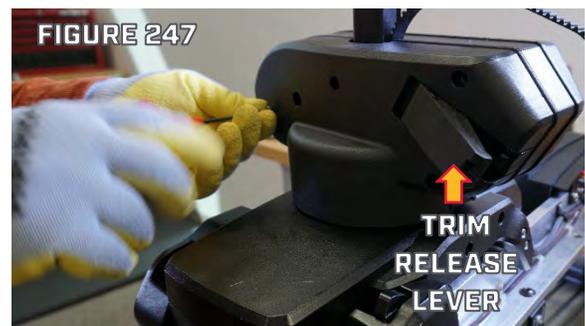
Step 1. With one hand, grasp the Motor Shaft and lift upward slightly to offset the weight of the lower unit relieving the pressure on the Trim Release; with your other hand, pull the Trim Release Lever to disengage the trim motor drive. Lower the Lower Unit and Motor Shaft slowly so the skeg rests on the floor. (Figure 247)

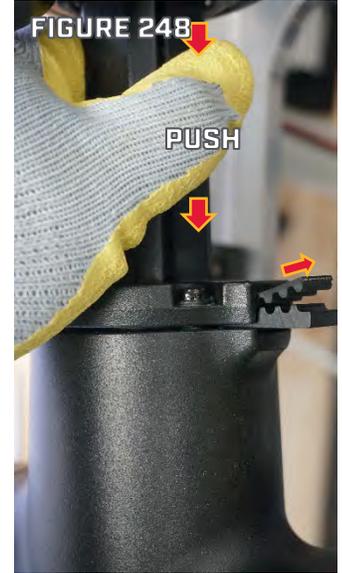
Step 2. Pull the belt downward creating at least 4" of Belt slack between the Steering Housing and Lower Unit, this slack is necessary for step 16. If the belt will not travel freely through the Trim Housing pull the Trim Release Lever back open. (Figure 248)

Step 3. Push Down/toward the Motor Lower Unit on the Belt to force the Lower Belt Block and the end of the Belt out of the Lower Unit Clamp Collar. If the Belt and Belt Block will not exit the Lower Unit Clamp by only pushing the belt a small pliers may be used to grip the end of the Belt and pull (Figure 248).

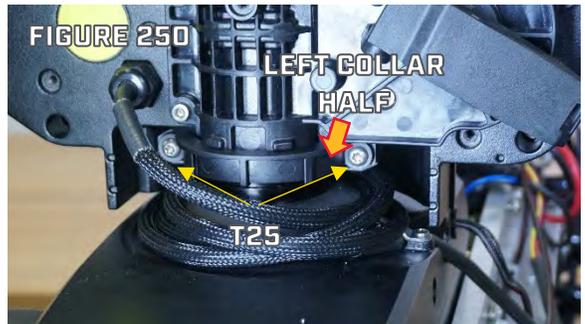
Step 4. Use a T25 Driver to remove the two Torx head screws from the Trim Steer Clamp Collar, that secures the Trim Housing to the Steering Housing. Set the Left and Right Collar Halves and Screws aside for use in reassembly, the Nuts will stay captive in the Right Collar Half. (Figure 250).

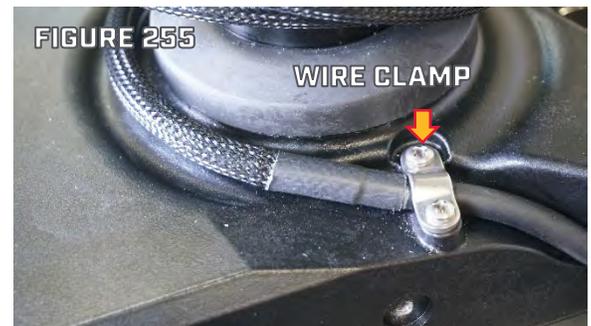
Step 8. Use a #2 Phillips Screwdriver to remove the Screws from the Wire Clamp Securing the Trim Housing Cable to the Steering Housing. Set the Wire Clamp and Screws aside for use in reassembly. (Figure 255)

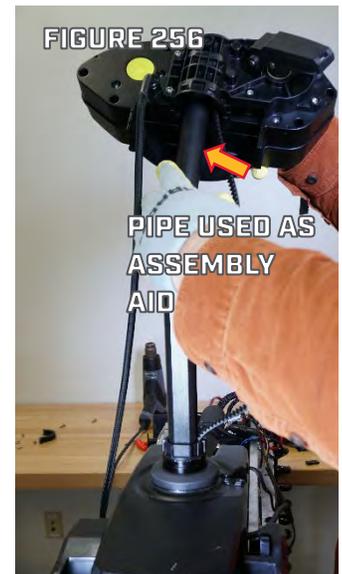
Step 9. Slide the Trim Module upward to remove it from the Motor Shaft. (Figure 256) ½”-3/4” PVC Pipe 6-12” used as a disassembly/assembly aid.

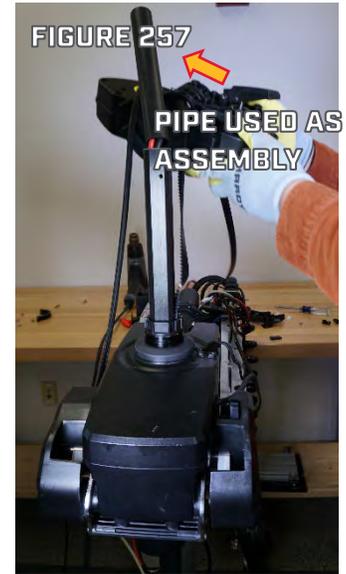
Step 1. Slide the new Trim Housing over the top of the Motor Shaft, positioning the Belt in the Belt Groove of the Motor Shaft. (Figure 257)

**NOTICE:** A 6-12" piece of 1/2"-3/4" pipe can be used to manage the wires from the motor shaft, this will make getting the Trim Housing in place significantly easier as shown in Figure 257.

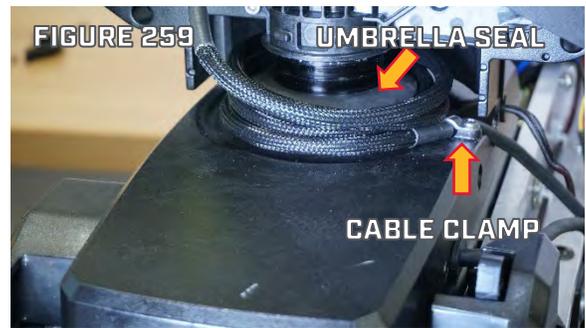
Step 3. Loosely wrap the Trim Housing Cord around the shaft at least three times before continuing out the cord detail on the top of the steering housing. When properly routed, the Trim Housing Cord will be around the Umbrella Seal, not on top of the Umbrella Seal, to prevent damaging the Umbrella Seal. Install the Cable Clamp over the Trim Housing Cord. (Figure 259).

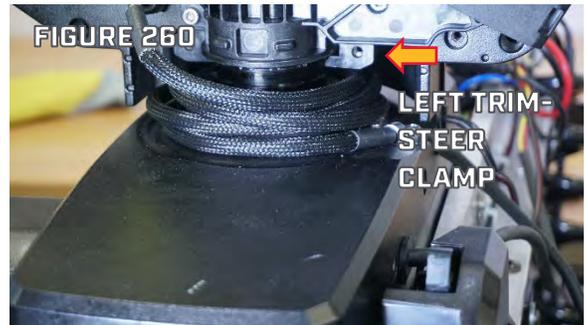
Step 4. Position the Left Trim-Steer Clamp Collar Half under the Trim Housing, such that the Left Trim-Steer Clamp Half engages both the Steering Housing Output and the ring at the base of the Trim Module. (Figure 260)

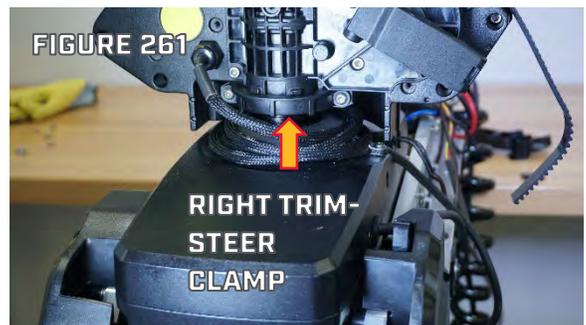
Step 5. Place the Right Trim-Steer Clamp Collar Half over the Steering Output Tube and ring at the Base of the Trim Module. Use a T25 Driver to install the two Screws that fasten the Right Trim-Steer Clamp and Left Trim-Steer Clamp into the Trim Steer Clamp. (Figure 261)

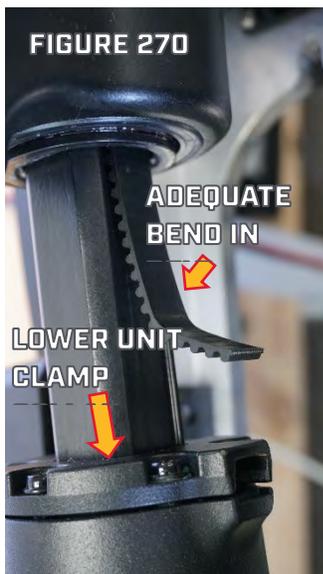
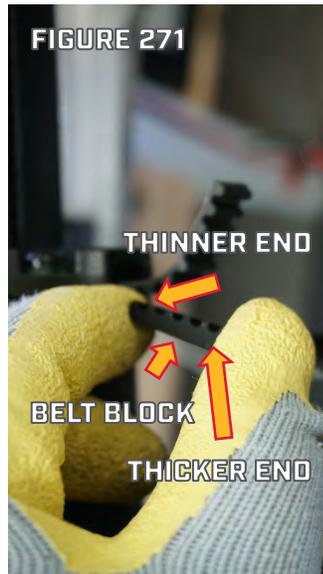
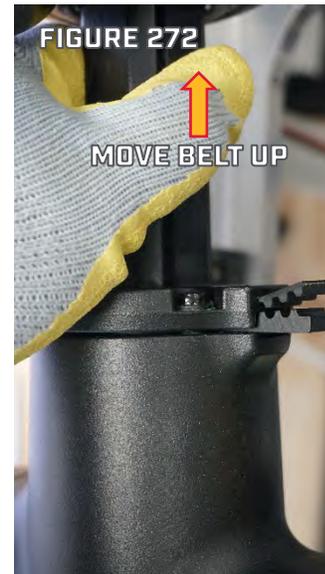
Step 2. Push the tip of the Belt into Lower Unit Clamp Collar, applying pressure to the Belt in the direction of the Lower Unit to get the Belt to slip through the Lower Unit Clamp Collar and out of the back of the Lower Unit Clamp Collar. Position the Belt Block so the thicker end of the Belt Block is toward the Prop and the thinner end is toward the Motor Shaft and the teeth are facing up. (Figure 271)

Step 3. Align the Belt and Belt Block so there is one Belt tooth in each slot in the Belt Block, pull the Belt and Belt Block into the Lower Unit Clamp Collar (Figures 272).

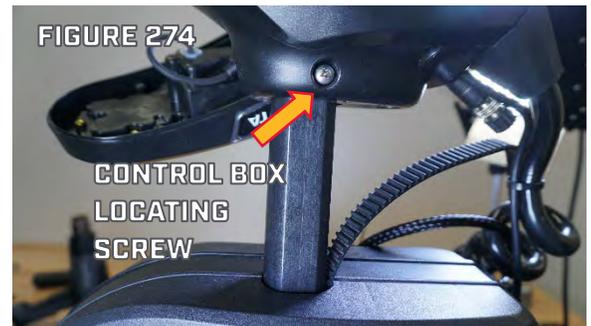
Step 1. Place the Control Box Assembly with the Coil Cord and Advanced GPS Controller onto the top of the Motor Shaft. (Figure 274).

Step 2. Place the Nut that was removed from the Control Box during disassembly in the hex shaped detail on the right side of the Control Box. Insert the Control Box Locating Screw through the Control Box and the hole in the Motor Shaft and tighten the control Box Locating Screw into the Nut. (Figure 274).

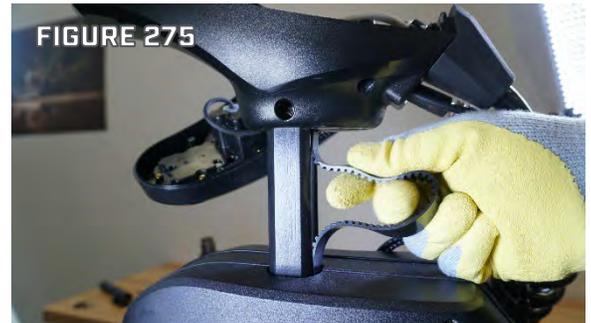
Step 3. Push the Belt into the Control Box via the space between the Control Box and the Shaft along the flat channel in the Composite Shaft. (Figure 275).

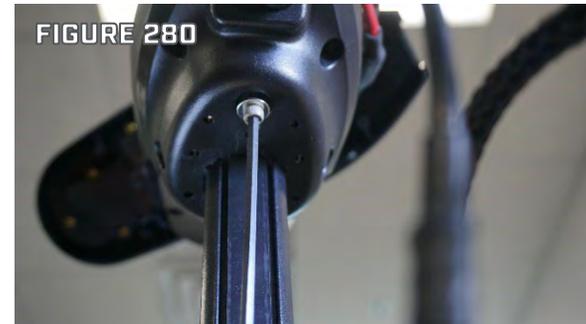
Step 8. Insert the Belt Tensioning Screw with Washer through the hole in the bottom of the Control Box. Engage the Belt Tensioning Screw into the Nut in the Belt Block. It may help to hold the Belt Block down with a free hand to get the Tensioning Screw Started into the Nut. Use a 5/32" Hex Key to tighten the Belt Tensioning Screw to a torque of 10 in-lbs/1.1nM. (Figure 280).

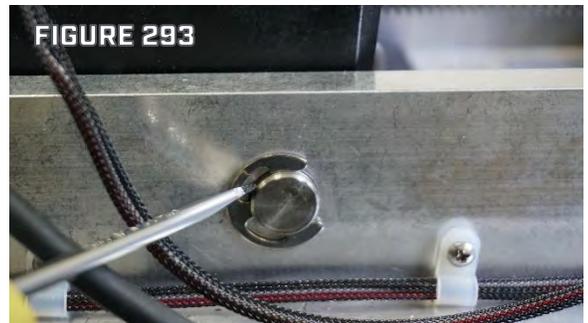
Step 3. Use a Flat Blade Screwdriver, Pick, or small Prybar to remove the E-Ring from one end of the Pivot Pin for the Steering Housing Assembly. (Figure 293)

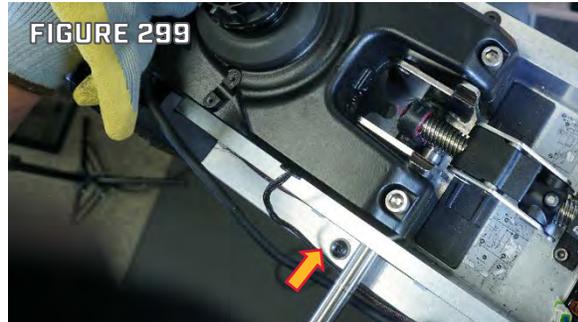
Step 3. Align the holes at the back of the Steering Housing Assembly with holes in the Base Extrusion and push the Pivot Pin through the Base Extrusion, Steering Housing, and Tilt Arms. (Figures 298 and 299)

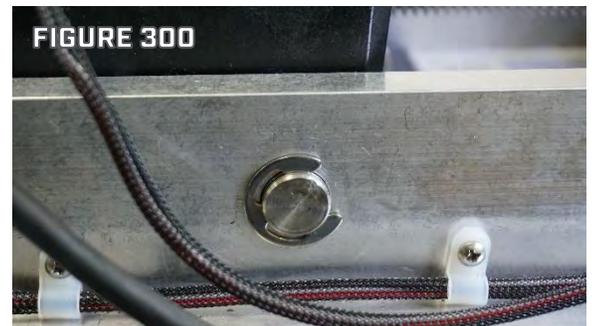
Step 4. Reinstall the E-Ring. Verify the E-Ring Fully seats in the groove of the Pivot Pin, as shown in Figure 300.

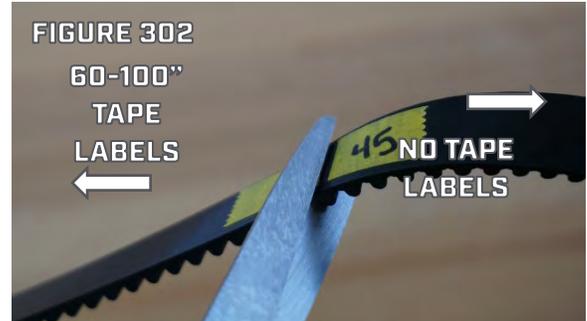
- Step 1. Locate the masking tape label with the corresponding shaft length being worked upon.
- Step 2. Use a sharp Scissors to cut the belt in the "valley" (low point between two Belt Teeth) that is closest to the line marked on tape and on the longer side of the mark. The marks are in sequence 45, 60, 72, 87, the longer side is in the direction of the next longer mark or farther from the previous shorter mark. (Figure 302).

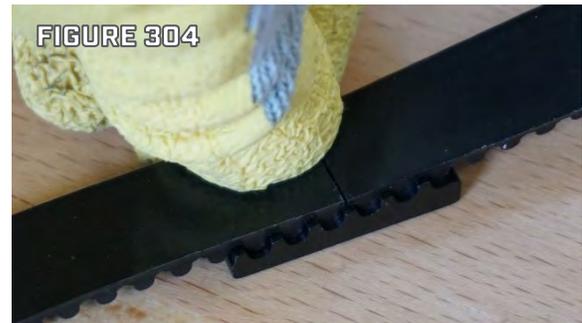
- Step 1. Set the new Belt and old Belt end to end in a Belt Block to set the spacing on the teeth. If the spacing of the teeth does not match, when engaging the output gear in the Trim Housing, the Belt will hang up and break the tape. (Figure 304).

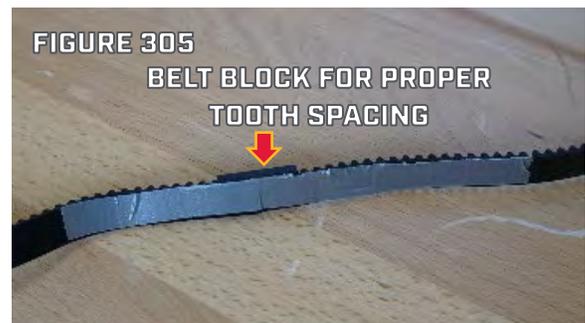
- Step 2. Prepare two strips of duct tape less than 1/2" wide, and at least 4" long.
- Step 3. Apply a strip of duct tape with its length running parallel to the Belts, across the old and new Belt linking them together. (Figure 305).

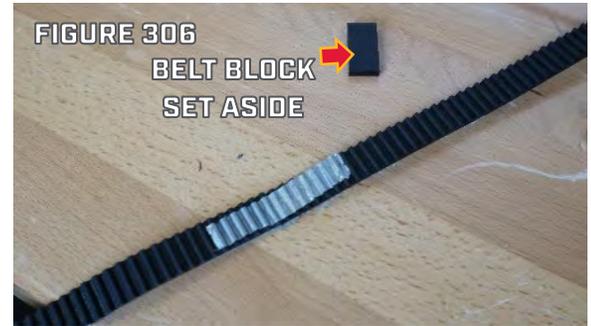
Step 4. Flip the joined Belts over, remove the Belt Block, and apply the other strip of tape to the toothed side of the two Belts, beginning at the seam between the belts and working towards the ends of the strip of tape press the tape into the teeth. (Figure 306).

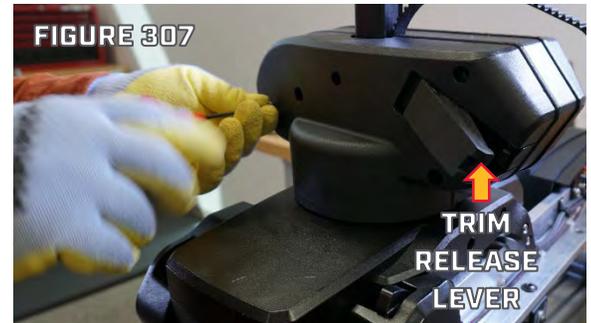
Step 5. Pull the Trim Release Lever out disengaging the Drive Shaft. Pull the old Belt out from the end without the new Belt attached, which will pull the new Belt through the Trim Housing. If any tension is felt on the Belt pull the Trim Release Lever out to release it. If tension develops before the taped seam exits the Trim Housing, and the Trim Release Lever is fully in the open position try backing out and verify the tape is not peeling away from the Belt. (Figure 307).

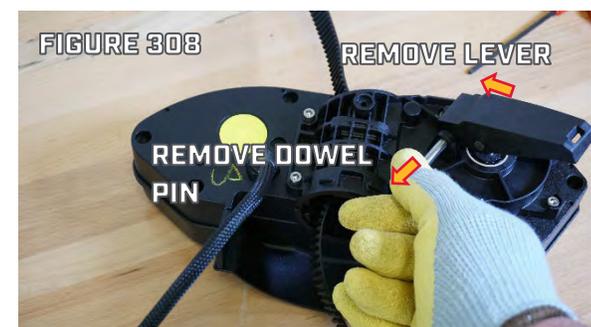
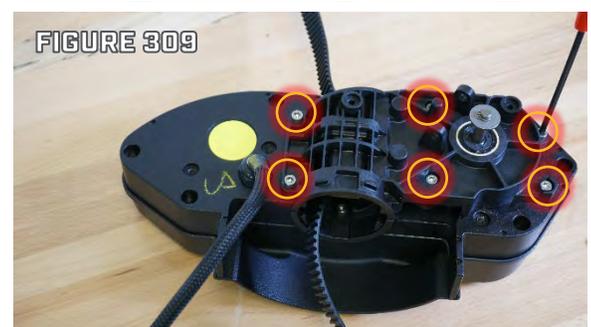
- Step 1. Place the Trim Housing on a work surface, with the plastic Output Collar facing up.
- Step 2. Press the Dowel Pin out of the Trim Release Lever then pull the Dowel Pin out of the Trim Release Lever. (Figure 308).
- Step 3. Slide the Trim Release Lever out from under the washer attached to Trim Gear Output Shaft. (Figure 308).
- Step 4. Use a 5/32" Hex Key to remove six Screws securing the Output Collar to the body of the Trim Housing. Lift the Output Collar off of the body of the Trim Housing. (Figure 309).

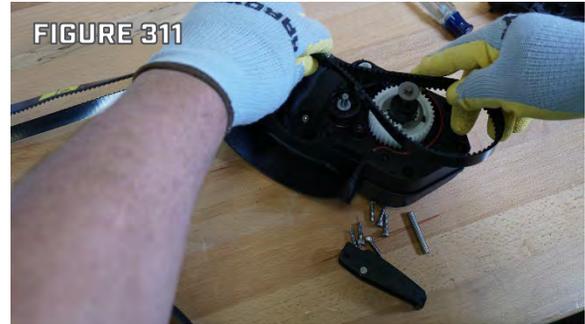
Step 6. Fold the new Belt in half with a loop towards the Drive Gear. Then, position it between the Idler Pulleys and lower the Idler Pulleys and Belt into the Trim Housing, ensuring the Belt lines up with the Drive Gear, with one belt tooth per gear tooth. (Figure 311)

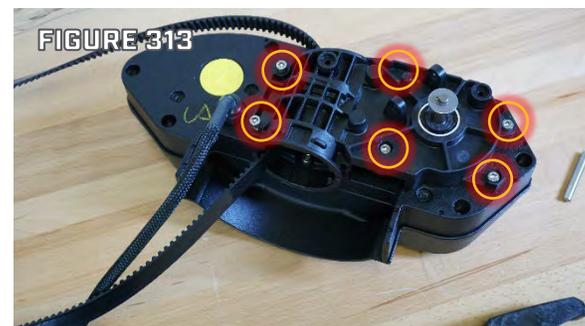
Step 9. Place the Output Collar over the Belt and Pulleys then use a 5/32" Hex Key to reinstall the six Screws that secure the Collar to the body of the Trim Housing. (Figure 313)

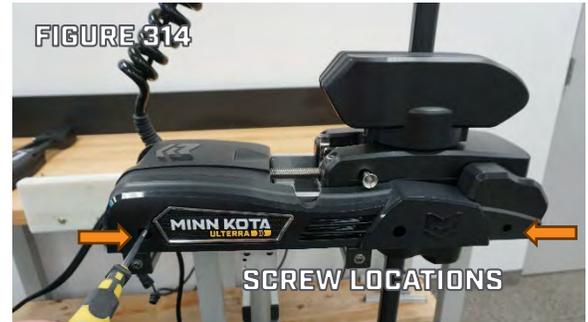
Step 1. Use a #3 Philips Screwdriver to remove the two Screws on the Port and Starboard Sideplates. Set the Screws and Sideplates aside for reuse during installation. (Figure 314)

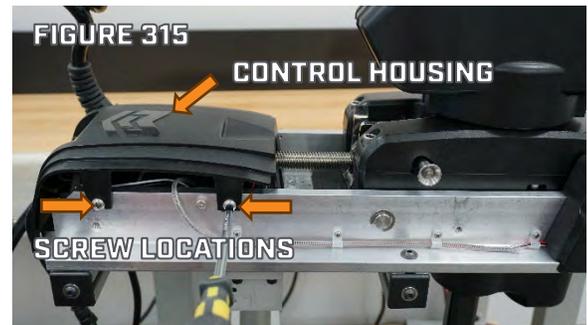
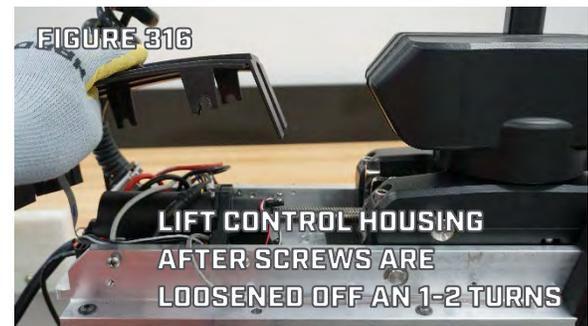
Step 2. Using a #3 Philips Screwdriver, loosen the four Screws that secure the Control Housing to the Base Extrusion by 1-2 turns. The Screws only need to be loosened and not completely removed. Carefully lift the Control Housing from the Base Extrusion to prevent damaging the Ribbon Cable for the Power Button. The four Screws can remain installed in the Base Extrusion. (Figure 315 & 316)

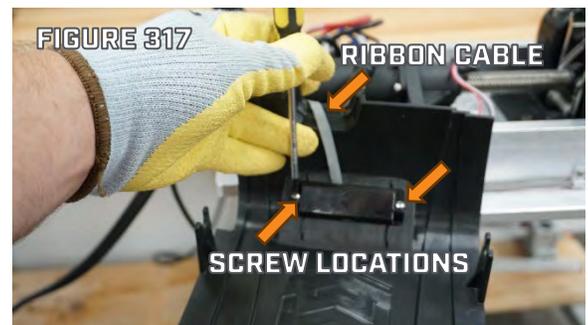
Step 3. Use a #2 Philips Screwdriver, remove the two Screws that attach the LED/Power Button Board to the Control Housing. (Figure 317)

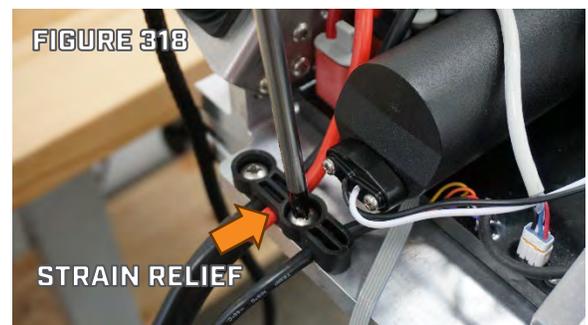
Step 4. Use a #3 Philips Screwdriver to remove the two Screws securing the Strain Relief to the Base Extrusion. (Figure 318)

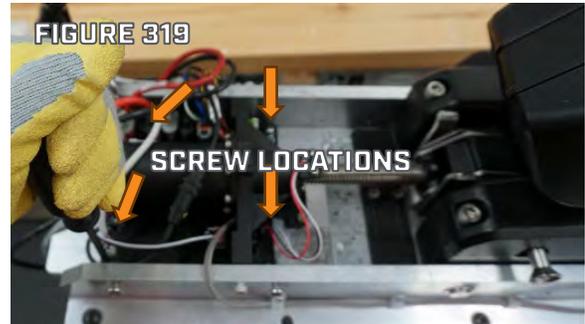
Step 5. Use a #2 Philips Screwdriver to remove the four Screws securing the Main Control Board to the Base Extrusion. Set the Screws aside for reuse during installation. (Figure 319)

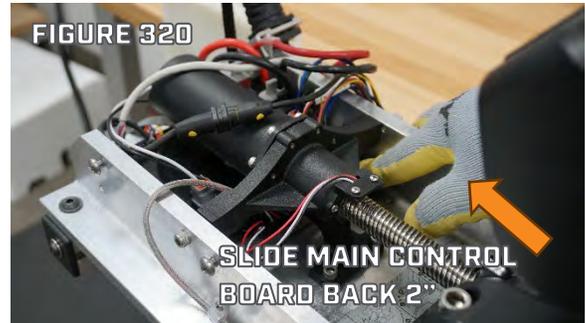
Step 6. Slide the Main Control Board away from the Steering Housing 2" to leave enough clearance to remove the Tilt Actuator Assembly. Leave all connections and wire harnesses intact when pushing the Main Control Board back. (Figure 320)

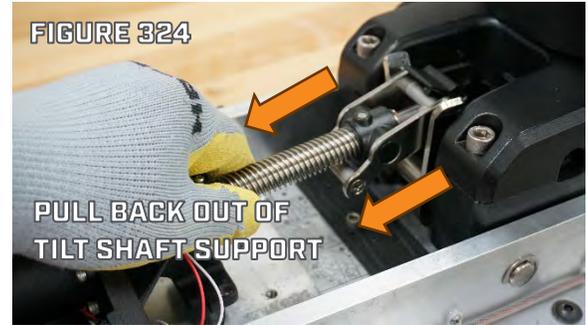
Step 10. Pull back on the Tilt Actuator Assembly to remove it from the Tilt Shaft Support. (Figure 324)

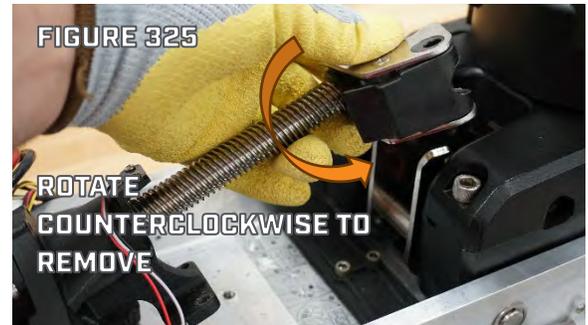
Step 11. With the Tilt Actuator Assembly and the Tilt Bracket Assembly free of the Tilt Shaft Support, rotate the Tilt Bracket Assembly counterclockwise as viewed from the end of the Tilt Actuator Screw, to remove the Tilt Bracket Assembly from the threaded shaft of the Tilt Actuator Assembly. (Figure 325)

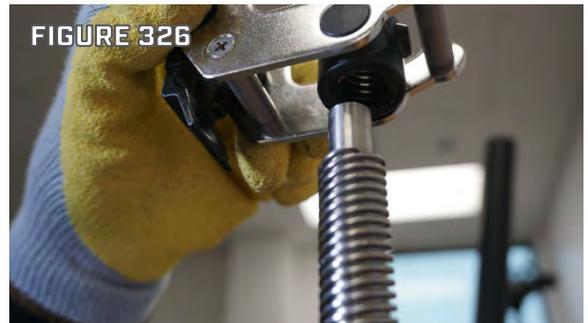
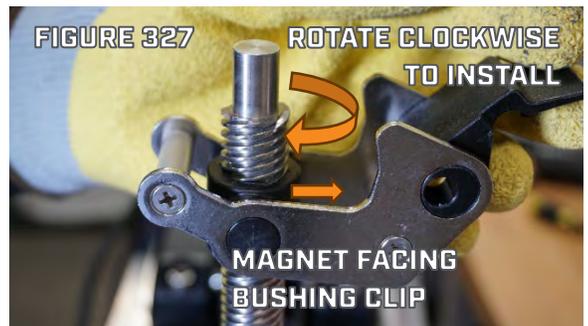
Step 13. With the threads properly aligned rotate the Tilt Bracket Assembly clockwise, as viewed from the end of the Tilt Bracket Screw, until five threads are fully engaged on the threaded shaft of the Tilt Actuator Assembly. This will allow proper installation of the Quick Release Pin. (Figures 326 & 327)

**NOTICE:** Figure 327 and 336 show the magnet facing up toward the Bushing Clip which is the correct orientation on the Tilt Bracket Assembly. If the magnet isn't facing up the Motor will not trim back onto the Motor Ramps during the stow sequence. The Motor will stay trimmed out 6" until the magnet is correctly oriented.

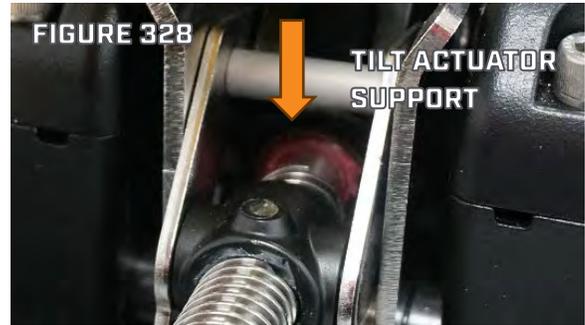
Step 14. Ensure the machined end of the Tilt Actuator Assembly is inserted into the Tilt Actuator Support before inserting the Quick Release Pin. (Figure 328)

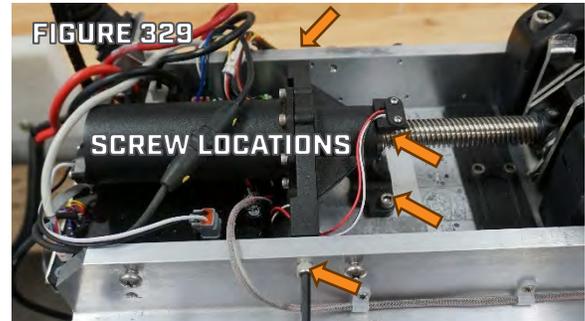
Step 15. Using a 3/16" Hex Key/Allen Wrench reinstall the four Screws that hold the Tilt Actuator Assembly to the Base Extrusion. (Figure 329)

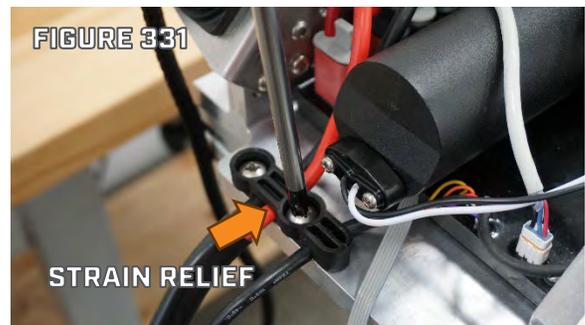
Step 17. Use a #3 Philips Screwdriver to reinstall the two Screws securing the Strain Relief to the Base Extrusion. (Figure 331)

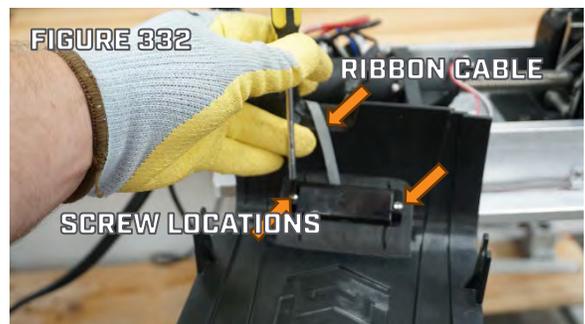
Step 18. Use a #2 Philips Screwdriver to reinstall the two Screws that attach the LED/Power Button Board to the Control Housing. (Figure 332)

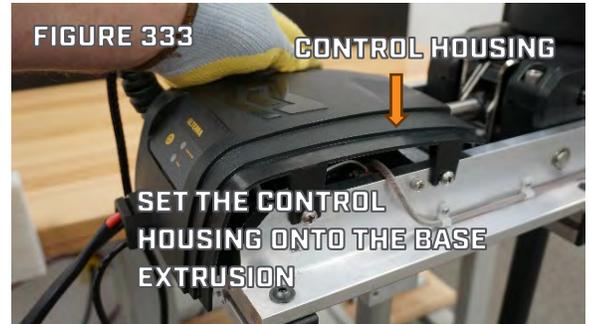
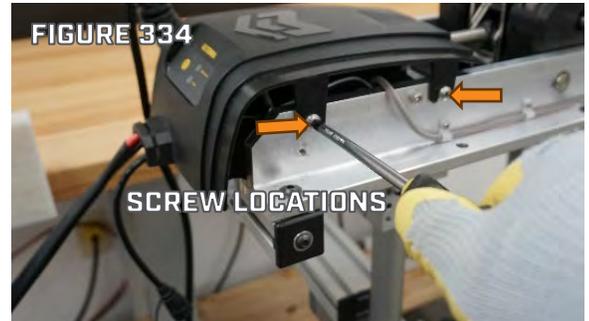
Step 19. Line up and slide the slots in the Control Housing onto the Screws in the Base Extrusion if not removed in Step 2. Use a #3 Philips Screwdriver to tighten the four Screws that were previously loosened 1-2 turns in Step 2. (Figures 333 & 334)

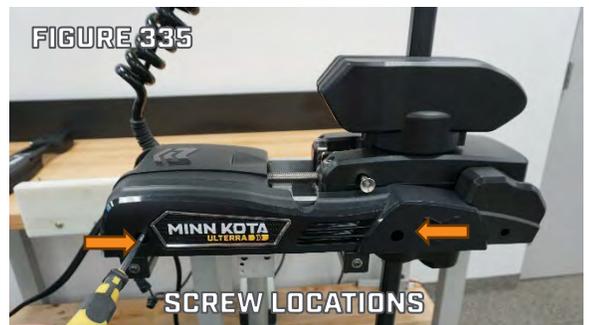
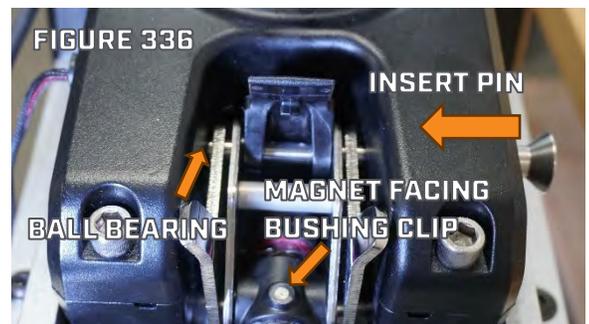
Step 21. Push the Release Button on the end of the Quick Release Pin, insert the Quick Release Pin into the Steering Housing through the five openings in the two Tilt Arms, Steering Housing, and Tilt Bracket Assembly. DO NOT use a mallet to force the pin into the other side of the Steering Housing as that will damage the Pin Sensor. (Figures 336 & 337)

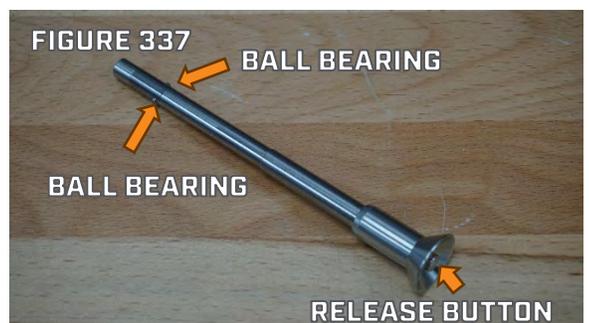
Step 22. Push down on the Bushing Clip to secure the Quick Release Pin and the Tilt Bracket Assembly together. (Figure 338)

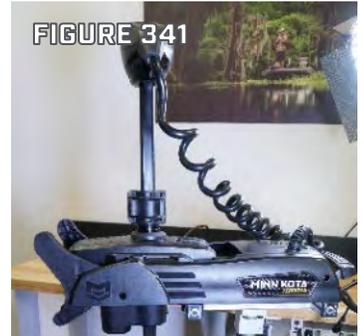
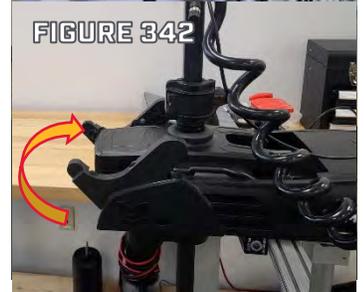
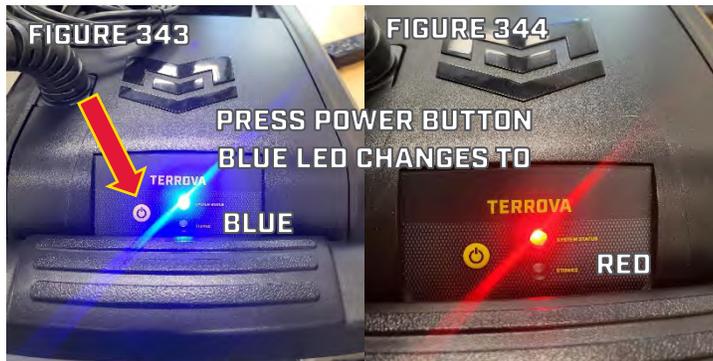
- Step 1. Place the Motor in the Deployed Position. Make sure the Motor is free to steer. (Figure 341)
- Step 2. Reposition the Motor Ramps so they are in the Stowed Position. (Figure 342)
- Step 3. Turn Motor Power On. The Motor should power up normally for a short time, then the Blue Light should go off and the Status LED should turn on Red. (Figure 343 & 344)

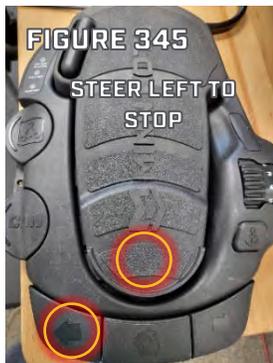
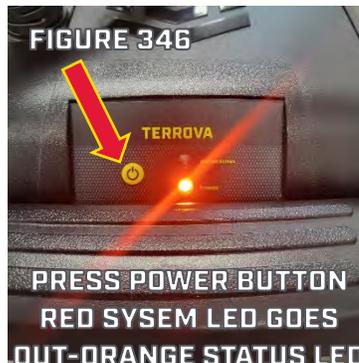
- Step 4. Steer Left until the Motor stops steering. (Figure 345)
- Step 5. Press and release the power Button, the Status LED should turn from Red to Orange. (Figure 346)

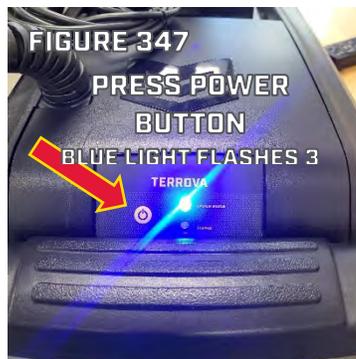
- Step 6. Steer Right until the Motor Stops. (Figure 346)
- Step 7. Press the Power Button to complete the process. Blue Light will flash to confirm the process is completed. (Figure 347)

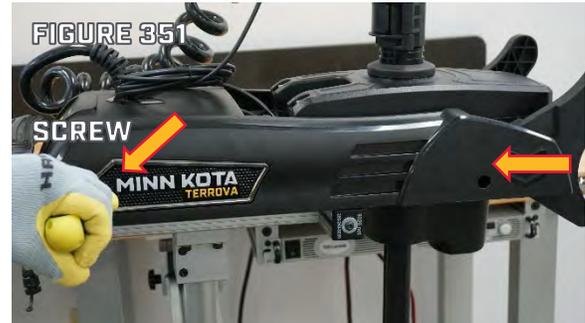
Step 1. Use #3 Phillips Screwdriver to remove the Screws retaining the Sideplates. Set the Screws and Sideplates aside for use in reassembly. (Screw locations indicated by arrows in Figure 351)

- Verify the Motor Ramps are tilted forward in the deployed position as shown in Figure 351.

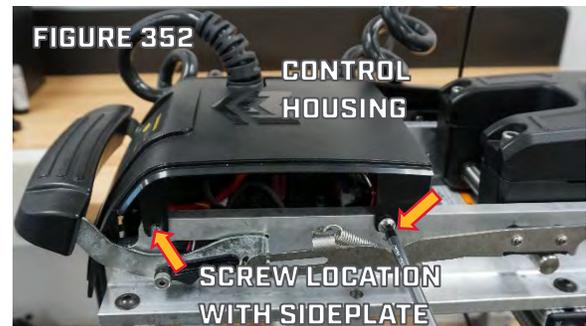
Step 2. Use a #3 Phillips Screwdriver to loosen the two Screws securing the Control Housing. It is not necessary to remove these Screws, loosening about two turns will allow the Control Housing to be removed. (Figure 352)

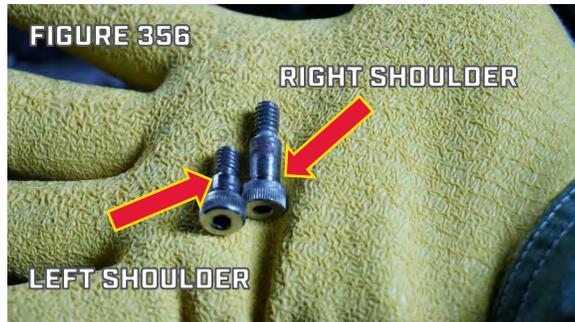
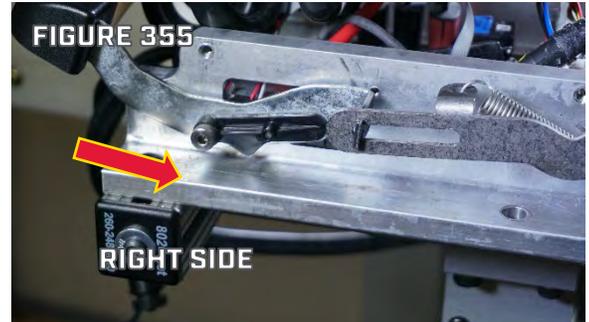
- b. Use the 5/32" Hex to remove the Shoulder Bolts that act as pivots for the Stow/Deploy Lever. Note that the Left Shoulder Bolt is shorter than the Right Shoulder Bolt. Set the Shoulder Bolts aside for use in reassembly. Figure 354, 355, and 356.

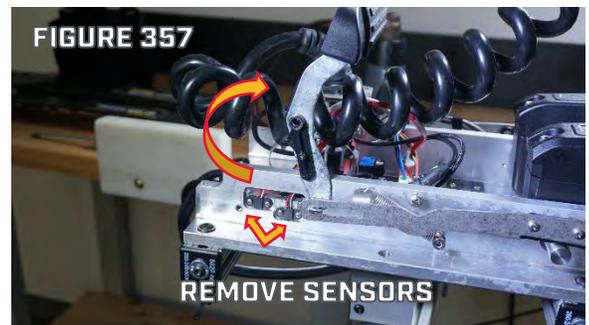
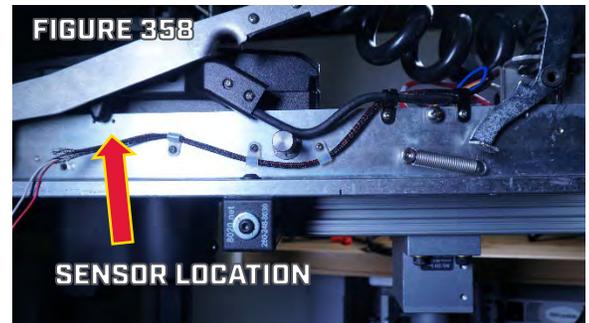
- c. Tip the Stow/Deploy Lever forward until the tabs of the Handle Assembly are in line with the slots in the Release Arms. Once aligned slide one Release Arm off of the Stow/Deploy Lever, and repeat on the other side to fully remove the Stow/Deploy Lever. (Figure 357)
- d. Use the appropriate driver, T10 Torx Bit or #1 Phillips, to remove the Screws retaining the Sensors. Replacement Screws are included in this kit, the removed Screws may be discarded. (Figure 358)
- e. Use the diagonal cutter or utility knife to cut the tie wrap securing the sensor wires.
- f. Move the Sensors from the outside wall of the Base Extrusion to the interior so they are ready to be removed with the board.

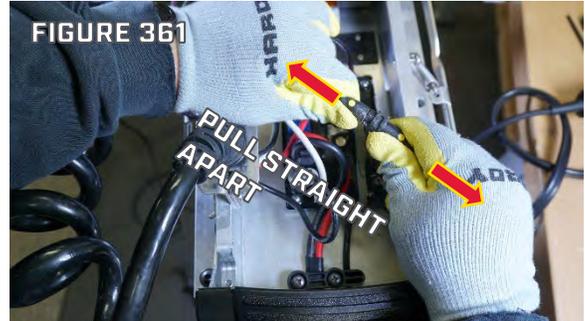
Step 8. Disconnect the Accessory Connector by pulling the two sides of the connector straight apart. Do not twist the connector, it is a straight pull. (Figure 361)

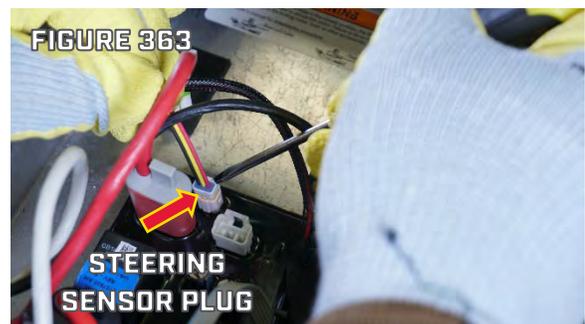
Step 10. Use a small Flat Blade Screwdriver or Pick to depress the locking tab on the plug for the Steering Position Sensor, then pull the Steering Position Sensor Plug from the Main Control Board. (Figure 363)

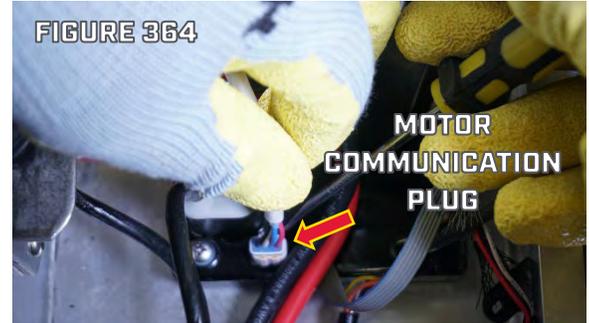
Step 11. Use a Small Flat Blade Screwdriver or Pick to depress the locking tab on the plug for the Motor Communication Cable, then pull the Motor Communication Cable Plug from the Main Control Board. (Figure 364)

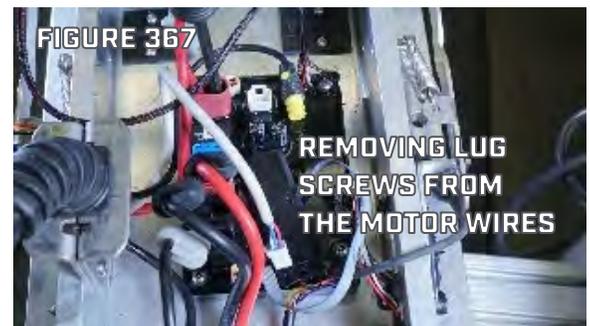
Step 13. Use #2 Phillips Screwdriver to remove the Lug Screws from the motor wires. Remove wires from the wire pocket and reposition so the wires are clear of the Main Control Board. (Figure 367)

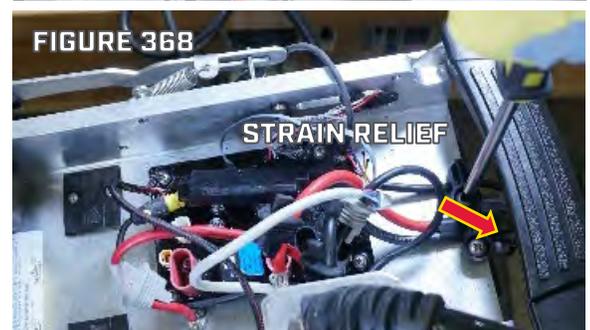
Step 15. Use #3 Phillips Screwdriver to remove the two Screws from the Strain Relief Block, set the Strain Relief Block and the Screws aside for reassembly. (Figure 368)

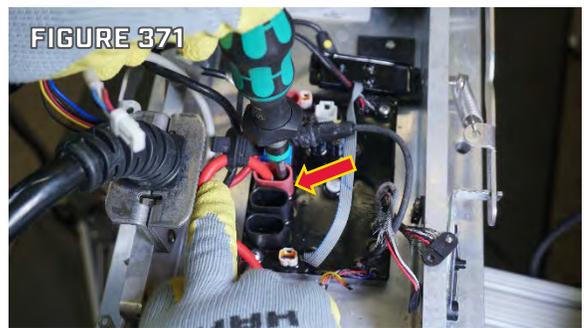
Step 3. Use the **WIRING DIAGRAM** on Page 18 to locate the correct wire pocket for the Motor + (Red) and Motor - (Black) Coil Cord Wires. Use a #2 Phillips Screwdriver Bit with a Torque Driver set to 15 in-lbs/1.7Nm to install the Lug Screws through the each of the Motor Wire Terminals into the Main Control Board. (Figure 370 & 371)

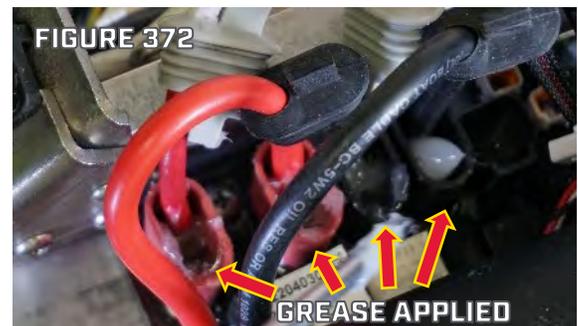
Step 4. Apply dielectric grease to fully cover the metal of each terminal. (Figure 372)

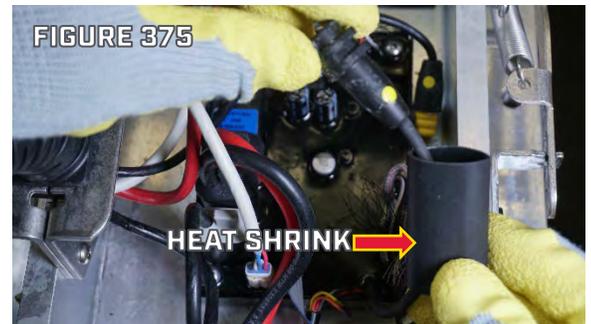
- a. Slide the included Heat Shrink, 2205412, over one side of the Accessory Connector. (Figure 375)

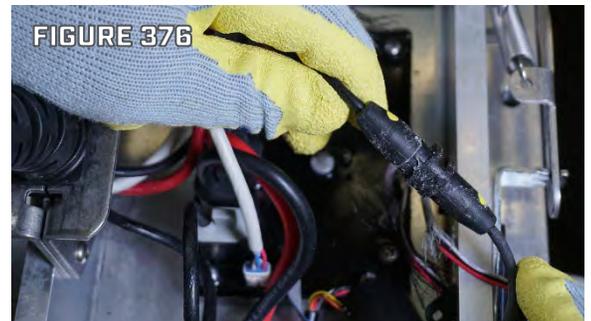
- b. Align the two sides of the Accessory Connector and then push them straight together until they are fully seated (no yellow showing between the two connector halves, the connector should “click” twice as you push it together.) (Figure 376)

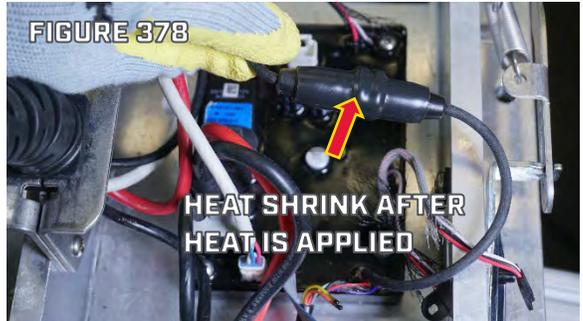
- c. Position the Heat Shrink so it covers the seam between the two Plug halves and use a heat gun to shrink the Heat Shrink sealing the connection. (Figures 377 & 378)

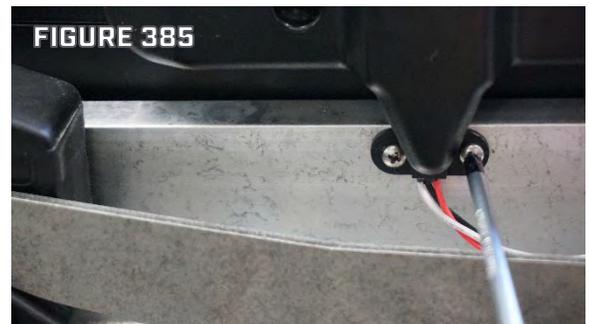
\*\*Phillips Screws shown from an early production motor\*\*

Step 15. Use a T10 driver to install two of the #4-40 Screws included in this kit through the Deploy Sensor, securing it to the Base Extrusion. (Figure 385)

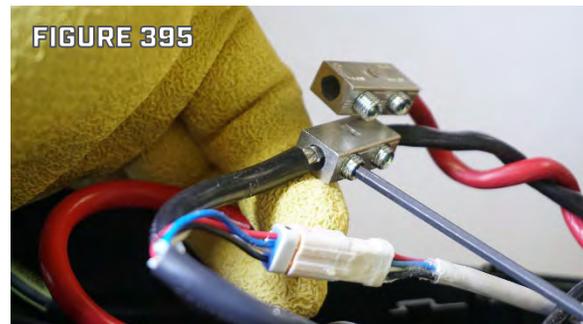
- Step 3. Use a 1/8" Hex Key or Allen Wrench to loosen one of the Set Screws in the Splicer on the Black Motor Power Wire and repeat for the Red Motor Power Wire, allowing the Motor Power Wires to be removed from the Splicers. (Figure 395)

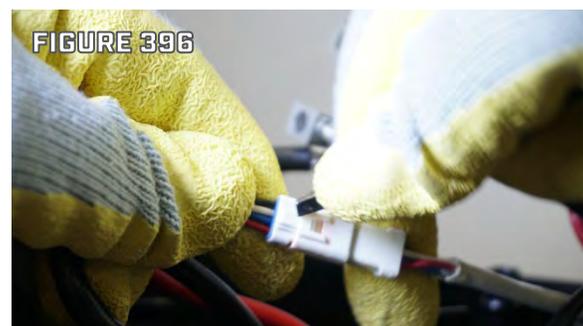
- Step 4. Use a Pick or Small Flat Blade Screwdriver to depress the locking tab on White Motor Communication Plug and pull to disconnect the Plug. (Figure 396)

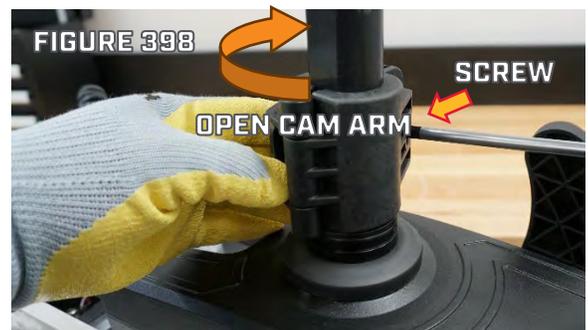
Step 8. Grasp the Shaft with one hand, to offset the weight of the Lower Unit and use the other hand to open the Cam Arm. Lower the Shaft and Lower Unit until the Skeg rests on the floor. #3 Phillips Screwdriver to remove the Screw from the Depth Collar opening the Depth Collar completely. Removing the Depth Collar from the Steering Housing Be aware of the Spring in the collar assembly, do not lose the Spring while removing the Screw from the Depth Collar. (Figure 398)

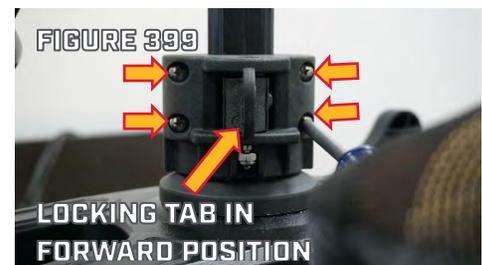
Step 10. Models that have a 72", 87", or 100" Shaft will need to have the Stow Lock Collar removed. Place the Locking Tab into the straight forward position. Use a #2 Philips Screwdriver to remove the four Screws, and take care to make sure the four Nuts don't fall out of the back half of the Stow Lock Collar. Set aside for reuse during installation. (Figure 399)

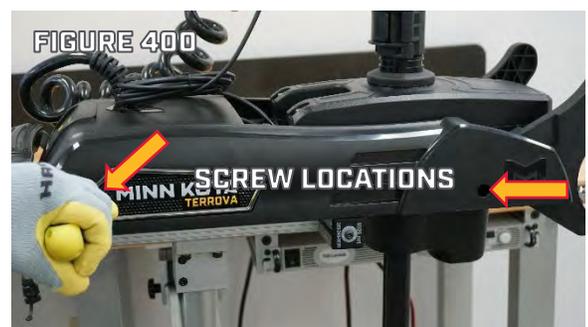
Step 11. Use a #3 Philips Screwdriver to remove the Screws holding the Port and Starboard Sideplates. (Figure 400)

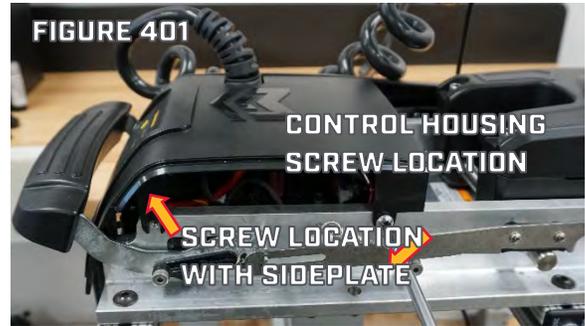
Step 13. Use a #2 Philips Screwdriver to remove the two Screws that secure the Ribbon Cable Power Button to the Control Housing. (Figure 402)

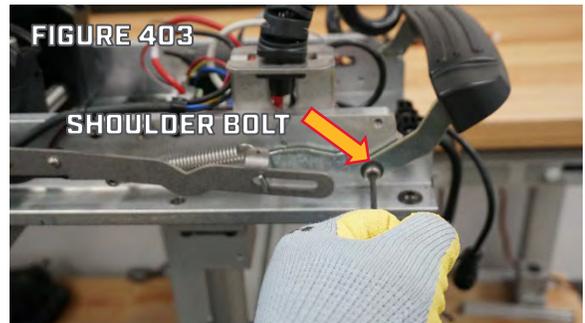
Step 14. With the Stow Deploy Lever in the vertical position use a 5/32" Allen Wrench to remove the Shoulder Bolts on the Port and Starboard side of the Stow Deploy Lever. The Shoulder Bolt on the Starboard side is the longer of the two. Push the Motor Ramps up into the stowed position, so the Latch Pin doesn't engage with the Base Extrusion later in the process of removing the Steering Housing. (Figure 403 & 404)

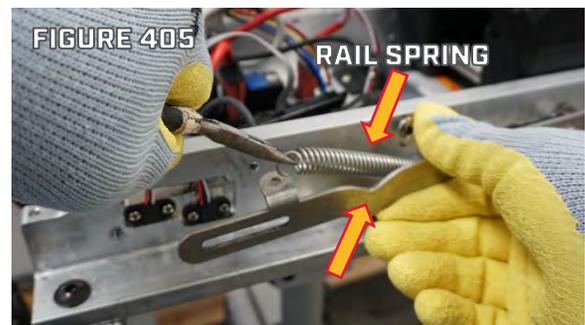
Step 15. While holding onto the Side Rail use a Needle Nose Pliers to remove the Rail Spring, on the Port and Starboard sides of the Base Extrusion. After removal of both Rail Springs let the Side Rail hang off to the side of the Base Extrusion. (Figure 405)

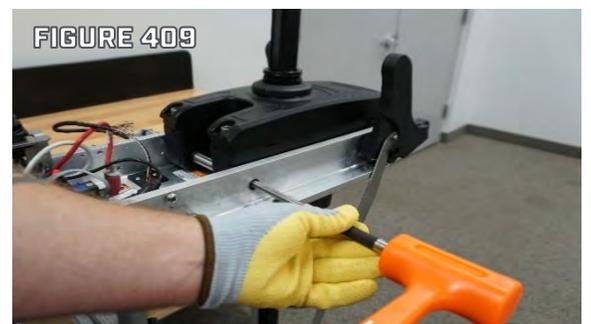
Step 19. After removing the Pivot Pin, slide the Steering Housing up and off of the Shaft. The Steering Housing has two Bushings, one on each side of the Steering Housing, where the Pivot Pin was removed. Set the Bushings aside for reuse during installation. (Figure 410 & 411)

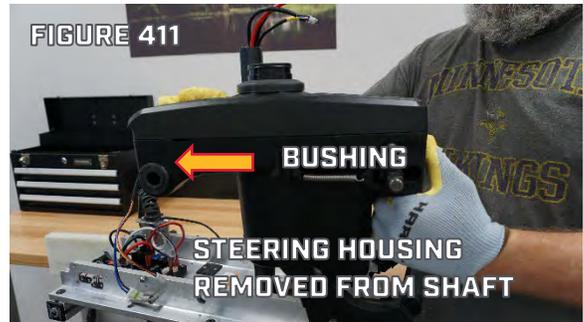
**NOTICE:** The Bushings (Part #2207311) are a wear part and will eventually need to be replaced. Before installing the two Bushings (Figure 411) into the Steering Housing, look over the two Bushings set aside during removal for any wear or damage. Replace the two Bushings if necessary.

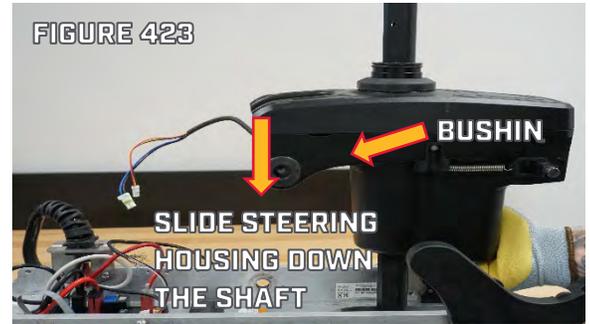
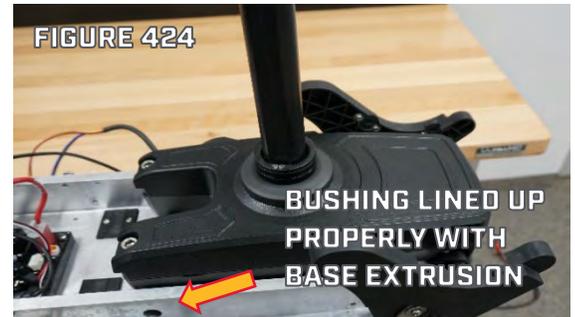
Step 1. Insert the two Bushings that were set aside during removal, into the replacement Steering Housing. Slide the Steering Housing down the Shaft and into place. Make sure the Bushings line up with the holes in the Base Extrusion so the Pivot Pin can be inserted properly. (Figure 423 & 424)

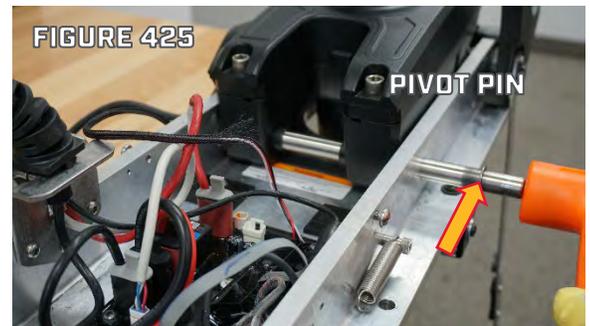
Step 2. Using a Mallet or Hammer with a Large Punch drive the Pivot Pin through the Base Extrusion and Steering Housing. Start reinstalling with a Mallet or Hammer first. Remember to install the E-ring that was set aside during removal onto the Pivot Pin. (Figure 425)

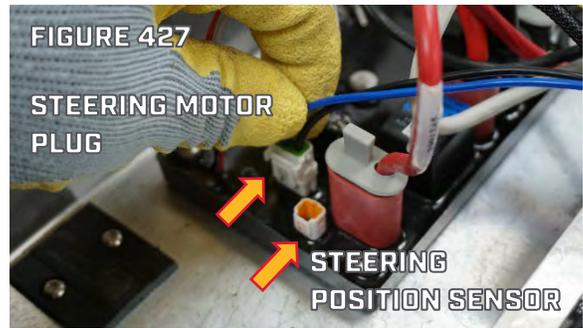
Step 4. Reinstall the Steering Motor Plug and Steering Position Sensor Plug into their respective connectors on the Control Board. (Figure 427)
