# MINN KOTA®

**SERVICE PROVIDER REPAIR MANUAL**

## **QUEST SERIES MOTOR REPAIR**

**ULTREX QUEST 2023-PRESENT**  
**ULTERRA QUEST 2023-PRESENT**  
**RIPTIDE INSTINCT QUEST 2023-PRESENT**  
**TERROVA QUEST 2023-PRESENT**  
**RIPTIDE TERROVA QUEST 2023-PRESENT**

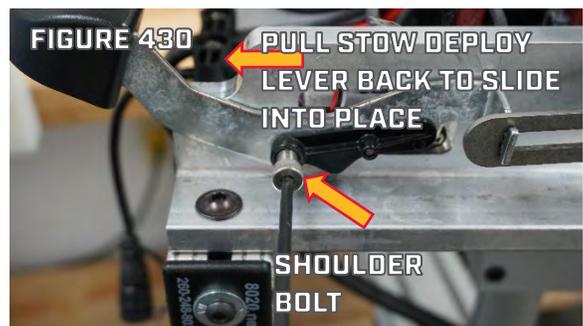
Step 6. With the Stow Deploy Lever in the vertical position, slide the ends of the Stow Deploy Lever into the slotted ends of the Side Rails on the Port and Starboard sides of the Base Extrusion. The longer of the two Shoulder Bolts goes on the Starboard of the Stow Deploy Lever. After the Stow Deploy Lever is installed, reinstall the Shoulder Bolts using a 5/32" Allen Wrench through the Stow Deploy Lever into the Base Extrusion. There will be tension on the Side Rails so you will need to pull back on the Stow Deploy Lever to install the Shoulder Bolts. (Figure 429 & 430)

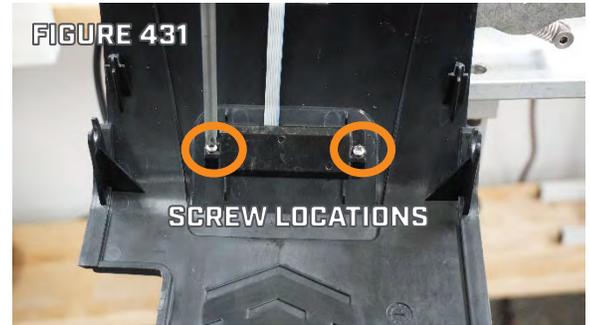
Step 7. Use a #2 Philips Screwdriver to install the two Screws that secures the Ribbon Cable Power Button to the inside of the Control Housing. (Figure 431)

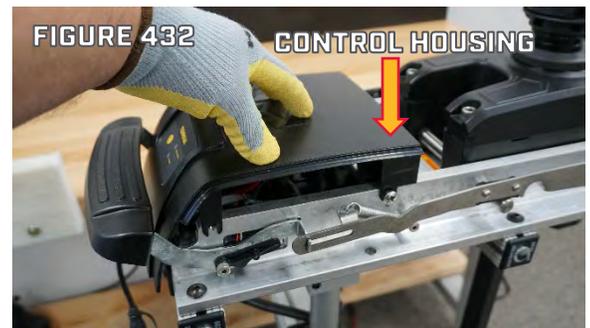
Step 9. Using a #3 Philips Screwdriver tighten the two Screws one or two turns to the Base Extrusion, if not removed in Step 11. The other two Screws will be reinstalled when the Sideplates are fastened to the mount. (Figure 433)

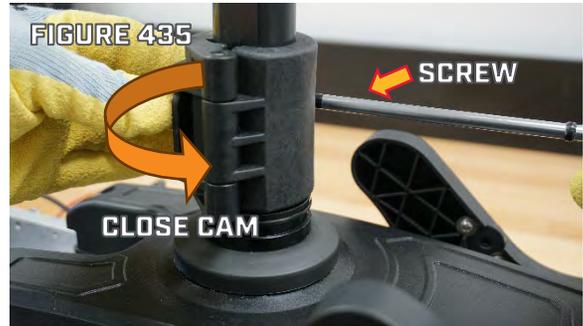
Step 12. Models that have a 72", 87", or 100" Shaft will need to have the Stow Lock Collar reinstalled. The Locking Tab will need to be in the straight forward position. Use a #2 Phillips Screwdriver to tighten the four Screws. The back half of the Stow Lock Collar has four Nuts you will want to make sure didn't fall out. (Figure 436)

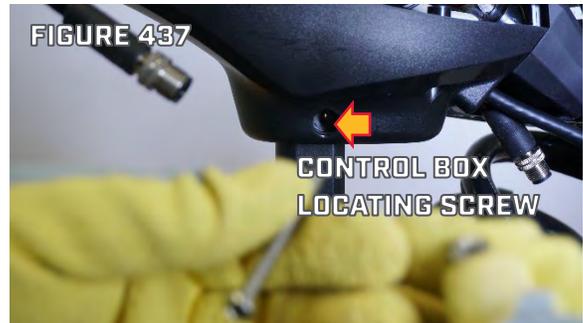
Step 13. Make sure the Nut for the Control Box Locating Screw is in the detail that captures the Nut on the right side of the Control Box. From the Left Side of the Control Box, slide the Control Box Locating Screw through the Control Box and Motor Shaft into the Nut. Use #2 Phillips Screwdriver to tighten the Control Box Locating Screw. (Figure 437)

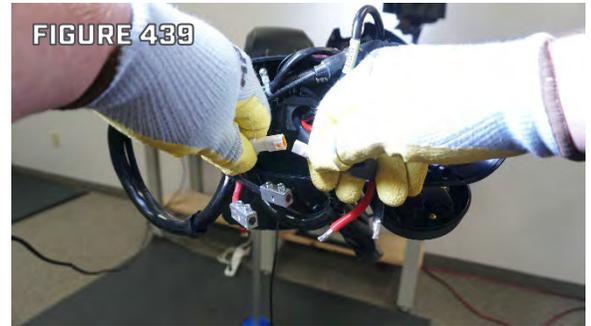
Step 15. Push the two halves of the Motor Communication Cable Connector together until the locking tab engages. (Figure 439)

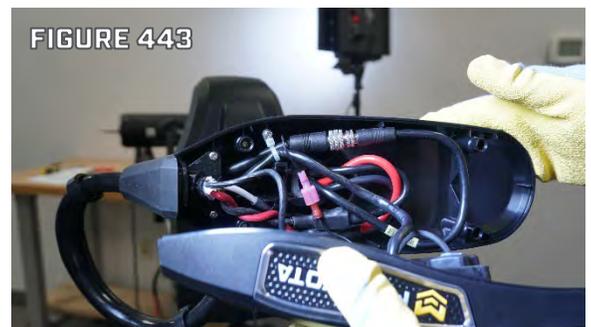
Step 22. Position all the wires such that none of the wires intersect a screw boss or the outer rim of the Control Box. (Figure 443)
