Ultrax

Case I. Motor will not steer using Footpedal.

Ultrex Sensor Board Replacement Instructions:

Ultrex Sensor Board Replacement 2884023

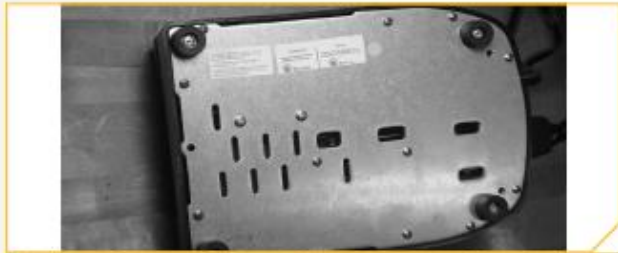
- a. Disconnect the motor from power and, with the motor deployed rotate the motor lower unit to place the foot pedal rocker in a level position. Turn the foot pedal over and use the #2 Phillips screwdriver to remove the twelve #8-18x5/8" screws and the two #10-32x1/2" machine screws from the bottom plate.

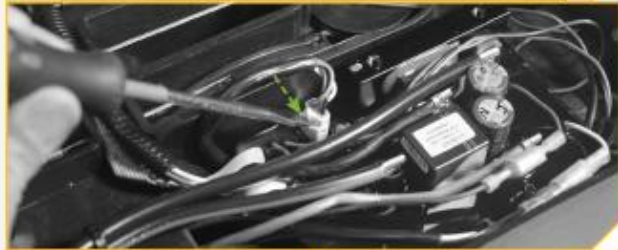
- b. Using a small flat blade screwdriver, disconnect the steering sensor board plug (with four wires red, white, green, and black) from the main control board.

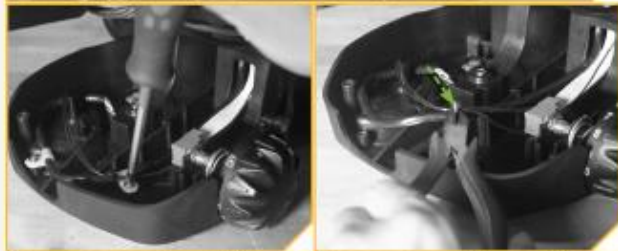
- c. Using the #2 Phillips screwdriver, remove the two #8-18x1/2" screws from the cable clamps that hold the steering sensor board cable. Use a small wire cutter to remove the cable tie that holds the two black momentary reed switch leads to the steering sensor board cable.

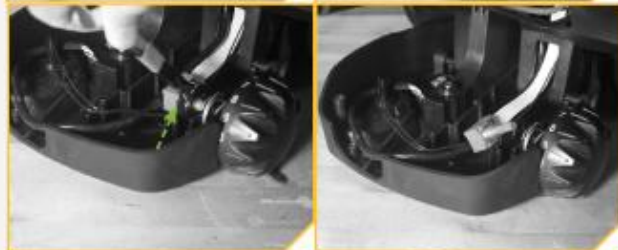
- d. Disconnect the control board potentiometer from the speed control knob, loosen the potentiometer nut completely using a 1/2" open-end wrench and slide it out.

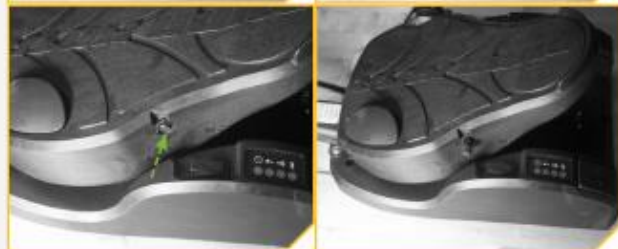
- e. Turn the foot pedal back over and locate the knurled side of the pivot pin. Use a hammer and a 3/16" punch to drive the pin out towards the knurled end.

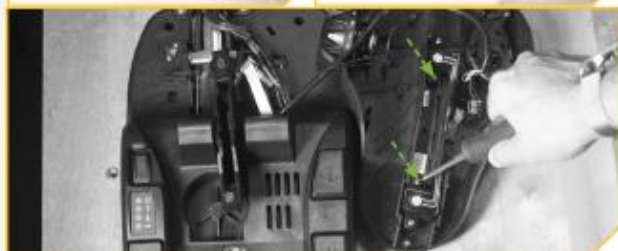
- f. Remove the foot pedal top with magnets and turn over to expose the steering sensor board. Use a #2 Phillips screwdriver to remove the four #6-20x3/8" screws from the steering sensor board and remove the steering sensor board with cable.

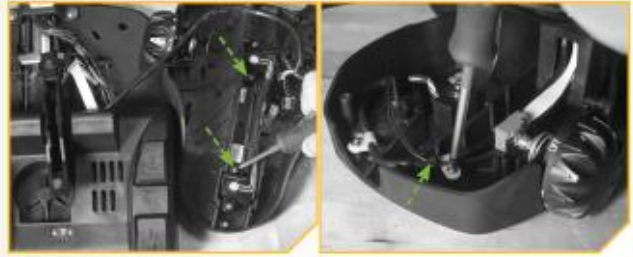
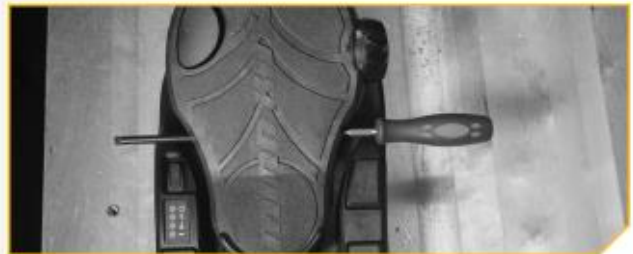
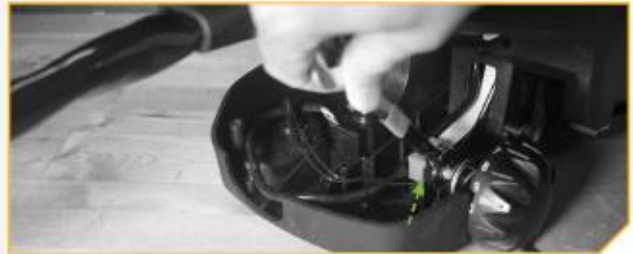
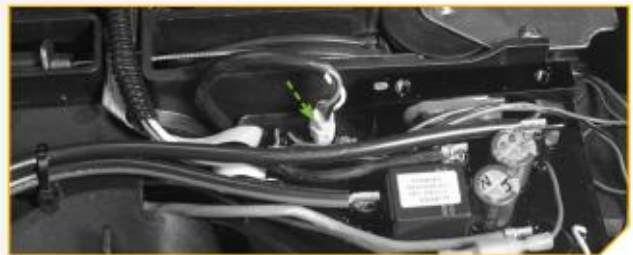
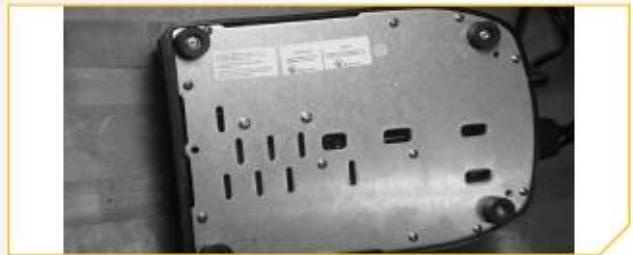
- a. Install the replacement steering sensor board and secure in place with the four #6-20x3/8" screws with a #2 Phillips screwdriver. Attach the two cable clamps to the steering sensor board cable using a #2 Phillips screwdriver and the two #8-18x1/2" screws. Use the supplied Tie Wrap to secure the two black reed switch wires to the steering sensor board cable indicated by the arrow in the image to the right. Route the steering sensor board cable through the small opening where the potentiometer ribbon cable and reed switch wires are located.

- d. Turn the foot pedal back over and connect the steering sensor board connector to the main control board, making sure it clicks into place.
- e. Position the bottom plate onto the foot pedal base and install the two #10-32x1/2" machine screws with a #2 Phillips screwdriver to secure the main control board to the bottom plate.

- f. Install the remaining twelve #8-18x5/8" screws into the bottom plate with a #2 Phillips screwdriver.

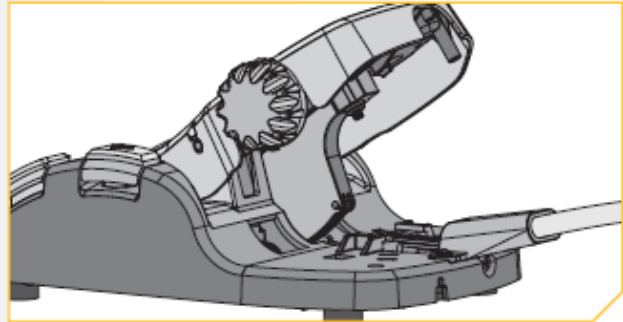
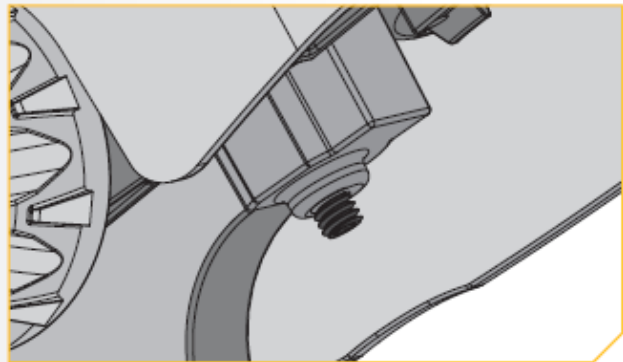
Over tightening the set screw may cause significant and irreparable damage to the electrical components of the unit and will severely diminish the expected range of performance.
