# MINN KOTA<sup>®</sup>

SERVICE PROVIDER REPAIR MANUAL

## BRUSHED TERROVA MOTOR REPAIR

**KAYAK TERROVA 2025-PRESENT**  
**TERROVA 2.5/RT TERROVA 2.5, ADV GPS EQUIPPED TERROVA 2023-PRESENT**  
**TERROVA BT/RT TERROVA BT 2017-2023**  
**TERROVA/RT TERROVA/RT ST 2007-2016**

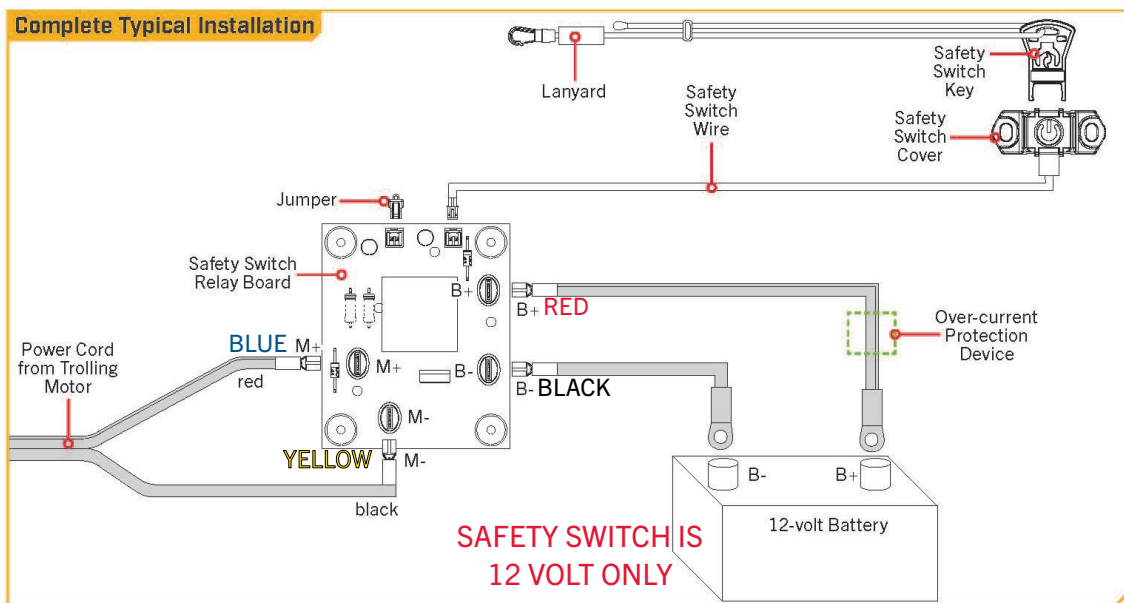
## SAFETY SWITCH WIRING DIAGRAM

- This is a two input Safety Switch, both inputs must be "closed" for the Safety Switch to send power to the motor. The "Jumper" closes the unused input and must be properly installed for power to get to the motor.
- The Safety Switch Relay Board installs inline on the power wires; the safety switch wire is 80" long.

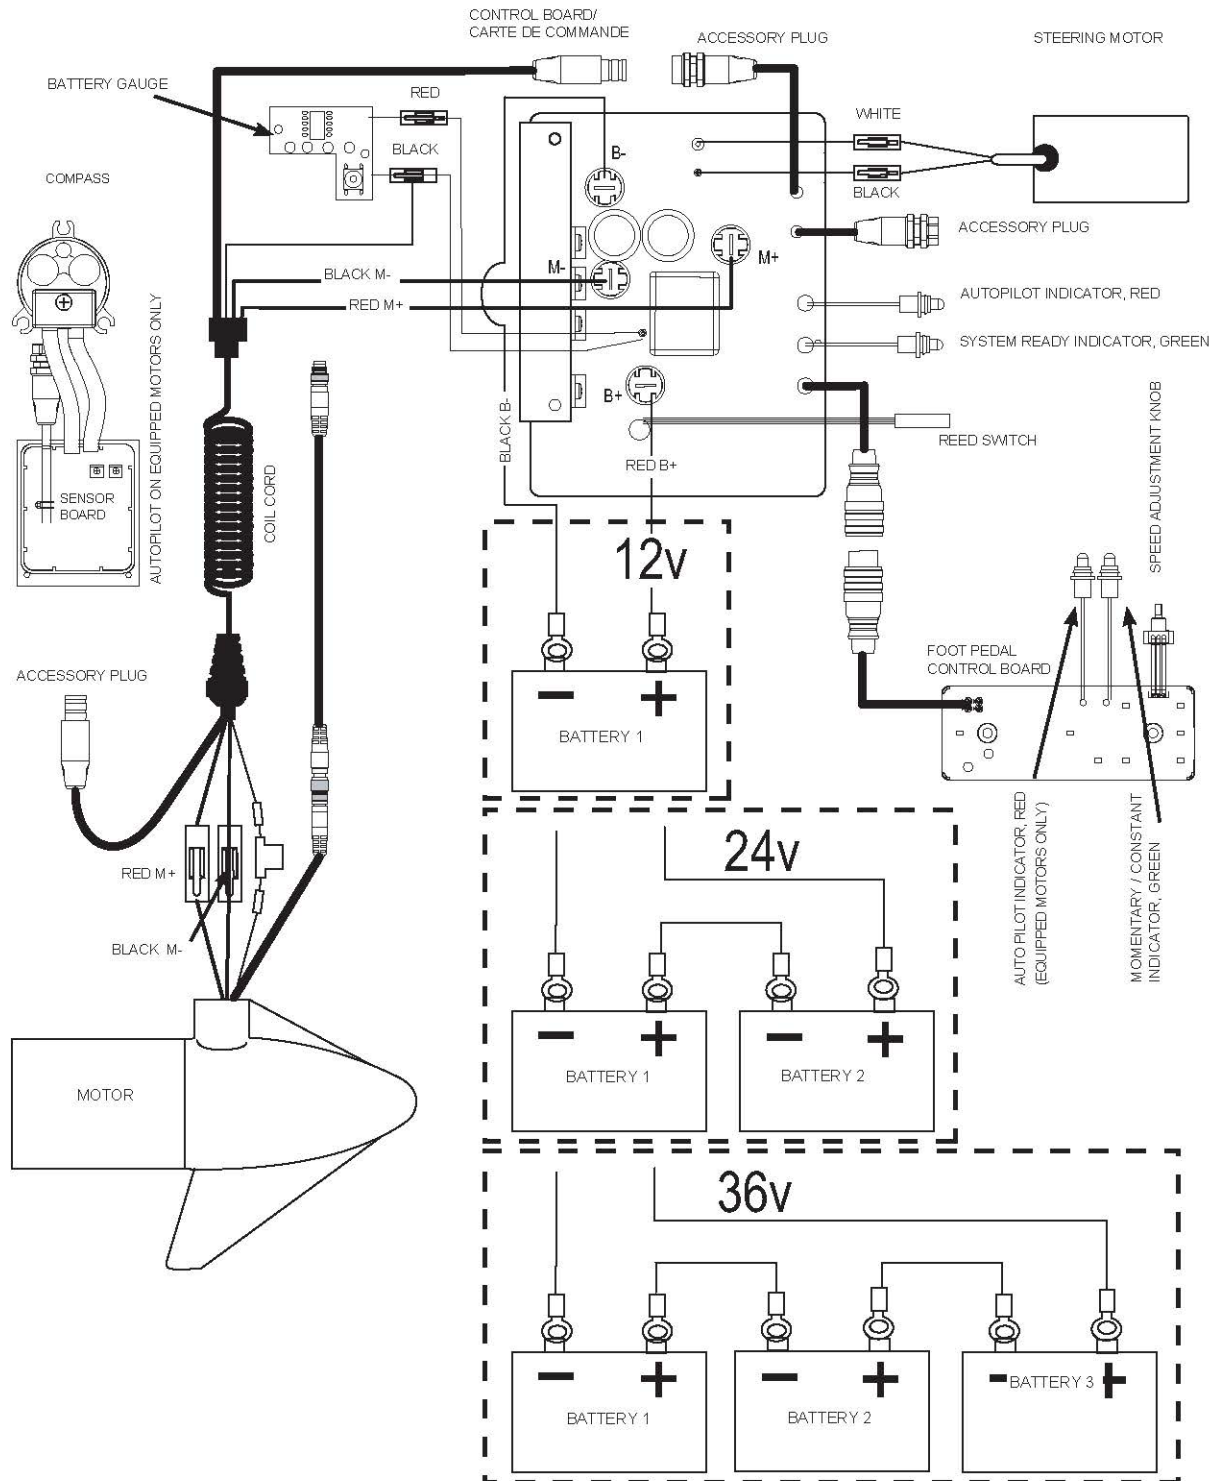
**WIRING DIAGRAM**

**THIS IS A UNIVERSAL MULTI-VOLTAGE DIAGRAM. DOUBLE CHECK YOUR MOTORS VOLTAGE FOR PROPER CONNECTIONS**

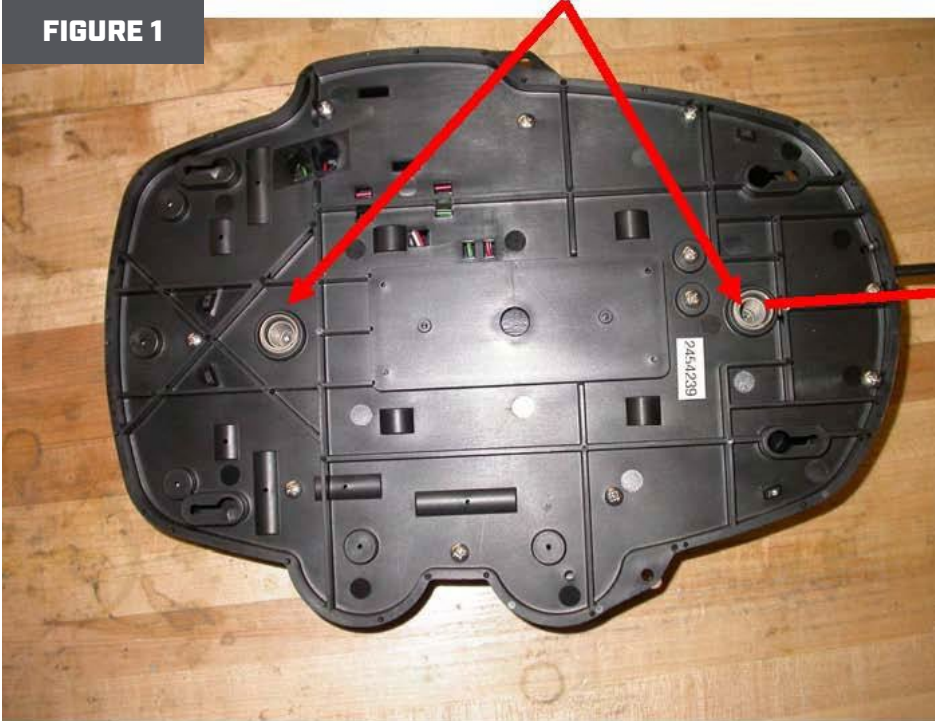
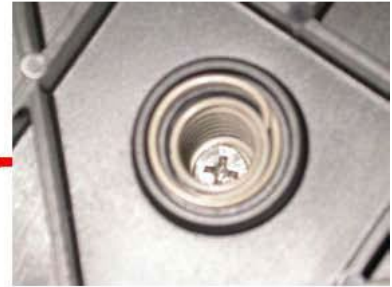
**FIGURE 1**

Step 1. Turn the foot pedal upside down and remove the two screws shown in FIGURE 1 with a #2 Phillips screwdriver.

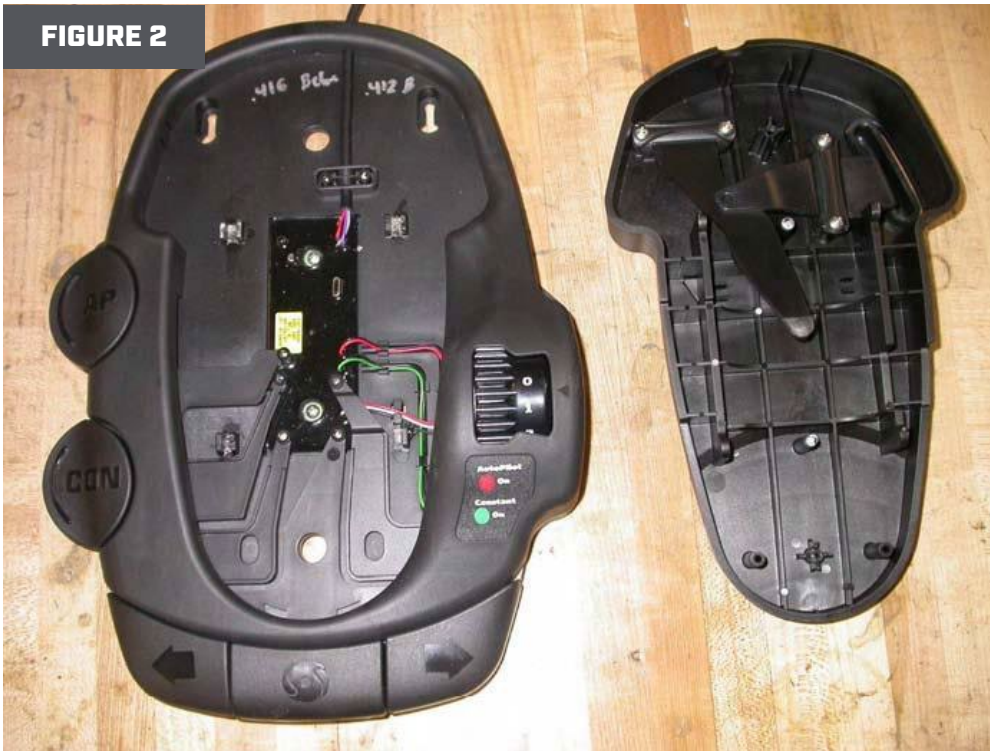
**FIGURE 2**

Step 2. Flip foot pedal over and lift heel/toe pedal off. (FIGURE 2)

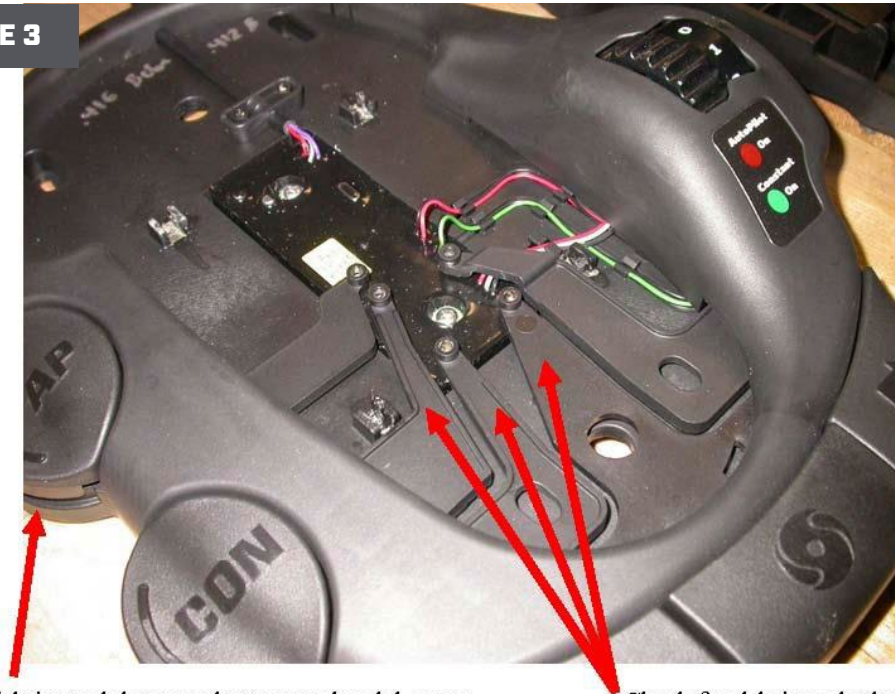
**FIGURE 3**

Step 3. Check for rocks, twigs, sand, or other debris that may be lodged under buttons or button arms (FIGURE 3). The foot pedal is waterproof and can be sprayed off or submerged in water to remove any foreign objects such as sand and rocks. (FIGURE 4)

Check for debris stuck between buttons and pedal cover

Check for debris under button arms

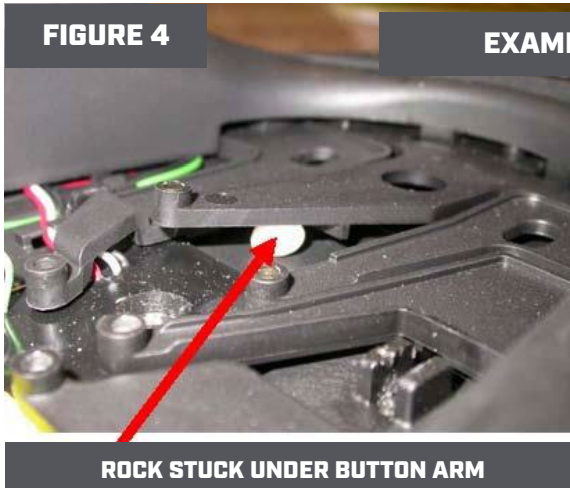
**FIGURE 4**

**ROCK STUCK UNDER BUTTON ARM**
**EXAMPLES OF DEBRIS**
**FIGURE 5**

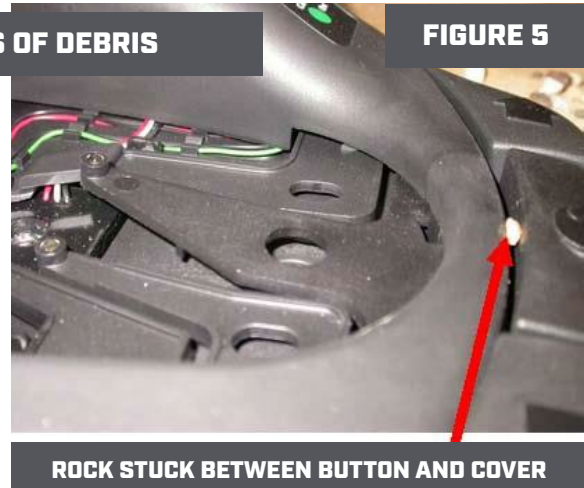
**ROCK STUCK BETWEEN BUTTON AND COVER**

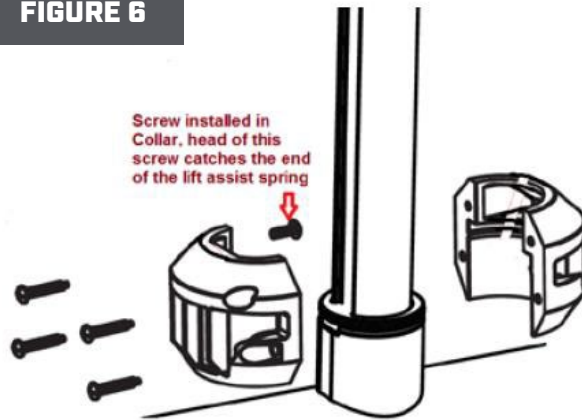
**FIGURE 6**

Step 2. With one hand, maintain pressure on the two collar halves so they do not release when the four screws holding the collar together are removed. Remove the four screws that hold the collar halves together. (FIGURE 6)

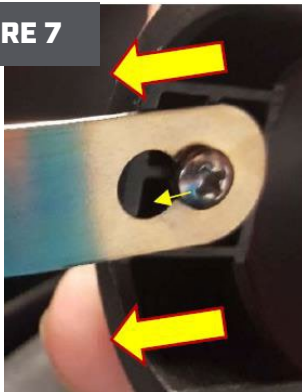
**FIGURE 7**

Step 4. Deploy the motor. Pull the spring out 6-8 inches, firmly grasp the spring, remove the lower collar from the spring by pushing it up until the screw head moves from the narrow portion of the keyhole slot to the open area (FIGURE 7). Then disconnect the spring from the screw/collar, and attach your lift spring assembly tool (p/n 2888800) to the spring by positioning the post of the tool into the keyhole slot. (FIGURE 8)

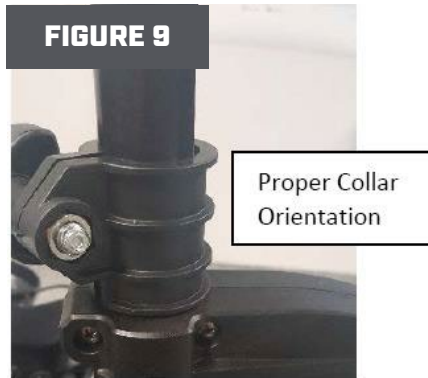
Step 7. Support the motor's lower unit (if it is not contacting the floor) then remove the depth collar. Note the orientation of the collar for proper reassembly later (the steering "drive" portion of the depth collar goes down against the mating "drive" of the Lift Assist Spring Assembly). (FIGURE 9)

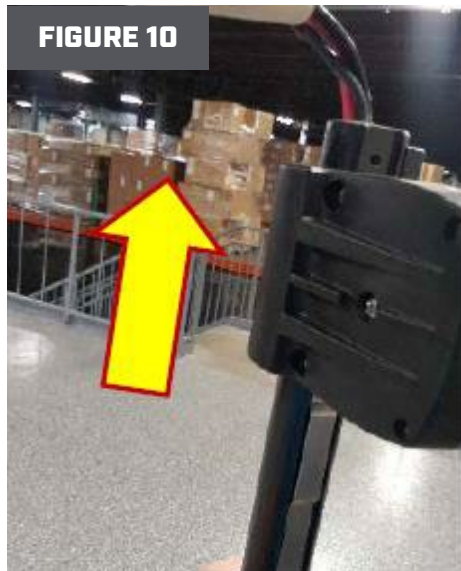
Step 8. Slide the Lift Assist Spring Assembly and the tool up and then off of the shaft. (FIGURE 10)

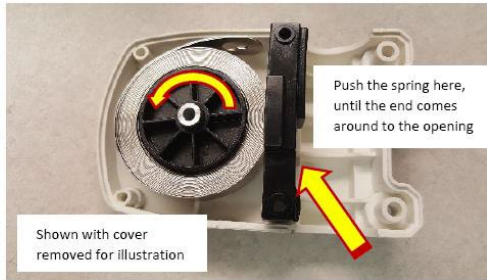
Step 9. Prepare the replacement Lift Assist Spring Assembly: The spring usually has 3-4 inches of spring extending from the housing, but due to vibration when shipping it may be fully retracted inside the housing. If it is fully retracted, you will need to gain access to the spring by reaching into the shaft opening from the bottom end and pushing upward on the spring assembly until the end comes around to the opening. Once the end is at the opening it will be possible to use the lift spring assembly tool (or a hook-shaped pick tool) to hook the end of the spring and pull it out of the housing. (As of October 2020, all Lift Assist Housings will be black in color. A material change was implemented to improve impact resistance and reduce damage from misuse, the new material is not available in white. After careful review it was decided the

benefit of the new material was worth the cosmetic change to the motor.) (FIGURE 11)

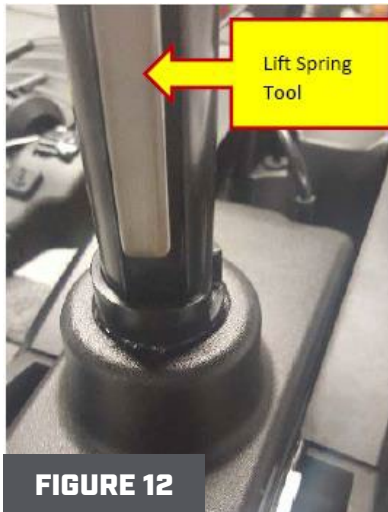
Step 10. Place the handle end of the tool against the flat side of the Terrova Shaft with the raised portion/offset oriented away from the shaft. (FIGURE 12)

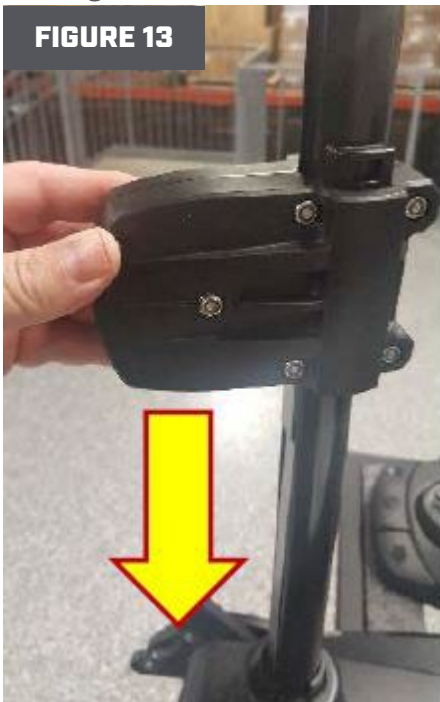
Step 11. Slide the tool down the shaft, keeping it tight to the shaft and guiding the tool through the steering housing. As the top of the tool reaches the top of the shaft, guide the lift spring housing onto the flat of the motor shaft. (FIGURE 13)

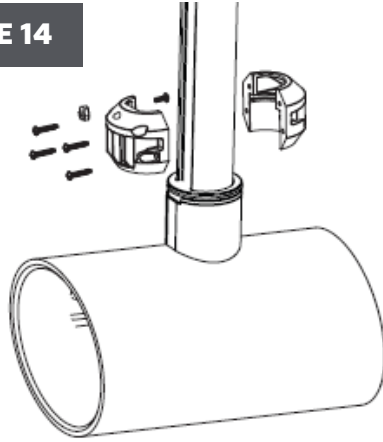
**FIGURE 14**

Step 12. Prepare the lower collar: Install the machine screw through the rear collar and into the nyloc nut. Verify that the screw in the inside diameter of the back half of the lower collar is installed with nyloc nut and that there is enough of a gap between the screw and collar to catch the keyhole slot at the end of the spring assembly in the next step. (FIGURE 14)

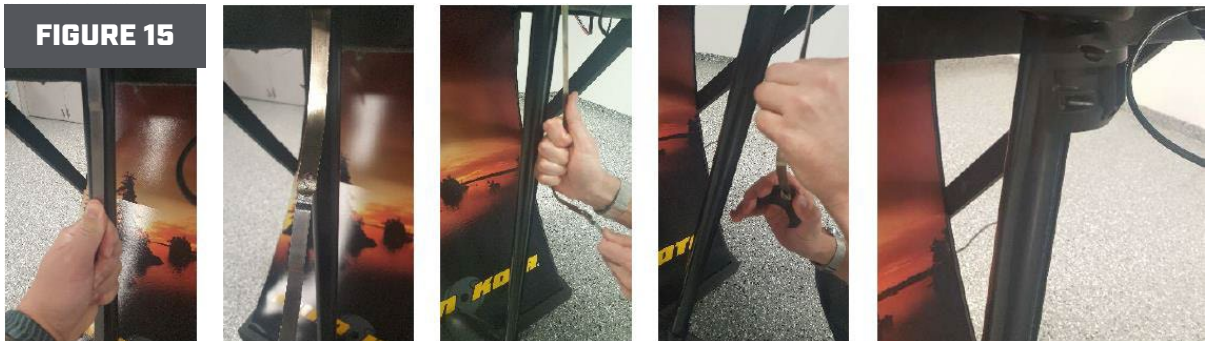
**FIGURE 15**

Step 13. Pull the handle of the lift spring tool down toward the lower unit until 4-5 inches of the lift spring is extended beyond the bottom of the steering housing. Firmly grasp the lift spring, remove the lift spring tool from the end of the lift spring, and attach the back half of the lower collar to the end of the lift spring. Use a #2 Phillips Screwdriver to tighten the machine screw that passes through the keyhole slot in the lift spring, through the rear collar, then into the nyloc nut. (FIGURE 15)

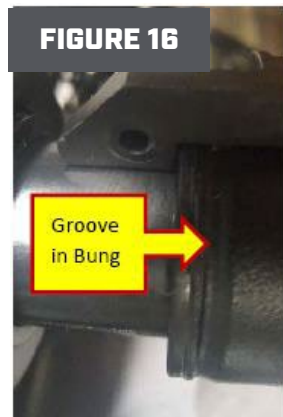
Step 15. With the motor stowed, place the front collar half against the motor bung so that the raised detail on the inside diameter of the collar is in the groove of the motor bung (groove is

located at the top of the bung, just below the plastic bung cap). (FIGURE 16)

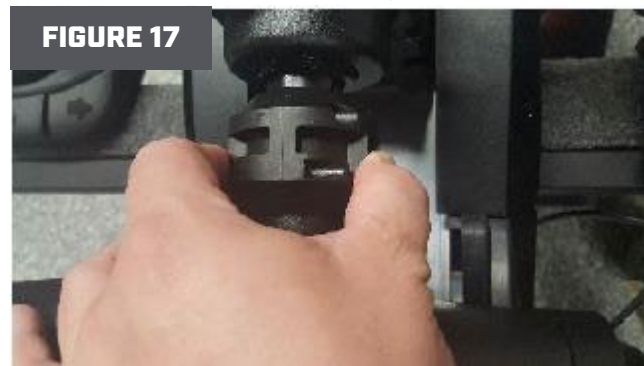
Step 16. Pull the back collar half and spring down from the steering housing and place the collar half on the motor bung so it aligns with the front collar half. Install and tighten the four screws that secure the lower collar in place. (FIGURE 17)

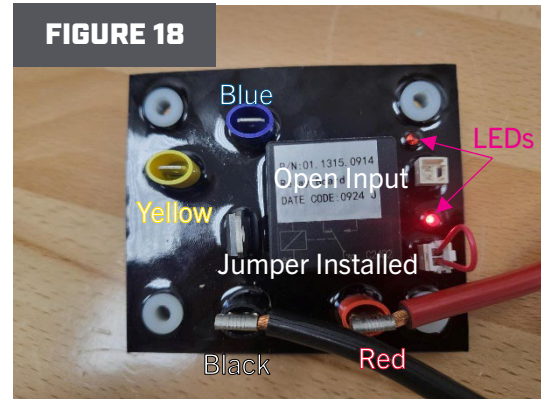
- a. The Jumper is always closed, whenever the Jumper is properly installed and 12 volts is supplied to the relay board, the LED adjacent to the Jumper should be illuminated as shown in Figure 18. If the Jumper is installed but the adjacent LED is not illuminated replace the Jumper.

- b. The reed switch at the end of the Relay Switch Wire closes when a magnet is nearby. The Safety Switch Key has an embedded magnet—when placed near the end of the Safety Switch Wire, it should cause the adjacent LED to light up. If the LED doesn't turn on when the Key is close or doesn't turn off when the Key is removed, replace the Safety Switch Wire

- c. If one LED illuminates but the other does not when it should, reverse the connectors.
  - i. If the same LED will not illuminate replace the Safety Switch Relay Board.

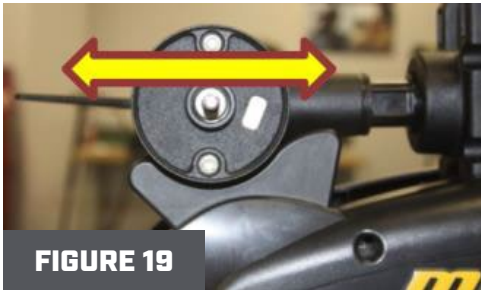
**FIGURE 19**

- Step 1. If the lower unit movement is forward and back as indicated by the arrows in FIGURE 19 AND FIGURE 20 or a range of twisting movement as indicated in Picture 6 then install shim kit p/n 2881721. (instructions are included with shim kit)

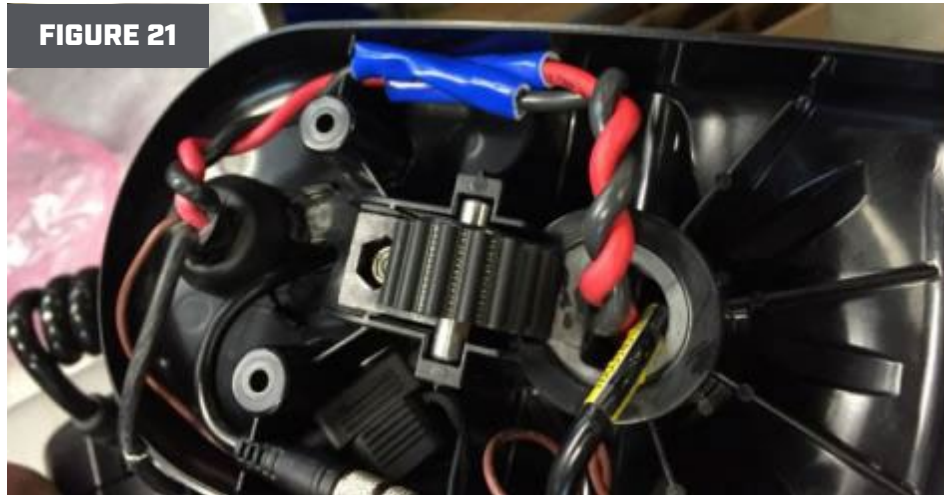
**FIGURE 21**

- a. If the motor shaft was shortened, the brush leadwire should also be cut back the same length.
    - b. If the motor shaft was shortened and the motor has a built-in transducer, the extra transducer cable should be routed out of the control box and down the coil cord.

**NOTICE:** The red/black wires should be twisted three times on both the coil cord and brush leadwire sides and then the insulator or shrink tube is slid in place over the spade connectors. This picture shows an Ulterra, but the wire routing is similar and critical for all motors with i-Pilot, i-Pilot Link, or Advanced GPS Navigation. See Figure 21.

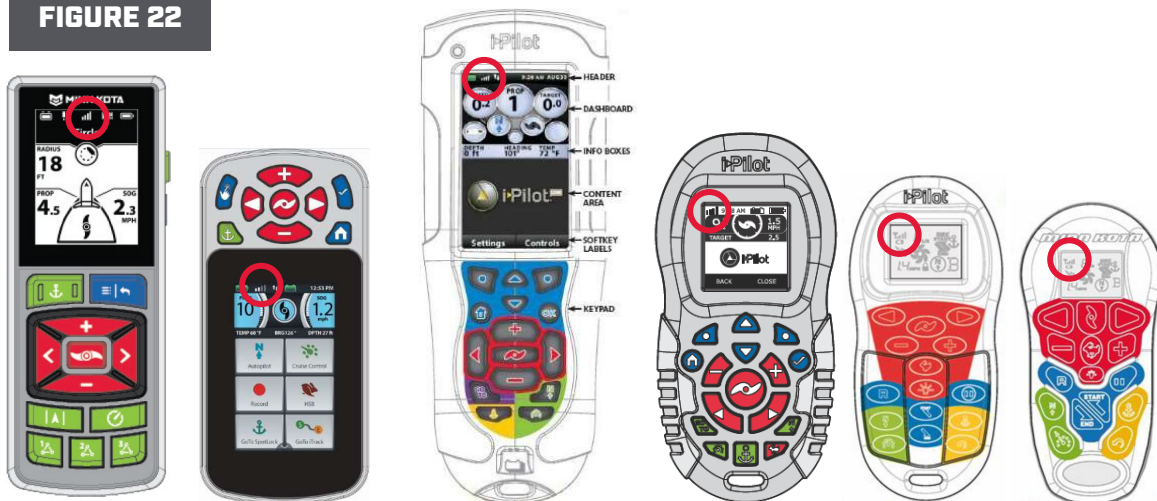
**FIGURE 22**

**NOTICE:** GPS signal strength is indicated by 1-4 bars on screen (Circled on each remote diagram). If no bars are displayed all GPS functions will be disabled. See Figure 21.

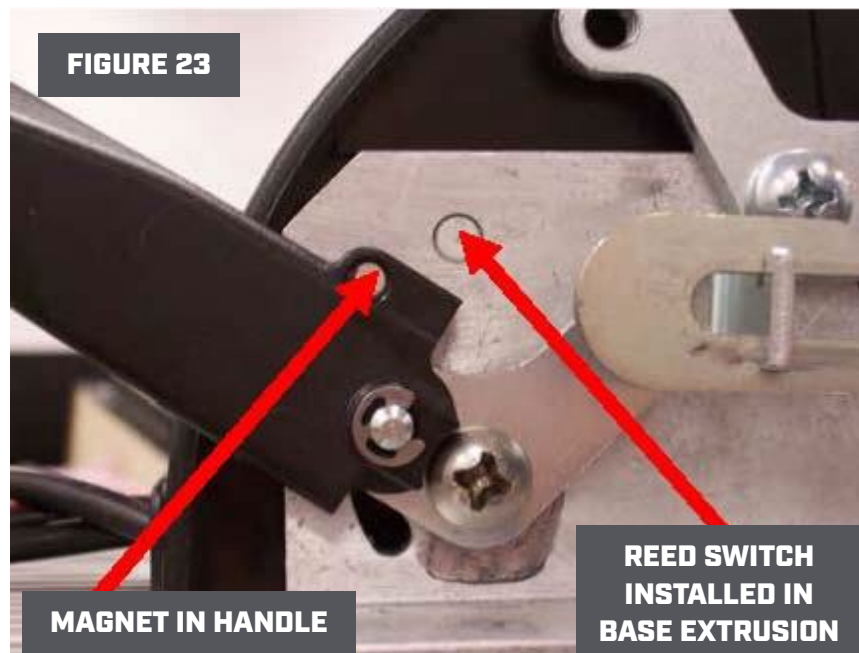
- Step 1. Ensure the release handle is fully latched and locked into the stowed position.
- Step 2. Check to ensure the system ready reed switch (small plastic cylinder with two wires going to control board) is positioned in the side of the base extrusion. (Remove the right sideplate for viewing.) (see Picture 1, below)
- Step 3. Inspect the release handle cover, p/n 2320215, for the presence of the magnet. Replace handle cover if magnet is missing.
- Step 4. If the reed switch and magnet are in place, but system ready LED remains lit when the motor is stowed, the reed switch is faulty. You can verify this by bypassing the reed switch (cut off the reed switch and connect the wires together). If the reed switch is determined to be faulty, replace the reed switch with Minn Kota p/n 2884050. (FIGURE 23)

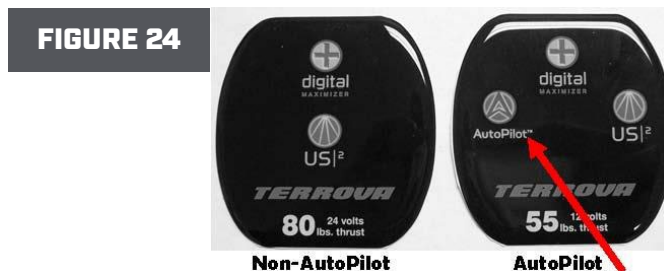
- a. All 2016 and earlier Terrova motors that leave the factory with the AutoPilot feature installed will indicate this on the control box cover decal. (see Picture 2) All Terrova motors made after 2009 will indicate their model information on the serial number decal, this will be the best indicator on 2017 and Later motors. (FIGURE 24)

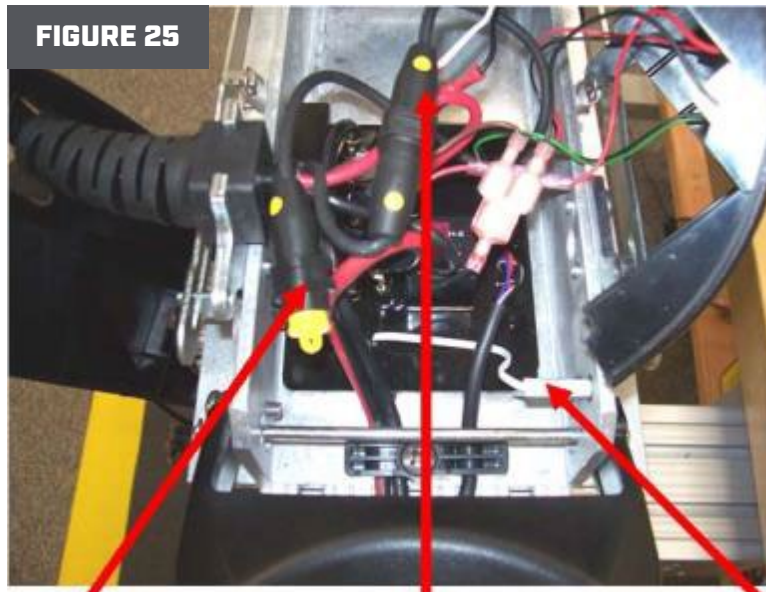
**FIGURE 25**
**Unused Network Plug**
**Network Plug Connected to  
Coil Cord/AutoPilot**
**Reed Switch  
System Ready Switch**

**NOTICE:** Starting In 2014 some control boards only have 1 network cable plug. Picture 3 is showing 2 network cables coming off control board. In this case, one is connected to the compass board network plug and the other is not being used. (No CoPilot attached, so yellow cap still on plug.) If there are 2 network plug leads from the main control board they are common and either lead can be connected to either accessory.

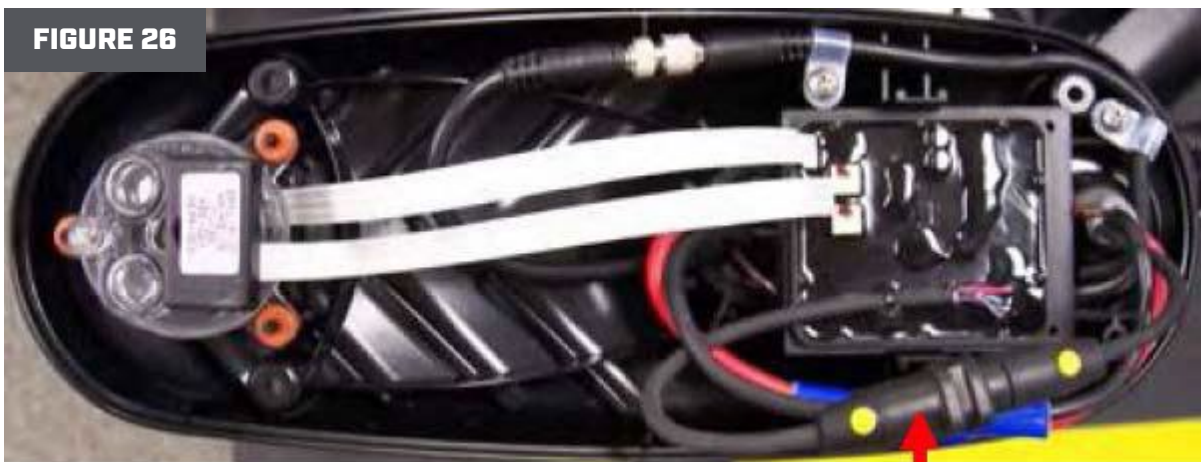
**FIGURE 26**
**Network Plug, Connected to AutoPilot Board**

**NOTICE:** Picture 4 shows a Control Box with AutoPilot Compass Board Installed.
