MINN KOTA®

BUILT-IN SONAR REPAIR

BUILT IN DSC (DUAL SPECTRUM CHIRP) 2023-PRESENT

US2 (UNIVERSAL SONAR 2) 2007-2023

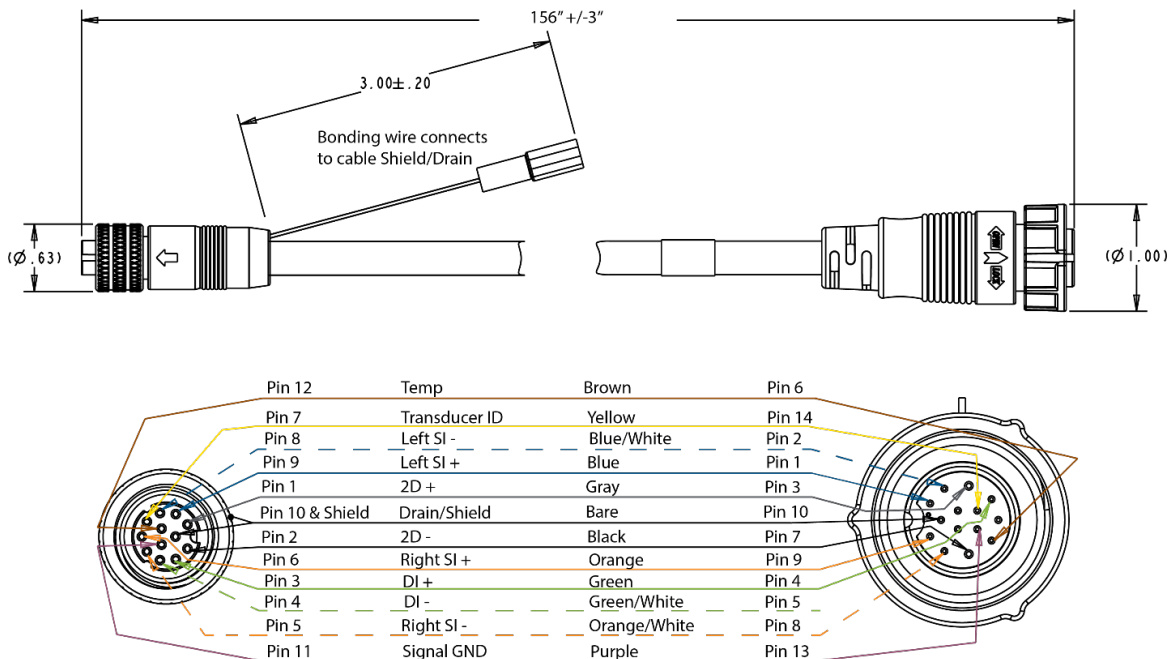
The output cable connected in the control box is 490516-3, diagramed below:

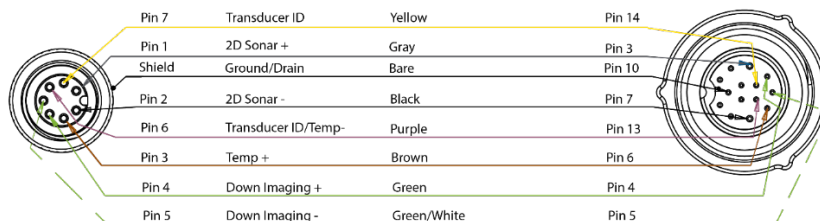
Depending on the motor, the cable connecting from the control box to the base of the motor will be either 490507-1 or 490507-2. These cables only differ from each other in length, and are diagramed below.

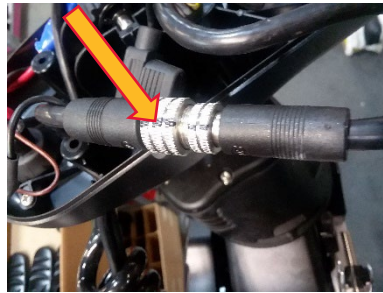
A-1. Loosen the connectors. Next, using your fingers only, tighten the connectors to a reasonable level.

A-2. Draw a line straight across both connector halves.

A-3. Using appropriate slip-joint pliers or similar tools, grasp each connector half. Using the above drawn line as a reference, tighten the connectors an additional $\frac{1}{4}$ of a turn. (see picture on next page)
