# Ulterra Repair Manual

**BT Ulterra & BT Riptide Ulterra 2017-2023**

**Ulterra 2015-2017**

**Riptide Ulterra 2016-2017**

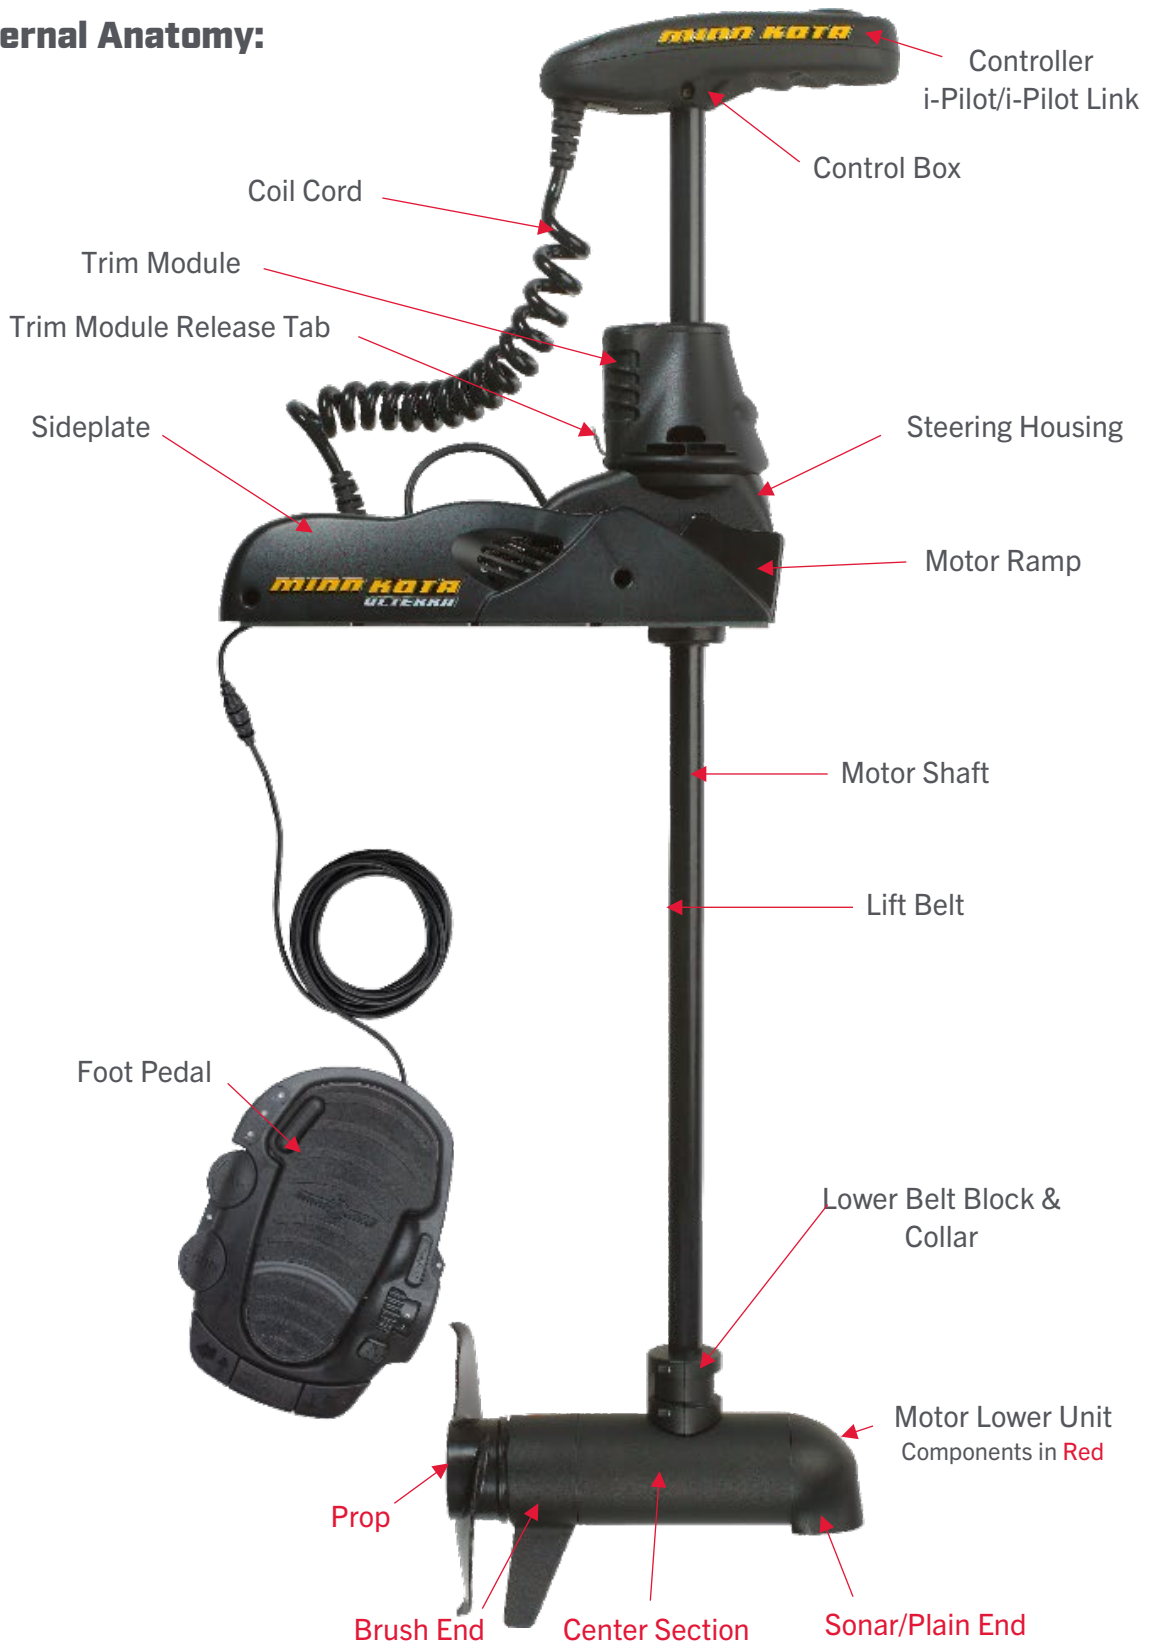
**Ulterra Anatomy:**  
**External Anatomy:**

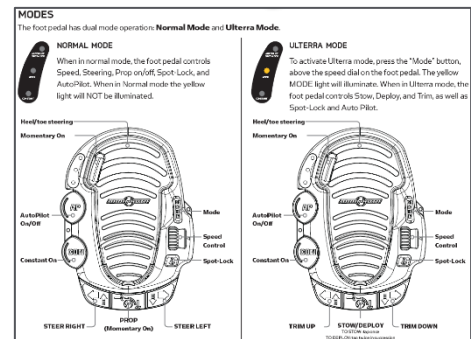
If the Ulterra's shaft is horizontal, but the Motor Lower Unit is not fully stowed on the Motor Ramps, the Ulterra will accept a trim up command. The Ulterra is considered horizontal when the Tilt Bracket Sensor is activated by the Magnet Holder attached to the Tilt Bracket. A connected Foot Pedal in Ulterra Mode is the only reliable way to send a Trim Up command.

Once the Ulterra has trimmed up to the point in actuates the Plunger it will not allow any further trimming, and the Trim Count will be zeroed, this is an alternative Trim Count Reset.

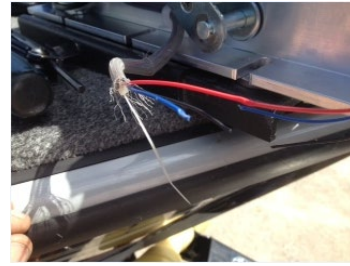
Actual photo supplied by a service provider showing damage caused by improper rigging.

**Possible Cause 2:** This malfunction is often found to be a result of unintentional/accidental damage to one or more of the three wires that connect each of the three Hall Effect Ulterra motor sensors to the main control board. The red, blue, and black wires going to each sensor are enclosed in black or gray mesh tubing running along both sides of the motor base extrusion. These wires can be accidentally damaged, pinched, or cut if care is not used to make certain that the

motor (or Quick Release Plate) mounting bolts do not damage the wires when the bolts are tightened. The cutting of any of the sensor wires will cause the motor to be inoperative.

**Corrective Action:** Examine the mesh covering on the wires for any signs of damage. If damage is found, pull back the mesh covering to expose the individual red, blue, and black sensor wires. Any wires found to be cut can be stripped, spliced, soldered, and sealed with small diameter heat shrink tubing to return the motor to proper function. Test stow, deploy, trim, steer, and operate the motor lower unit to ensure proper operation. When the motor is returned to the customer advise the customer that they use care to avoid pinching or cutting the sensor wires inside the mesh tubing.

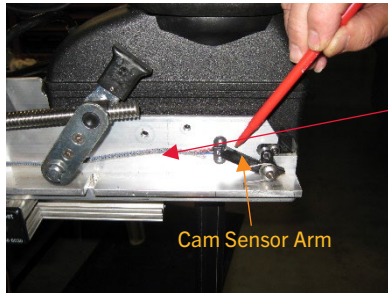
Picture 1

**Corrective Action:** Remove the Ulterra right side plate, held in place with two (2) ¼-20 x ½” Phillips panhead screws, then use a 3/16” Allen wrench to remove the two (2) ¼-20 x 1” socket head cap screws that hold the right motor ramp in place. With the ramp removed the cam sensor arm can be seen along with the cam sensor. (Picture 1) Examine the back surface of the cam sensor arm. At the end of the arm, opposite the pivot point, a chrome-plated, 3/16” diameter magnet should be visible (Picture 2), or you can slip a thin blade screwdriver behind the arm to verify the presence of the magnet based on the magnetic pull of the magnet. If there is no

magnetic pull, then it is missing. If the magnet is missing then the cam sensor arm (p/n 2777903) should be replaced.

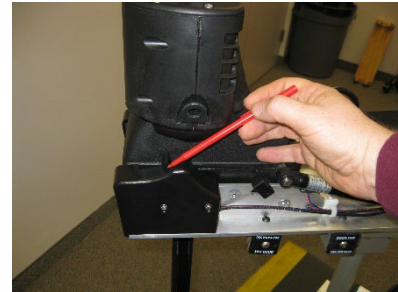
Left Motor Ramp/Plunger

**Cause:** The magnet in the plunger assembly within the left front motor ramp is missing or the wires going to the plunger sensor are damaged. (See Picture) As a result, the plunger sensor does not signal that the motor is stowed and the trim housing keeps trying to pull the motor up on to the ramps when it is already stowed. (Beginning with s/n **P224MK01075** and later all magnet holders are using a mechanically staked-in process to prevent magnet loss.) To reduce the opportunity for the plunger to become stuck down the linear plunger was replaced by a rotary plunger in early 2020.

**Corrective Action:** Remove the Ulterra left sideplate by unscrewing the two ¼-20 x ½ inch Phillip head screws that hold the sideplate in place. Then use a 3/16 inch Allen wrench to remove the two ¼-20 x 1 inch socket head cap screws that hold the left front motor ramp on to the aluminum base extrusion. On the back side of this ramp you will find a spring plunger that is held in place by a single Phillip's head screw and washer. Remove this screw and washer then remove the plunger and spring. Examine the back side of the plunger. A small chrome plated 3/16" diameter magnet should be seen at the lower end of the plunger. When it is missing the Ulterra motor will malfunction as described above. Replace the left motor ramp assembly that includes the plunger (112 Motor: p/n 2773947; 80 Freshwater: p/n 2773946; 80 Saltwater: p/n 2773948) to correct the issue. Reassemble the motor in reverse order of disassembly.
